Railway Accident Investigation Unit

INVESTIGATION REPORT

Structural failure of a platform canopy at Kent Station, Cork

18th December 2013
RAIU Report No: R2014 – 005
Published: 7/11/2014

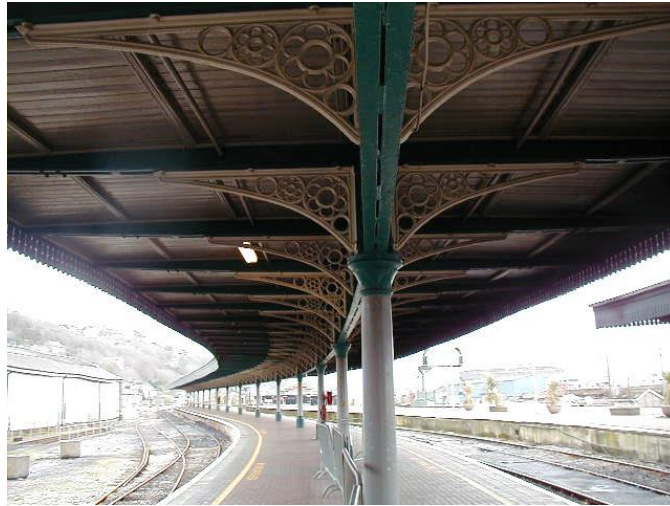
Figure 5 – Canopy above Platforms 1 and 2

- 11 All rails are laid on timber sleepers in Platform Bays 1, 2 and 3 and on concrete through Platforms 4 & 5 (mainline).
- 12 The original construction of the station included a canopy placed over Platforms 1 and 2, shown in Figure 5. The construction of the canopy will be discussed in more detail later in this report.

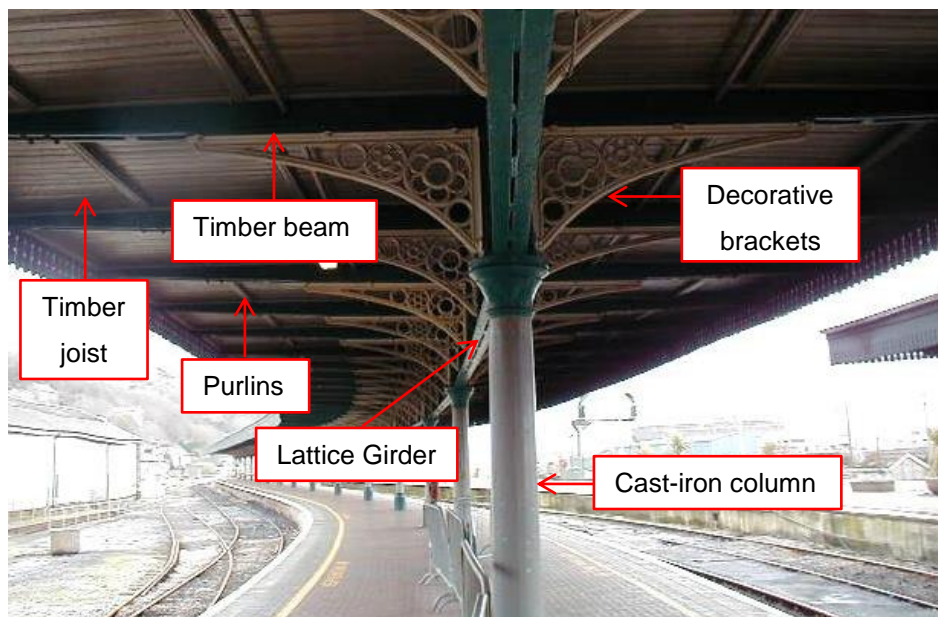
Figure 10 – Canopy above Platforms 1 and 2

32 The canopy was approximately 156.5 m long consisting of a timber roof *cantilevered* over Platforms 1 and 2 which was supported through the centre by a single row of 17 cast-iron columns which were 2.74 m in height. These columns were approximately 10 m apart and braced longitudinally by lattice girders (See Figure 10).

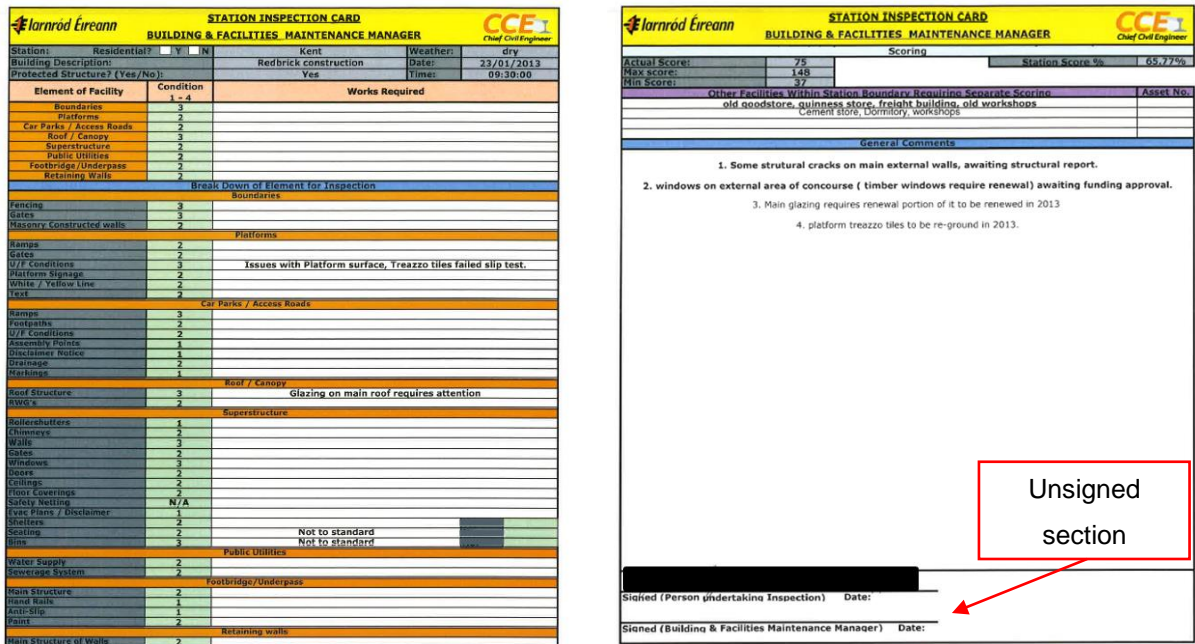
Figure 11 – Annual inspection card

37 I-FBD-8100 requires B&F staff to arrange for a surveyor to undertake an inspection of an asset and sets the parameters for this work with documented forms to complete. This standard was introduced on the 23rd December 2004. However, as of July 2010 no inspections had been carried out. A review of this standard commenced in late 2010 by B&F management personnel and a new ‘Annual Inspection Card’ was created and implemented within the B&F Department to establish the condition of their assets (see Figure 11).

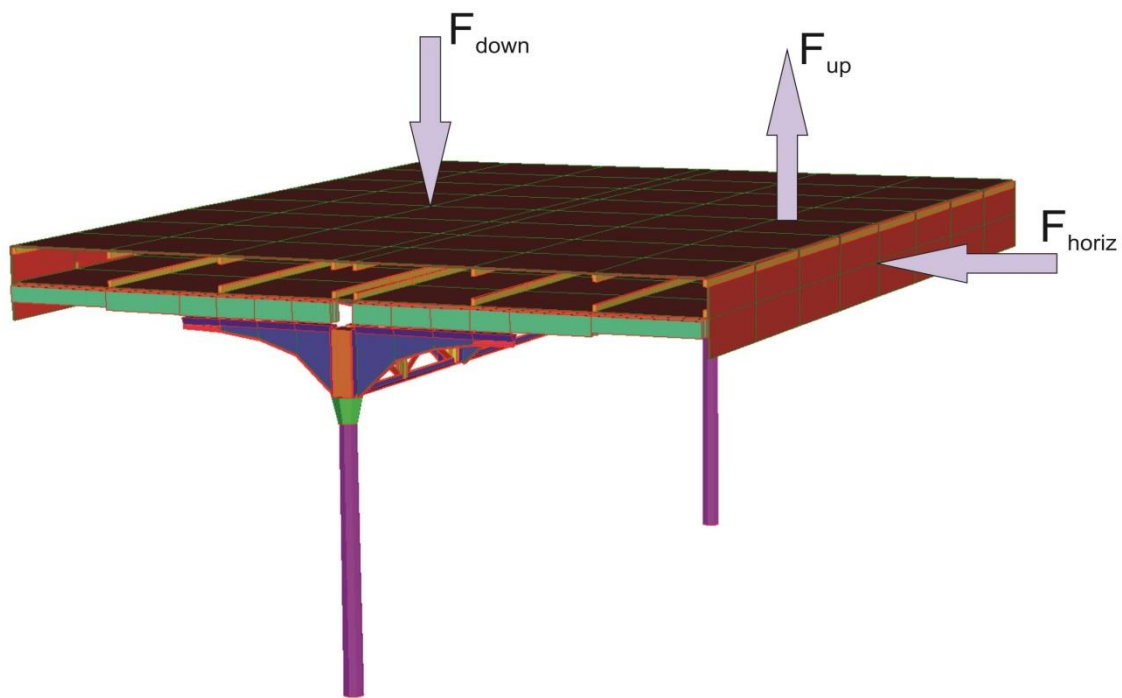
Figure 23 – Single bay used for FE analysis, Fluvio (2014)

70 A single bay of the canopy was created by Fluvio using FE modelling as shown in Figure 23. This element was then used to create a model of the entire structure.

71 A nominal pressure distribution was applied to the plate elements modelling the upper skin of the timber roof (F_{up} and F_{down}) and the plate element modelling the vertical timber sheeting were also subject to a uniform loading ($F_{horizontal}$). This wind pressure was ramped at a rate of 300 MPa/s until the structure collapsed fully.

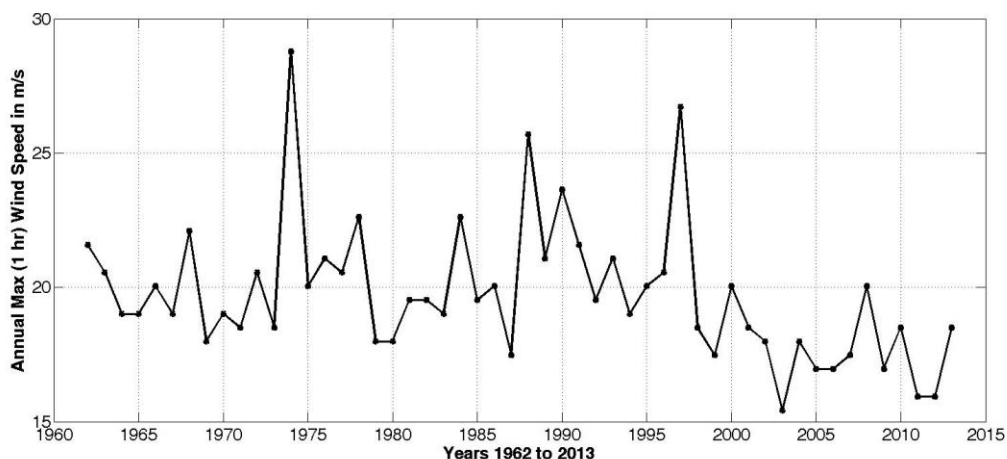
Figure 25 – Annual Maximum (1 hour) wind speed at Cork airport 1962 to 2013, Fluvio (2014)

79 Hourly wind speed data was also analysed by Fluvio to determine the annual maxima and show these as a time series values (Figure 25). The highest recorded hourly annual maximum in the 52 year period for Cork Airport was 28.8 m/s in 1974. By comparison the highest hourly wind speed recorded in 2013 was 18.6 m/s.
