INVESTIGATING REPORT

on the railway incident
occured on the 8th of September 2009 in the railway station Ilva Mică

*Final Edition
May 25, 2010*

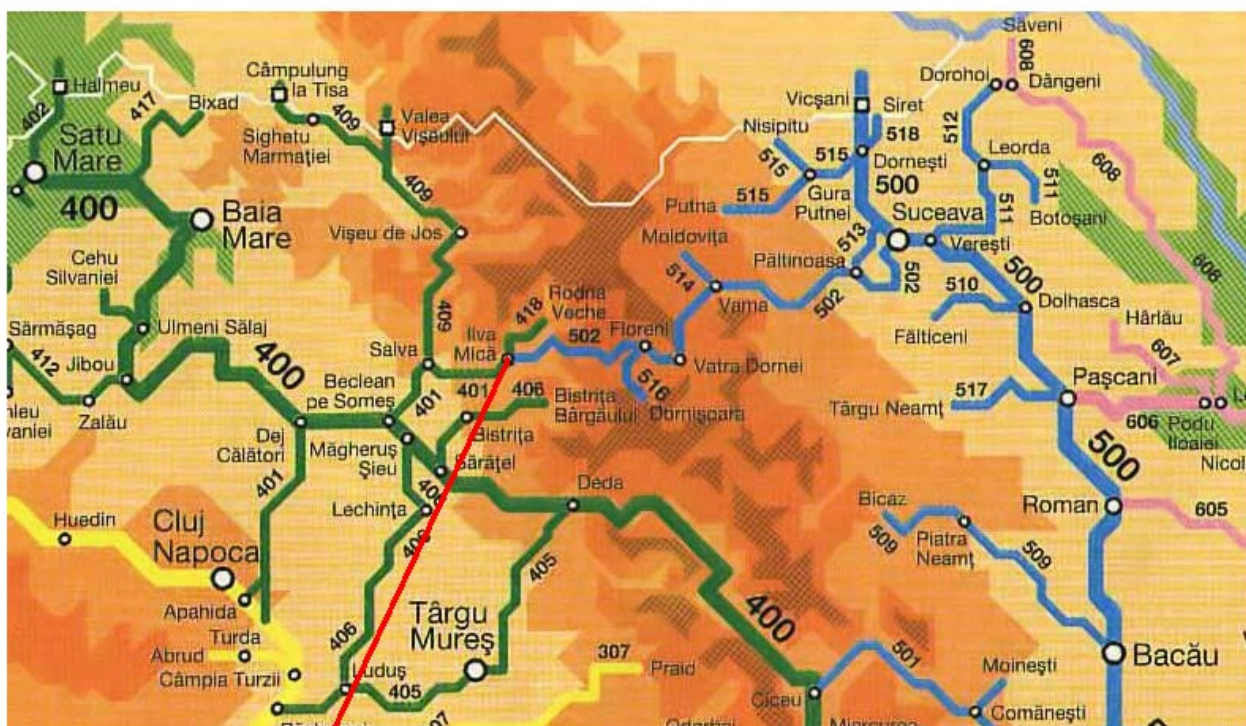
locul producerii incidentului

After separating the sleeping car according to the passenger-train composition list, the train was dispatch from the railway station Vatra Dornei at 19:20 o’clock and running until the entry in the railway station Ilva Mică where it had the order for stabling at line 6.
