INVESTIGATING REPORT

of the railway accident
occurred on the 17th of November 2010, on the running wire I,
between the subway stations Piata Unirii – Timpuri Noi

FINAL EDITION

The 3rd of February 2011

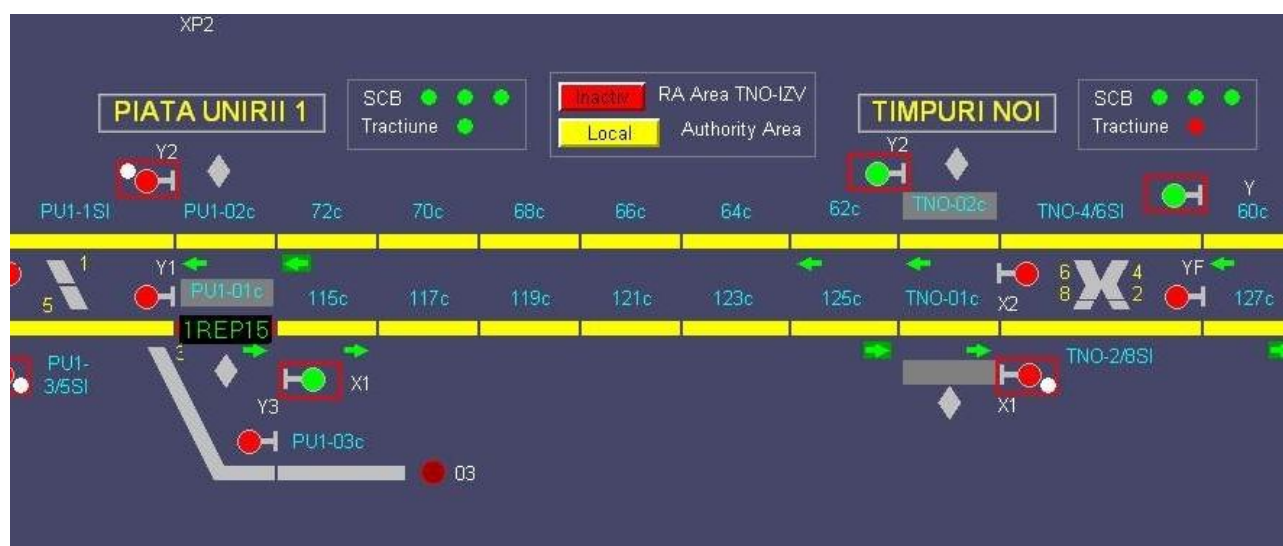
Due to the running of REM 175 in this condition, the 3rd rail corresponding to the running wire I was damaged and taken out of the operation parameters on the area of the km 5+858-6+269.

The other axles of REM 175 and also the axles of the other REMs were not derailed and did not have specific signs of derailment.
