INVESTIGATING REPORT

of the railway accident

occured on the 14th of February 2013, in the activity of the Branch of Regional Center for Railway Operation, Maintenance and Repairs Galați Galati, between the railway stations Galati Brateș and Cătușa, in the running of the freight train no. 76052

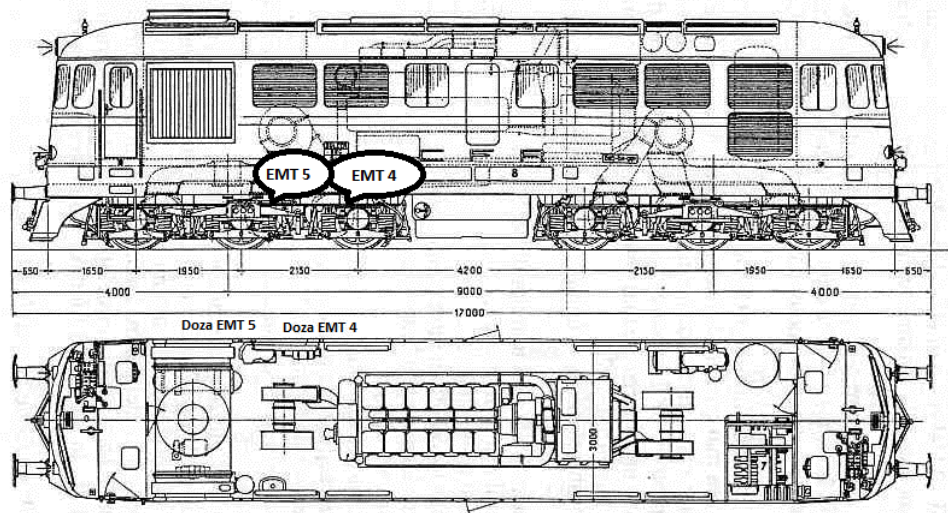
Photo no. 10 Locomotive type LDE 2100 CP

- in the time of the hauling of the train on the section Galați Brateș – Cătușa the diesel engine and traction engines are stressed at maximum load and then had place the heating of the force cabling, with different potentials, afferent to the terminals E and F of the traction engine no. 5 (photo no. 10);
- due the decreasing of the isolation resistance as a result of aging phenomenon has occurred the breakthrough of cable insulation at a distance of 300 mm from traction engine no. 5 simultaneously with a short-circuit, fact which led finally at the welding of the cables and the ignition of their insulation;
- fire propagation was favored by the poor state of cleanliness of the traction engines due the losses of fuel and oil from the installations.
