INVESTIGATING REPORT

of the railway accident occurred on the 02nd of February 2013,
in the activity of the Branch of the Regional Center for Railway Operation, Maintenance and
Repairs Timișoara, in the running of the freight train no. 23817 (belonging to the railway
undertaking SNTFM „CFR Marfă” SA), in the railway station Pui, through the derailment of the
last two wagons, due the circular breakage of the wheel's no. 2 web (monobloc wheel) of the wagon
no. 81536655875-8.

Final edition
Bucharest, the 21th of January 2014

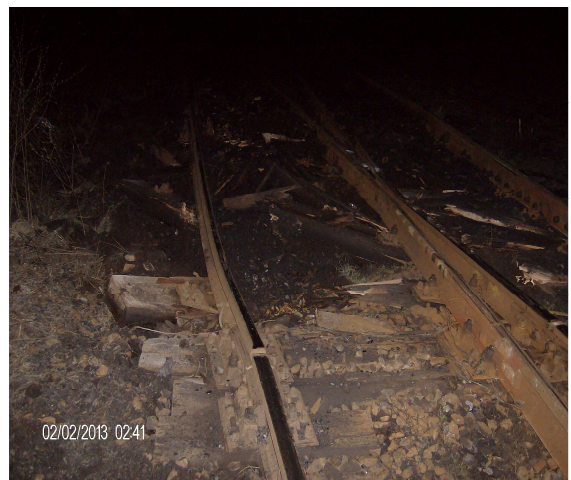
Photo no. 13

6. In the right of the simple frog of switch no. 15, the derailed wheels snatched the check rail from direct line of the simple crossing frog, place where occurred the derailment of bogie 2 from wagon 81536655875- and also the derailment no. 81536656212-3 (photo 13), followed by the breakage of the train, emergency braking and the overturning of the two wagons.
