MINISTRY OF TRANSPORTS AND INFRASTRUCTURE
ROMANIAN RAILWAY AUTHORITY - AFER

ROMANIAN RAILWAY INVESTIGATING BODY

INVESTIGATING REPORT

on the derailments of the electric multiple units type Z 6100
occurred between the 25th and 26th of January 2010

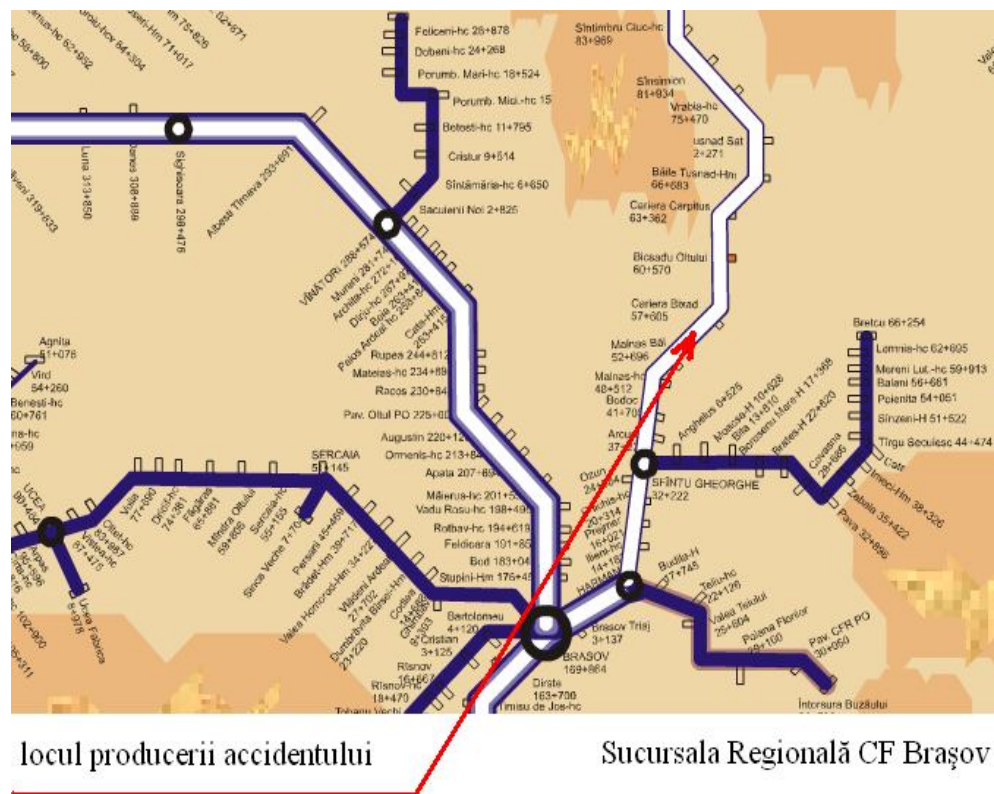
The train ran without problems up to the km 54+862 where occurred the derailment of the first carrying bogie from the trailer coach no. 111 of the electric multiple unit no. 011, speed of 64 km/h. The train stopped at the km 55+650, at 7,30 hour, when the speed decreased from 64 km/h to 0 km/h.

The railway accident consisted in the derailment of both axles from the first bogie in the running direction of the wagon no. 2 of the electric multiple unit no. 011, in the curve between the km 54+760 and the km 55+283.

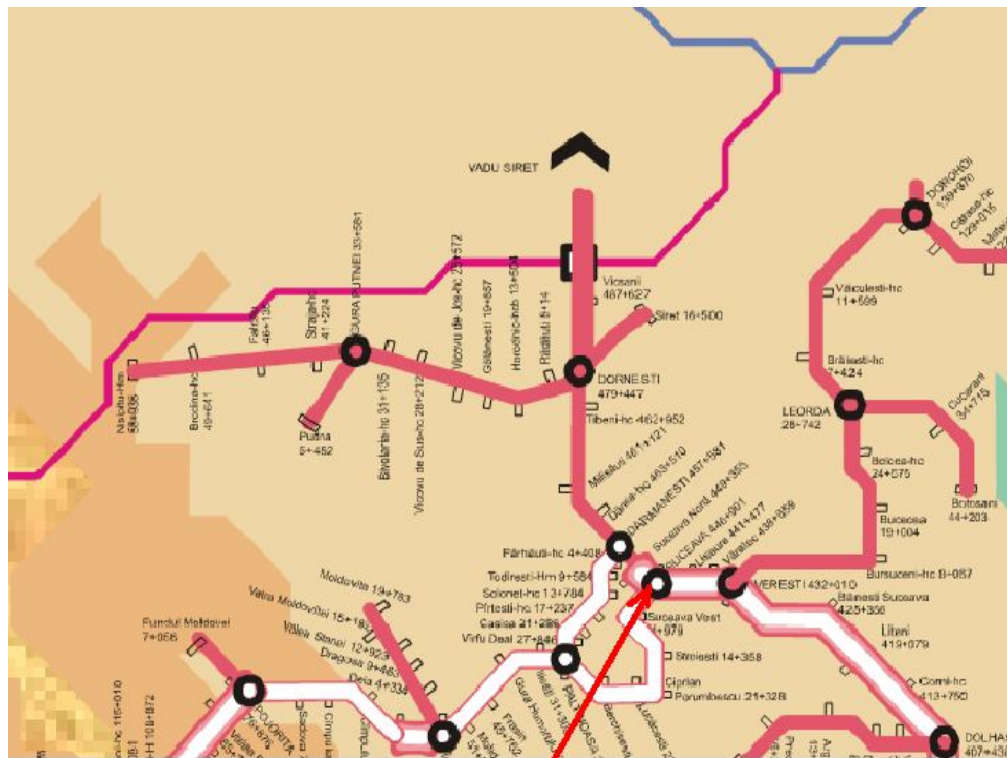
locul producerii accidentului

On the 26th of January 2010, at 04,00 hour, the passenger train no. 5501 was dispatched from the railway station Pascani, running without problems up to the railway station Varatec,

where it was stabled at 4,59 hour. After a stop of 1 minute, at 5,00 hour, the train was dispatched without remarks to the railway station Suceava.

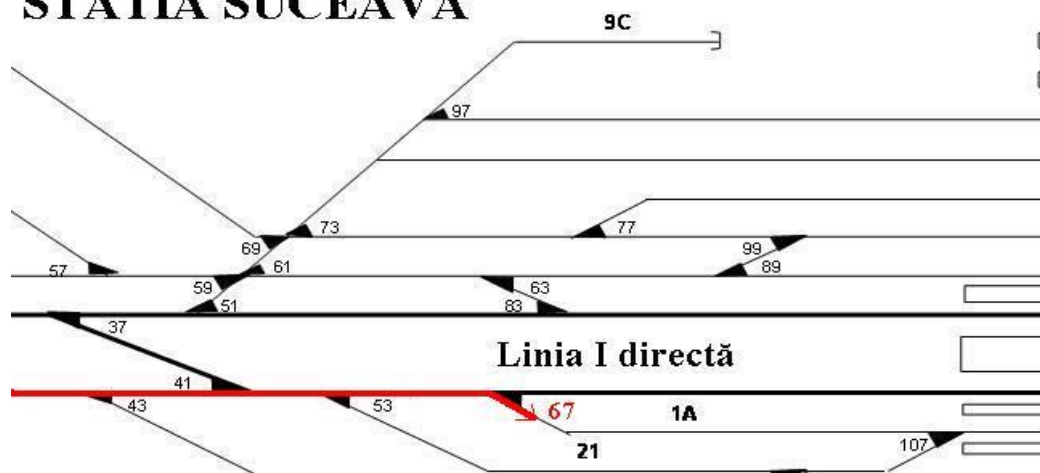
STATIJA SUCEAVA

At the entry in the railway station Suceava, at the passing over the switch no. 67 (run over the facing point), operated on the potion “deflecting section” ,on the connection rails area occurred the derailment of the second bogie (in the running direction) of the trailer coach no. 207 from the electric multiple unit no. 007, generating also the derailment of the first bogie of the same wagon.

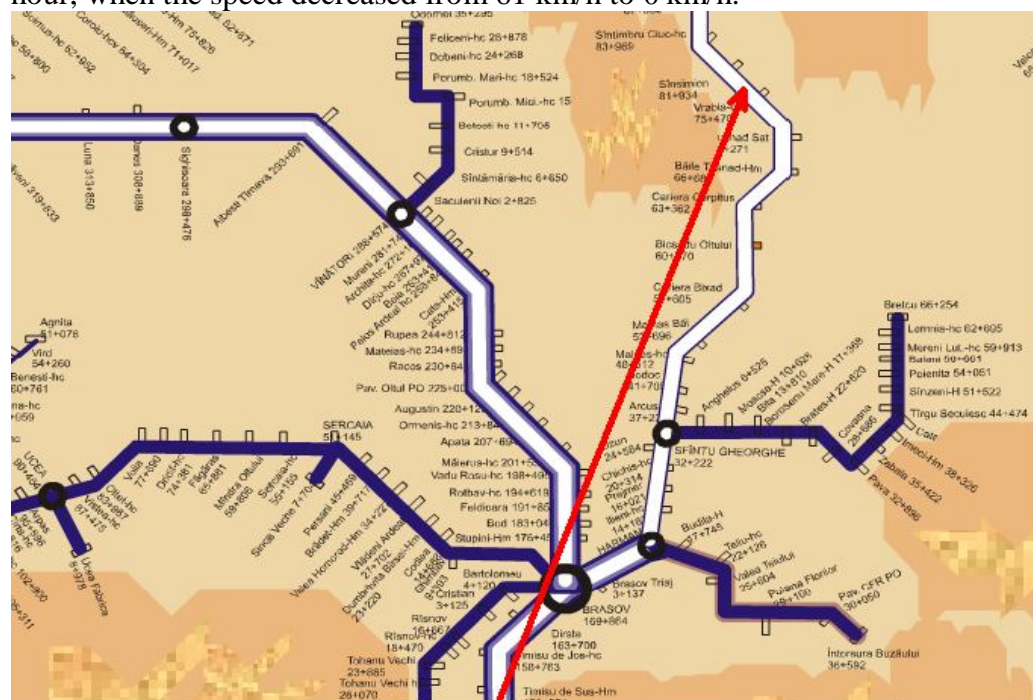
locul producerii accidentului

The train ran without other problems up to the km 79+422 where derailed the first bogie (carrying bogie) from the power coach of the electric multiple unit no. 010 (first in the running direction), at the speed of 61 km/h. The train stopped at the km 79+302, at 14:22 hour, when the speed decreased from 61 km/h to 0 km/h.
