MINISTRY OF TRANSPORTS AND INFRASTRUCTURE
ROMANIAN RAILWAY AUTHORITY - AFER

INVESTIGATING REPORT

of the serious railway accident

occurred on the 16th of October 2013, in the activity of the Branch of the CREIR Cluj, between the railway stations Monor Gledin and Rapa de Jos

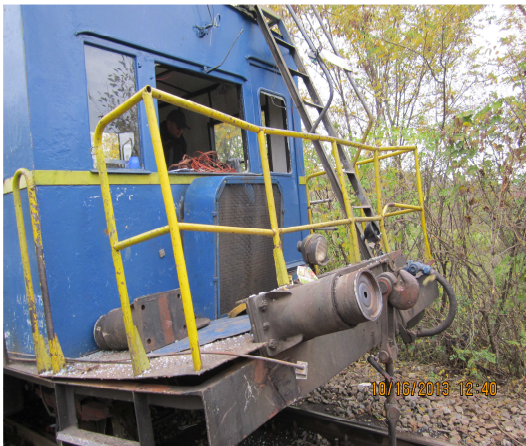
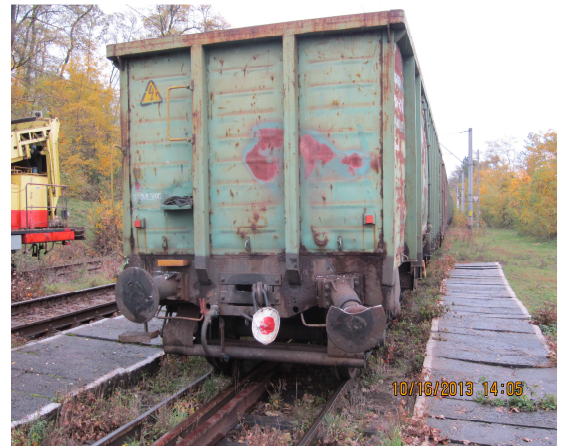
Following the accident was produced the derailment of the second axle of the tower wagon DP 58, damages of the rolling stock were recorded, the serious injury of 13 persons and perturbation in the railway traffic.

The accident did generate serious injuries at a number of 13 persons.
