Summary
Safety Investigation Report
Collision between a passenger train and
the rear of a freight train
Hermalle-sous-Huy - 5 June 2016

SUMMARY

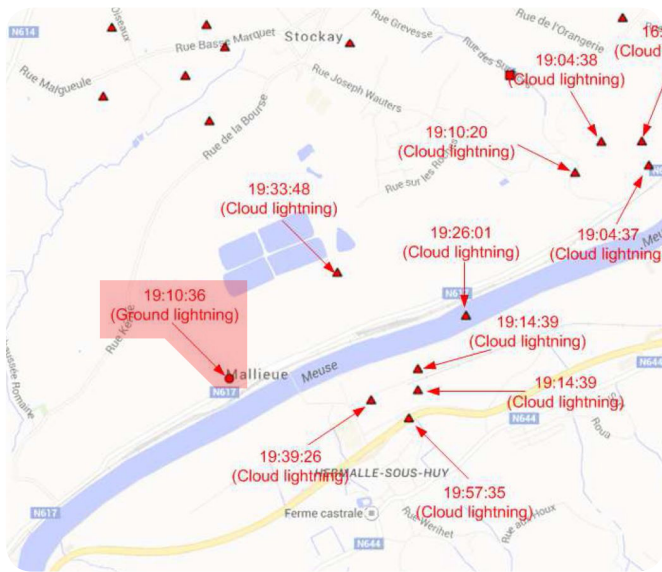
Following storms that occurred on 5 June 2016 around 7 p.m., a lightning strike caused various disturbances to the signals on line 125 at Hermalle-sous-Huy: three track circuits were interrupted. As a result, the signals protecting access to the concerned sections turned red: the three signals involved (B222, K.10 and KX.10) were thus closed.

Figure: location of the lightning strikes registered in the vicinity of the accident site on 5 June 2016 between 7 p.m. and 8 p.m. (source: Elia).
