# Rail Accident Report

**Broken Rails at Urchfont and Kennington  
following the passage of a freight train  
5 January 2006**

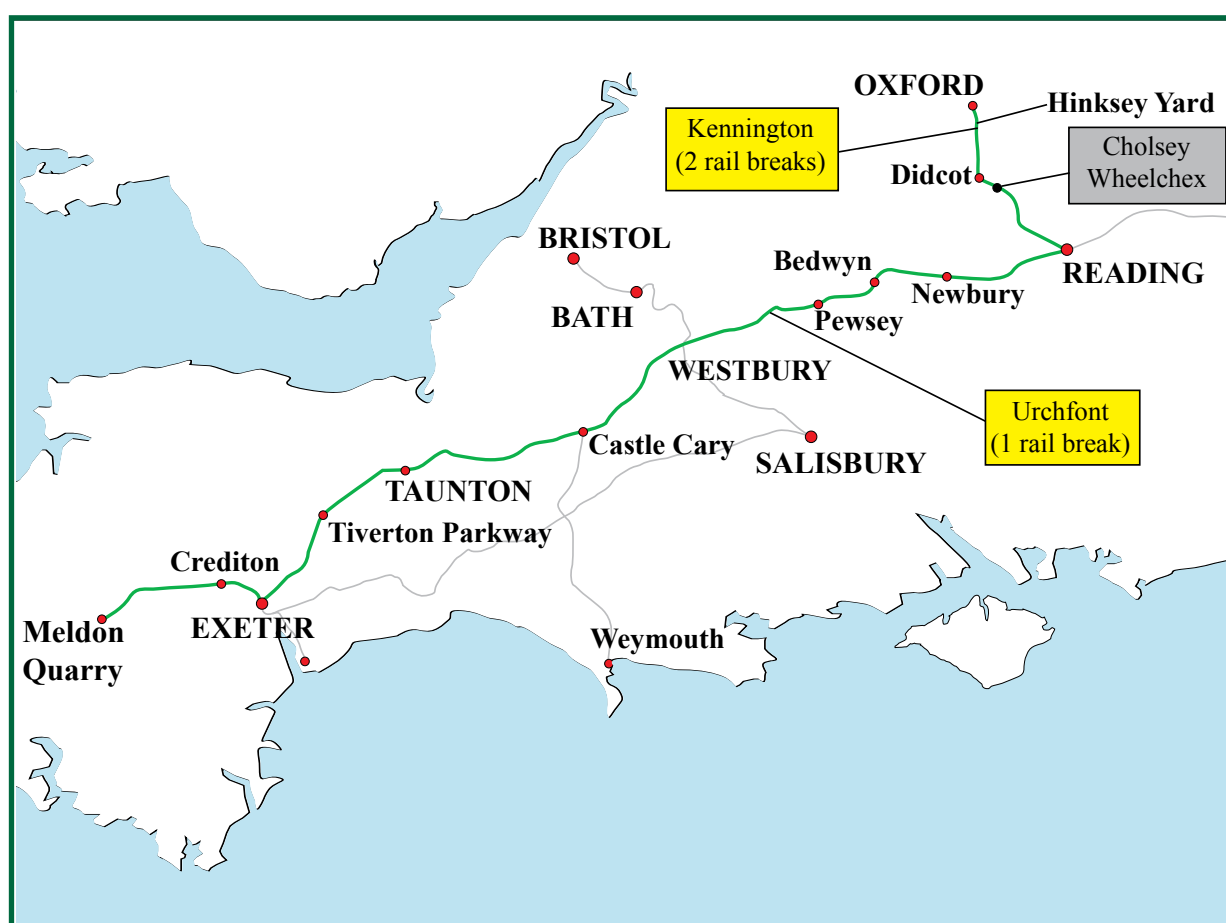
Figure 1: Location of rail breaks and the route of train 6F95.

- 18 The route taken by train 6F95 on 5 January 2006 is shown in Figure 1. Quarry trains run routinely four times a week from Meldon Quarry to Exeter Riverside yard where they reverse direction. The service then travels up the West of England main line initially to Cogload junction, east of Taunton, before it joins the Berks and Hants line to Reading West Junction via Castle Cary, Westbury, Urchfont and Pewsey. At Reading West Junction, the train travels in a northerly direction to Didcot East Junction and then on to Hinksey yard near Oxford, via Kennington. The total mileage from Meldon Quarry to Exeter Riverside is 26 miles (42 km) and from there to Hinksey is a further 175 miles (280 km).

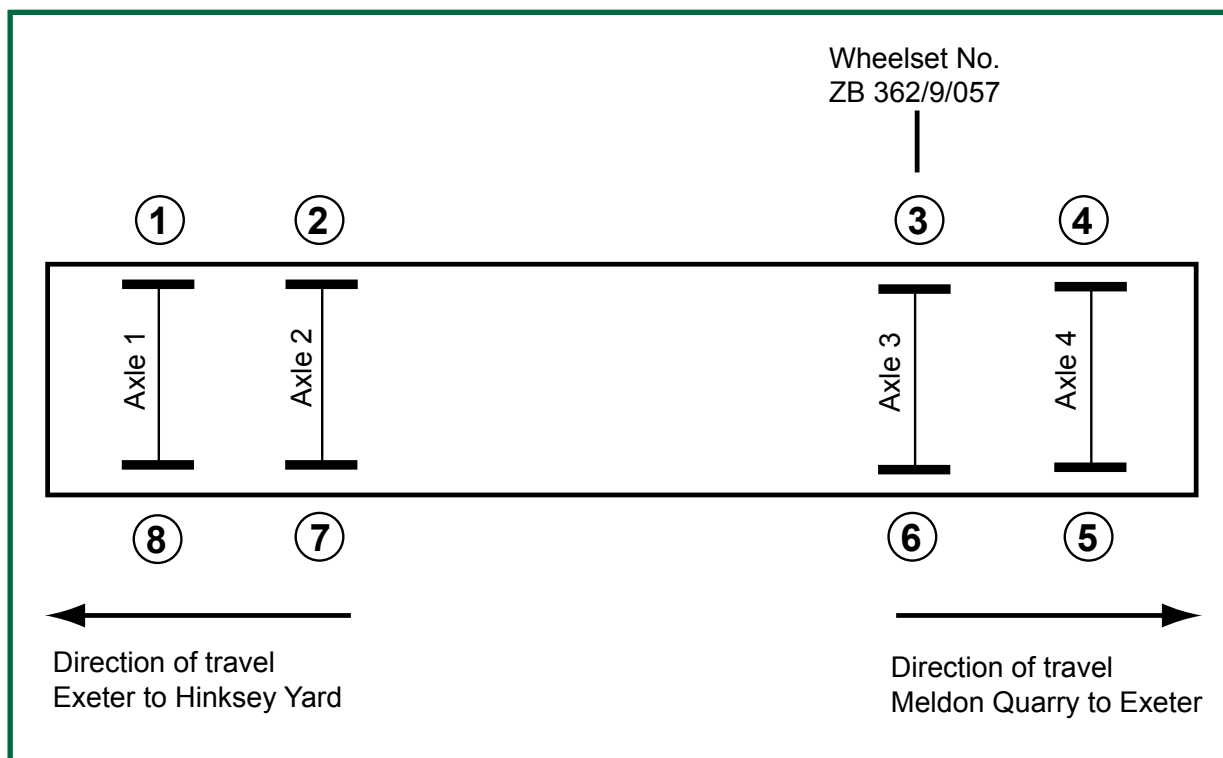
Figure 3: Wagon NLU 29553 directions of travel with respect to wheel and axle number

The orientation of wagon NLU 29553 with respect to the Meldon–Exeter and Exeter–Hinksey legs of the journey and the wheel and axle numbers referred to later in this report are shown in Figure 3.

- 57 Wagon NLU 29553 was subject to further examination at Derby on 17 & 18 January 2006 by Network Rail and the RAIB. The wheel flats were on axle 3 (wheel numbers 3 and 6), which was the trailing axle of the leading bogie from Meldon (Figure 3). The flats were well defined, indicating that they had been freshly created during the last journey.

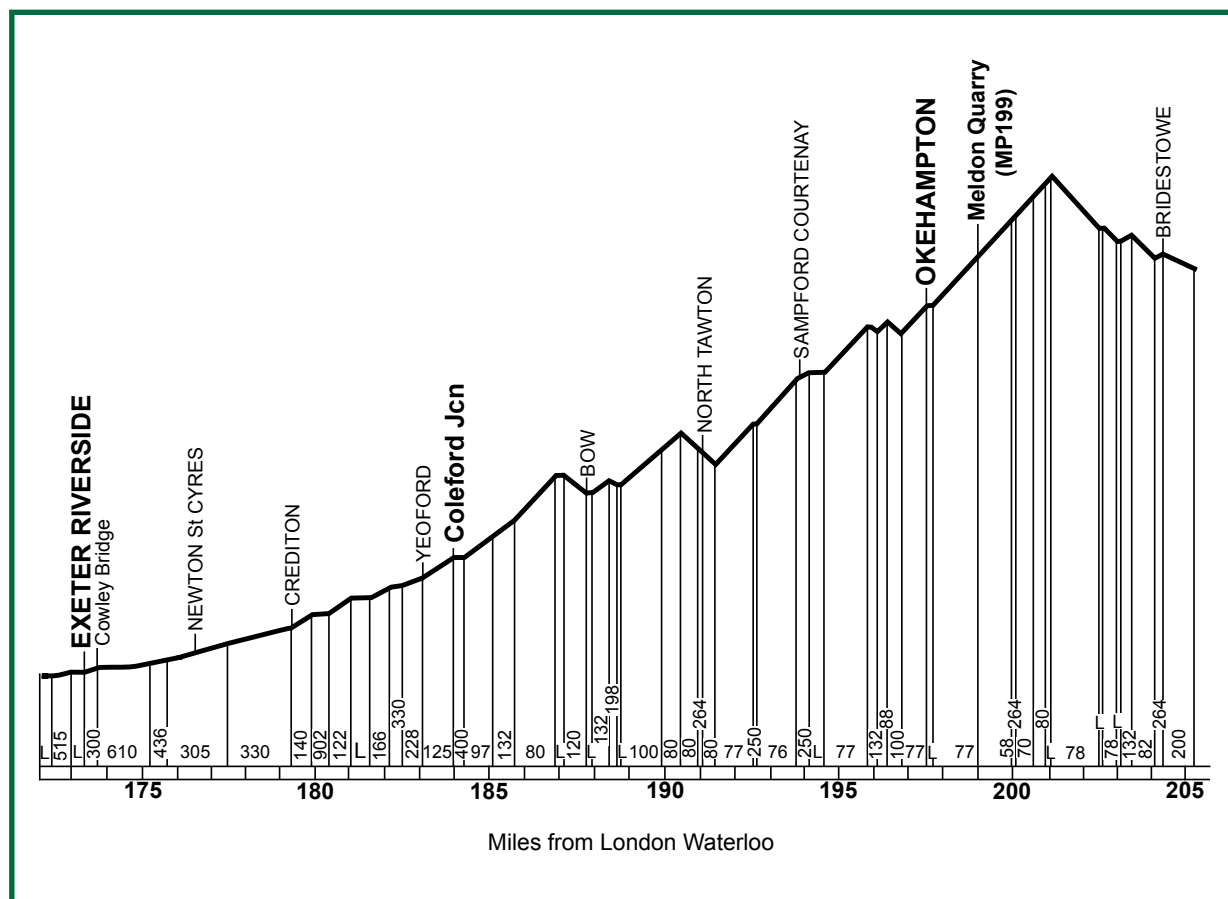
Figure 4: Gradient profile between Meldon Quarry and Exeter.

- 28 The first 15 miles of the journey from Meldon Quarry to Coleford Junction (Figure 4) is over a single *bi-directional* line. Trains must stop at Okehampton and Meldon Quarry where the shunter operates ground frames. Over most of this distance there is a relatively steep falling gradient, the maximum being 1 in 76. There are also some short sections of rising gradients at North Tawton (1 in 80) and Bow (1 in 120).

- 29 For loaded quarry trains, the maximum line speed from Meldon Quarry to Okehampton is 25 mph (40 km/h) and from Okehampton to Coleford Junction it is 40 mph (64 km/h), with one restriction down to 30 mph (48 km/h) for the bridge at Greenslade, located at 191 miles 55.5 chains from London Waterloo. The steep downhill gradients over these two sections of the route require the driver to make frequent brake applications to control train speed if running at the maximum line speed.

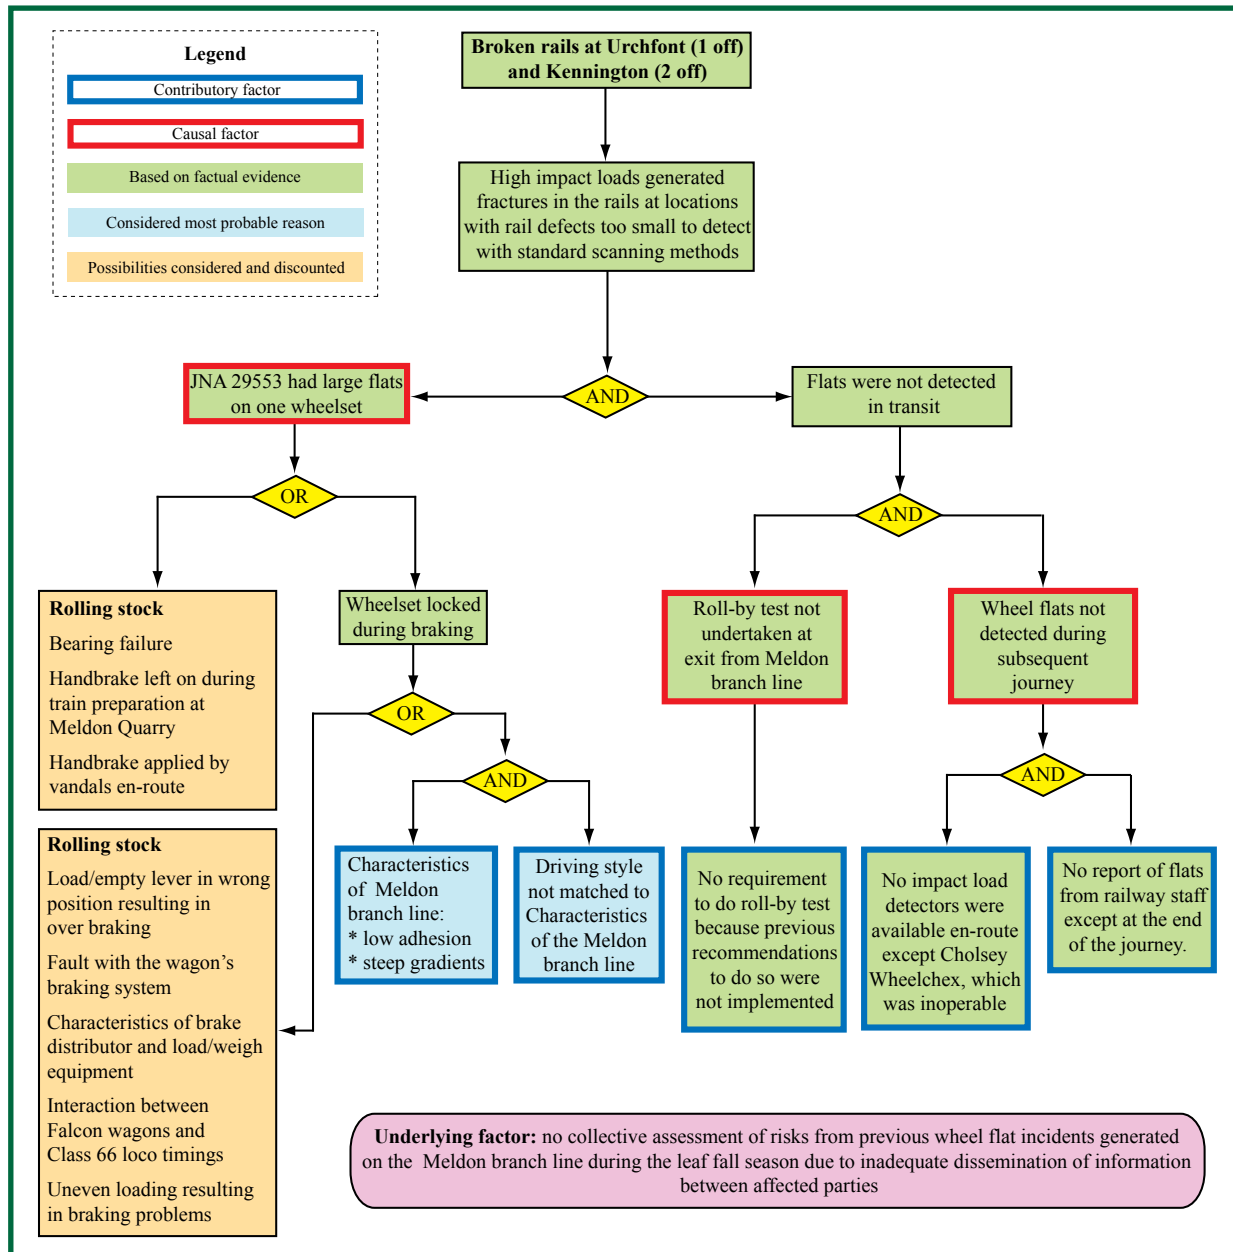
Figure 8: Summary of causal chain

116 A summary of the causal chain is shown in Figure 8. Working downwards from the incident, each box contains the reason why the preceding event occurred or is considered to have occurred.
