Rail Accident Investigation Branch

# Rail Accident Report

**Signal T172 passed at danger at Purley station,  
Surrey  
18 August 2006**

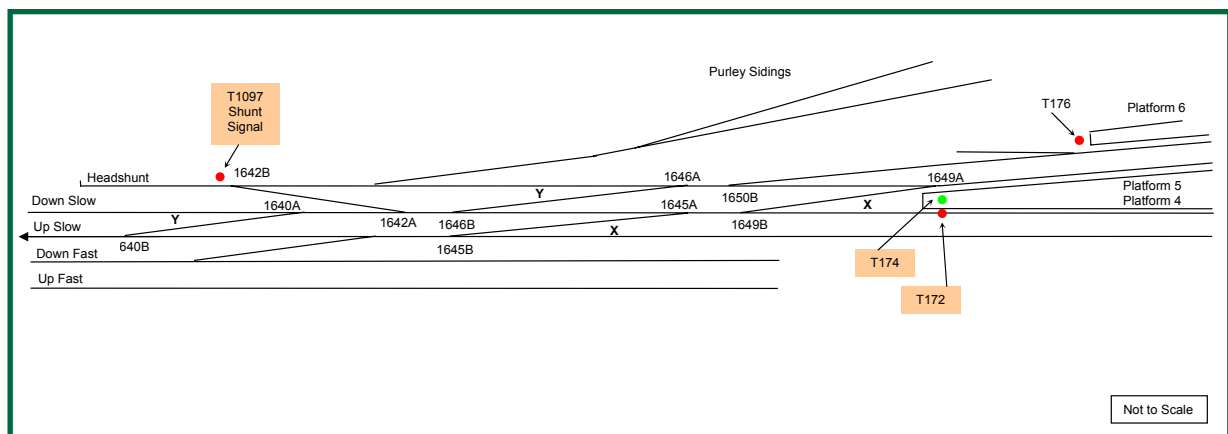
Figure 5: Purley station and the London end layout indicating point ends and crossovers

- 45 Following the TPWS reset, the driver of train 6V66 continued travelling towards London on the up slow line. As a consequence, train 6V66 ran through 1646B points which had been set for the passenger train, 2Y52. The driver of train 6V66 did not see the points set against him and was unaware of the run through.
- 46 The run through of 1646B points caused some minor damage to the front *stretcher bar* and a broken *stretcher bar* bracket which initially left the points usable only in their *normal* position. This resulted in the blocking of the routes into and out of the London end of platform 6.
- 47 There was no damage to either train.
- 48 The driver of train 2Y52 avoided a possible collision with train 6V66 by controlling his train to a stop while still in platform 5.
- 49 The passenger train was travelling at 11.9 mph (19.15 km/h) when the driver braked.

- 58 Network Rail staff were sent to site and undertook repairs to the damaged point end.
- 59 The OTDR download of locomotive 59 203 was completed at Acton yard on the 18 August 2006 when the train finally arrived from Purley.
