Rail Accident Investigation Branch

# Rail Accident Report

**Minor collision between an engineering unit and  
two manual trolleys near St. John's Wood  
25 October 2007**

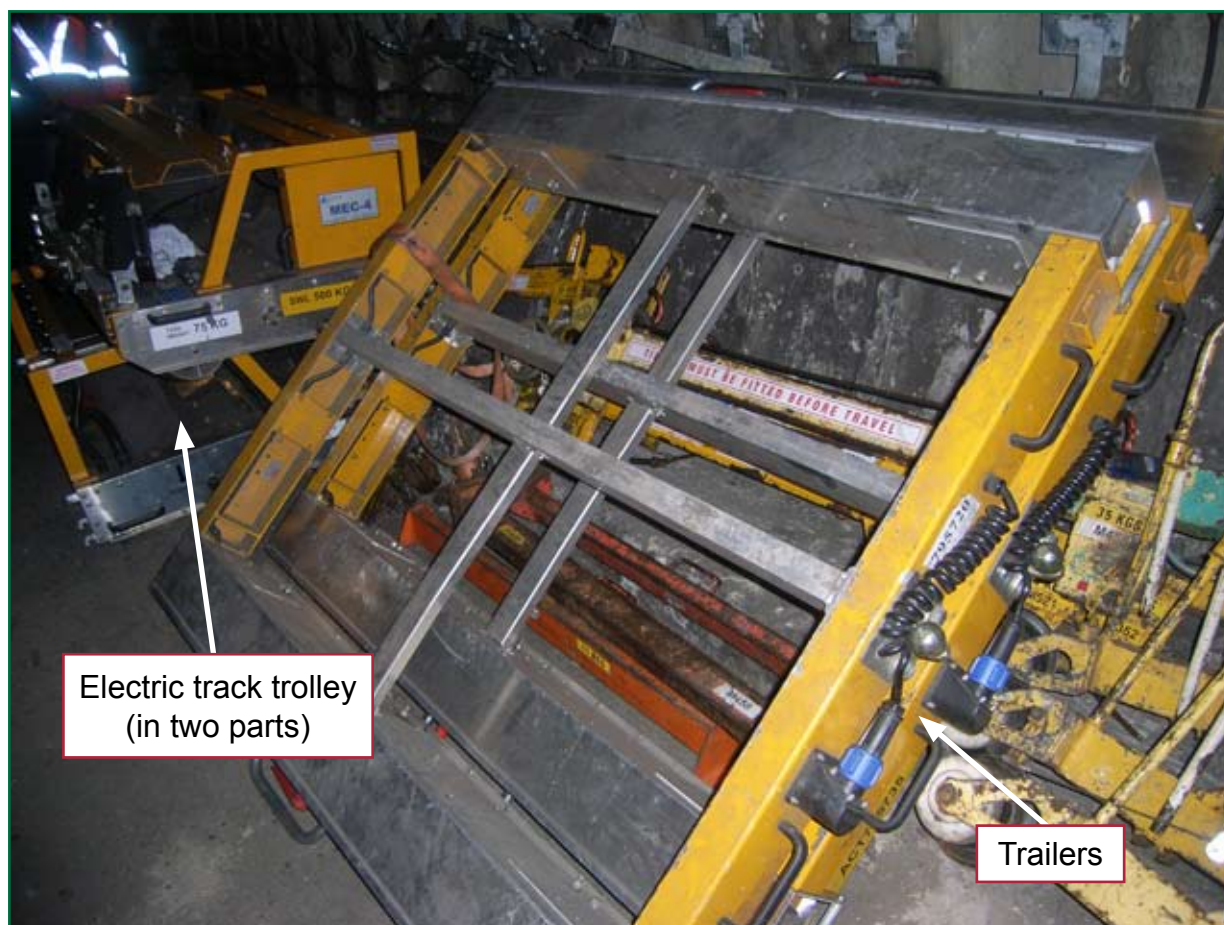
Figure 6: First cross passage at St. John's Wood showing storage of engineering unit

- 32 The engineering unit had been used at the same location and been used for similar duties for the two nights prior to the incident after being returned from TransPlant after repairs to the trolleys motors. The unit had been operating correctly since its return from TransPlant.
- 33 The engineering unit was being stored in the first cross passage (see Figures 2 and 6). The electric track trolley was split into its two parts (as described in paragraph 57) and stored one part on top of the other. The two trailers were laid against the wall of the passage.

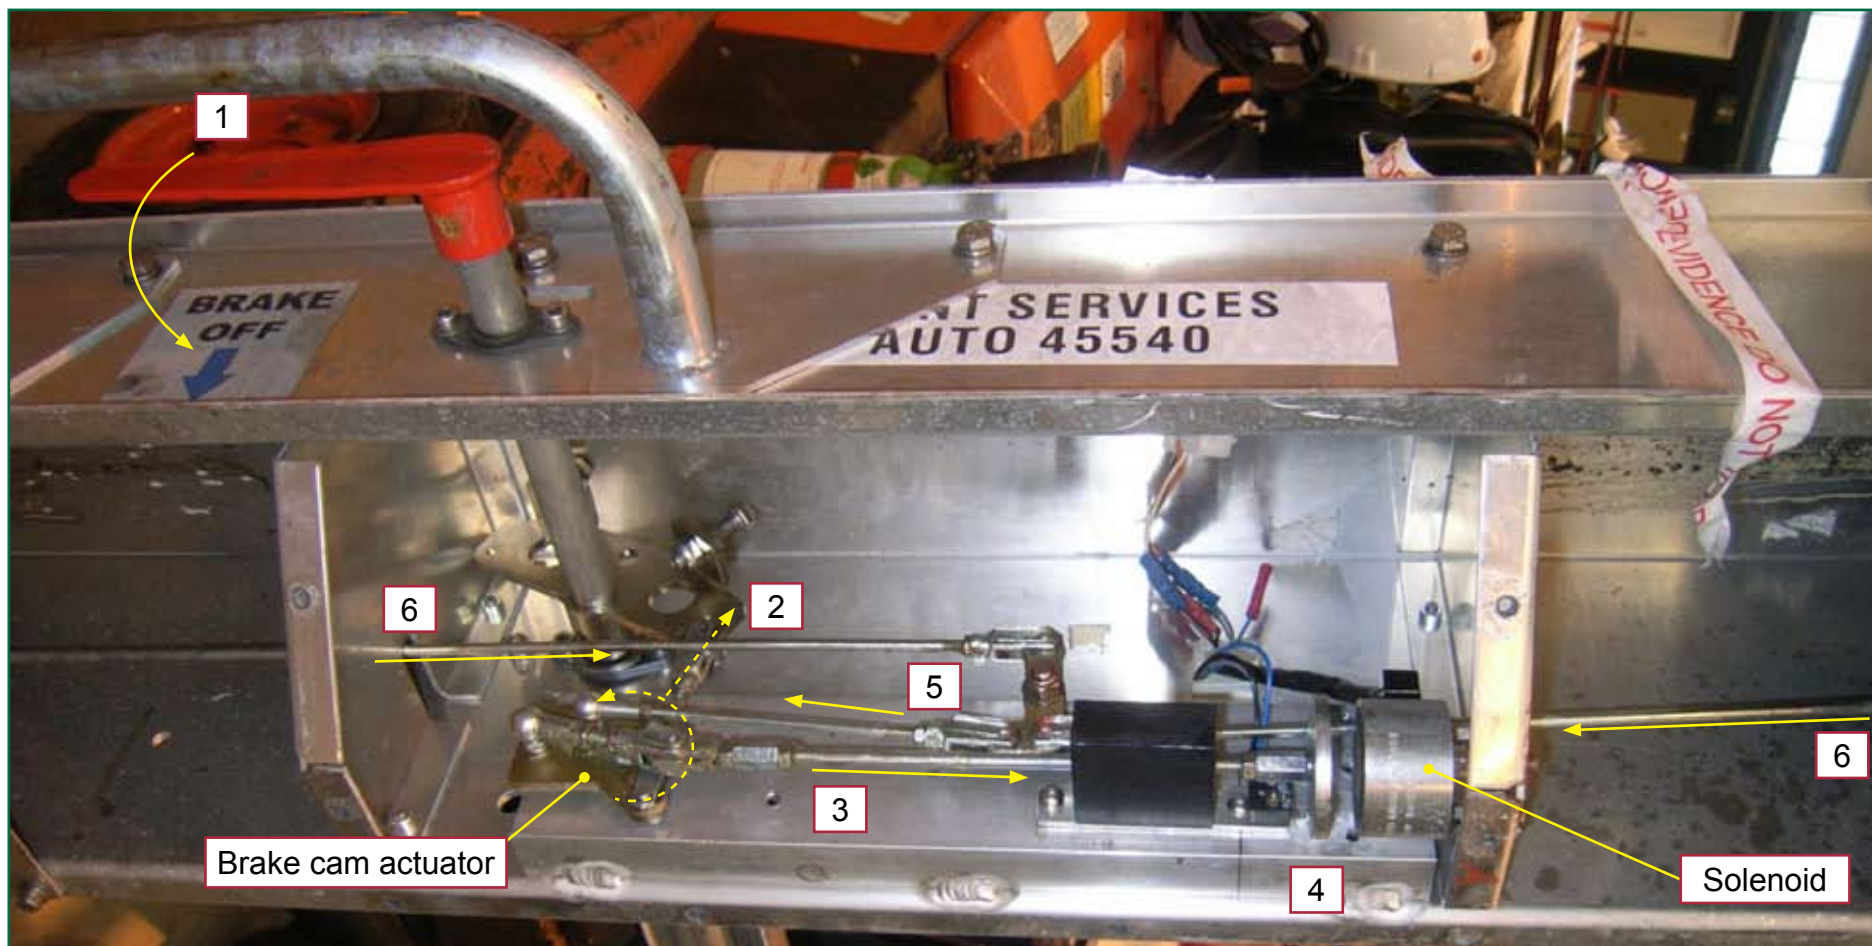
Figure 8: Trailer side showing operation of the braking system (the arrows indicate the direction of movement)

69 Figure 8 shows the brake system in the 'brake on' position. The combined manual and electrical operation of the brakes to their 'off' position is described below (the numbers with arrow heads in Figure 8 refer to the numbers below):

1. the Track Trolley Operator moves the brake lever into the brake 'off' position;
2. the brake cam actuator follows this movement and turns anti-clockwise (shown with dotted lines);
3. the rod connecting the brake cam actuator to the solenoid moves to the right;
4. the solenoid plate latches to the main solenoid as the system is energised;
5. the rod connecting the brake cam actuator to the brake pivot moves to the left; and
6. both rods connecting the brake pivot to the spring applied brakes move to the left and right respectively, thereby pulling the brakes off against their return springs.

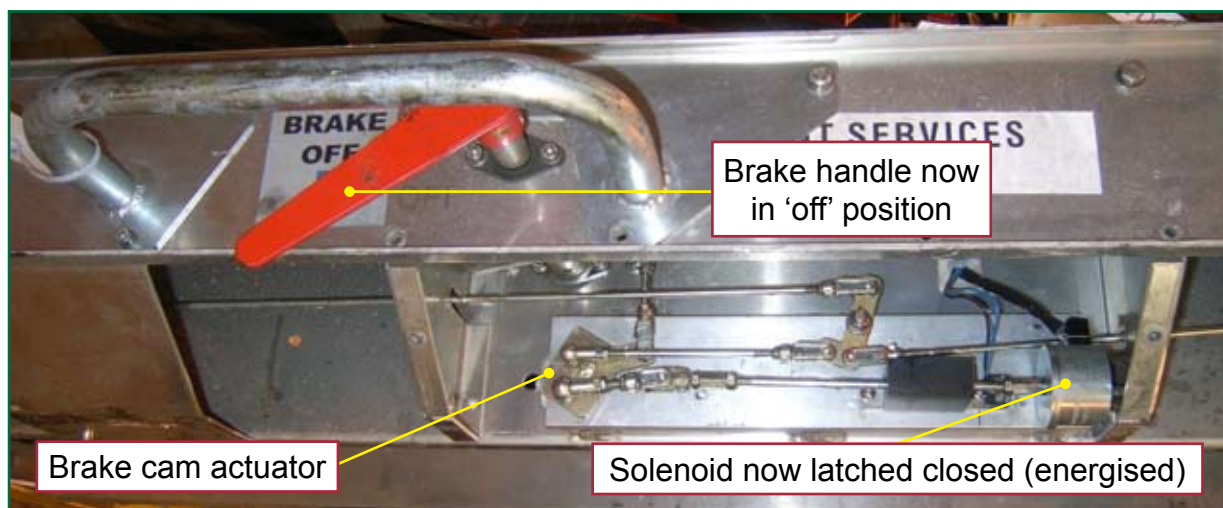
Figure 9: Trailer side showing brake system with brake off and solenoid energised

70 Figure 9 shows the brake system in the 'brake off' configuration.

71 The solenoid and brake cam actuator systems are enclosed behind a metal plate. Only Consillia staff normally had access to this area.
