Rail Accident Investigation Branch

# Rail Accident Report

**Derailment of a freight train near Stewarton,  
Ayrshire  
27 January 2009**

Report 02/2010  
February 2010

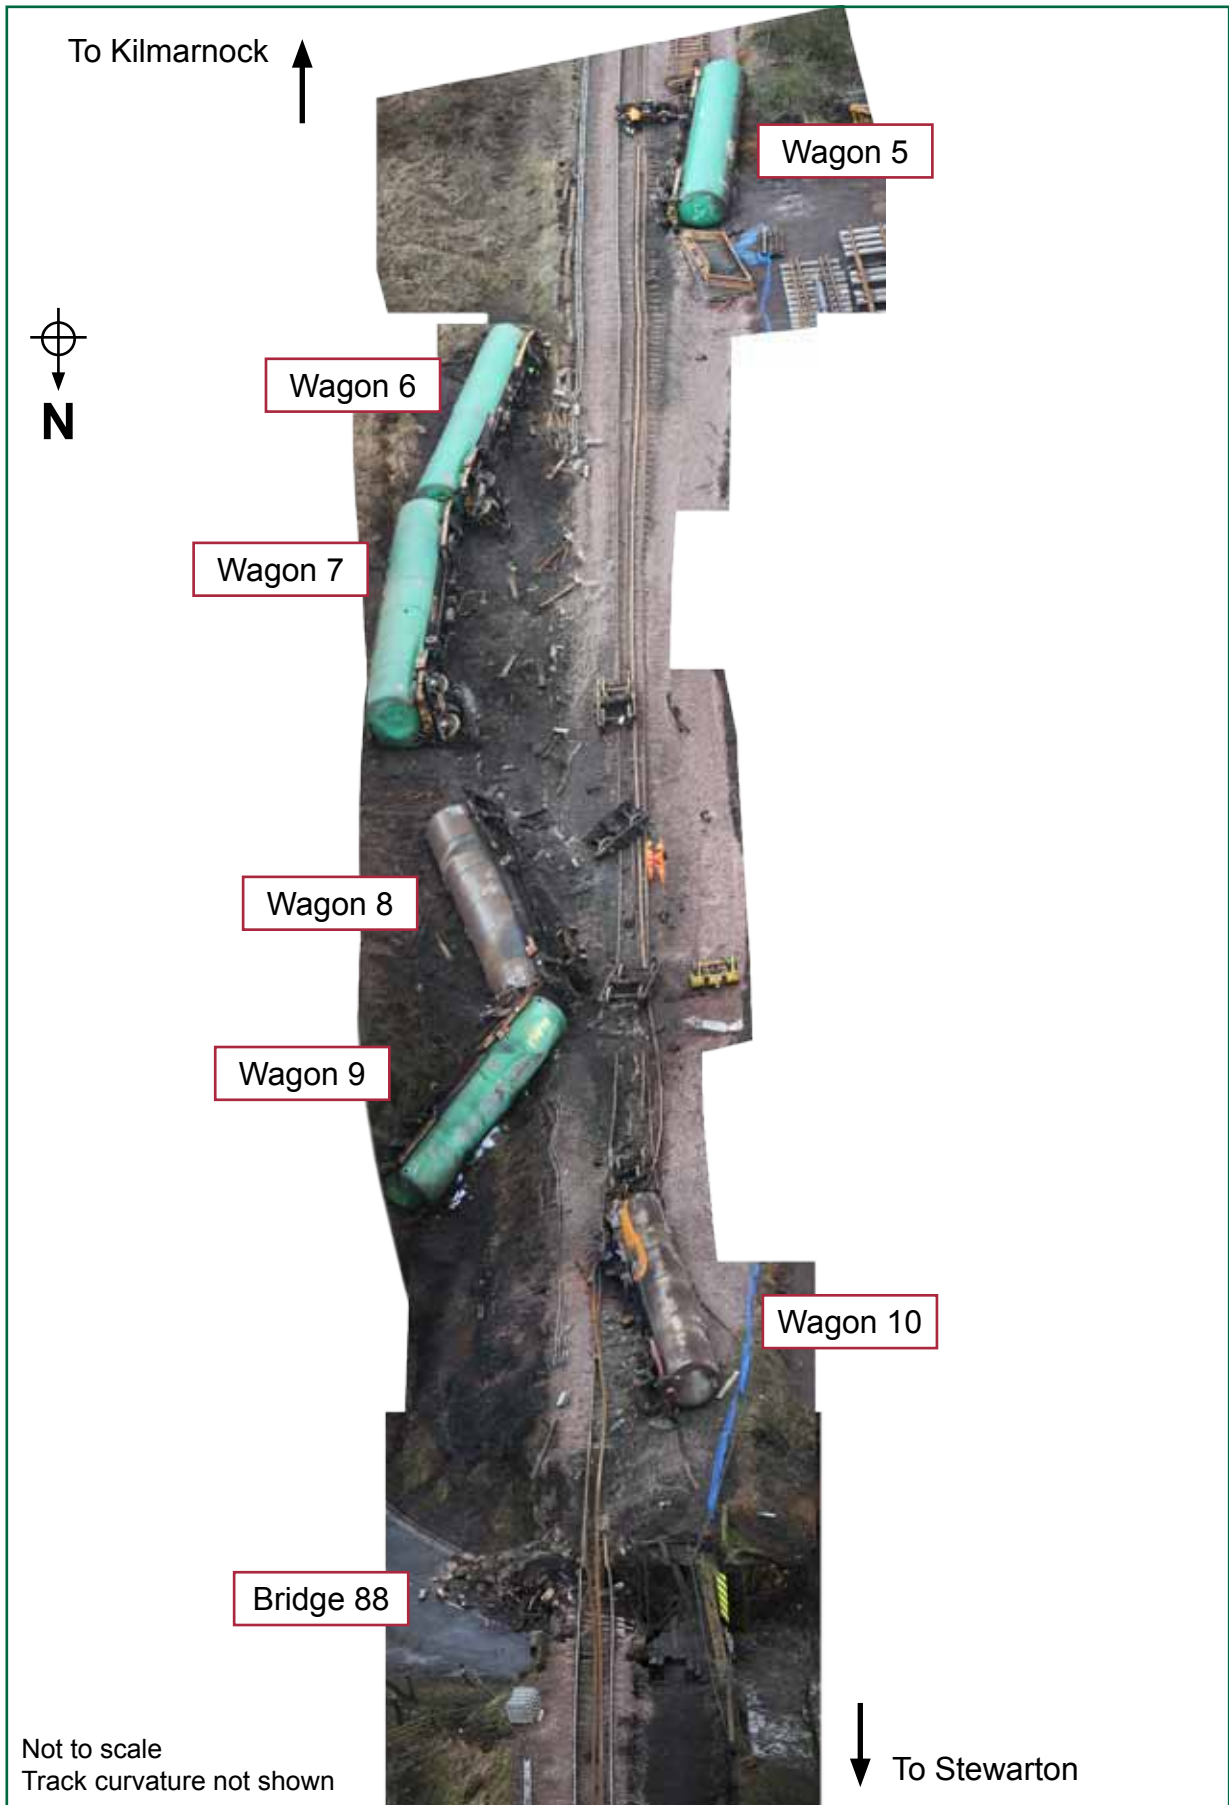
Figure 2: Composite aerial photograph showing the collapsed bridge and the location of the derailed wagons on the southern side (photographs courtesy of Network Rail)

- 84 Figures 2 and 8 show the locations of the six rear wagons after derailment.
- 85 The tanks of wagons 6, 8 and 10 were all punctured by the drawhooks of adjacent wagons, and a *pressure and vacuum valve* was damaged on the top of the tank on wagon 7. Kerosene leaking from wagon 10 ignited.

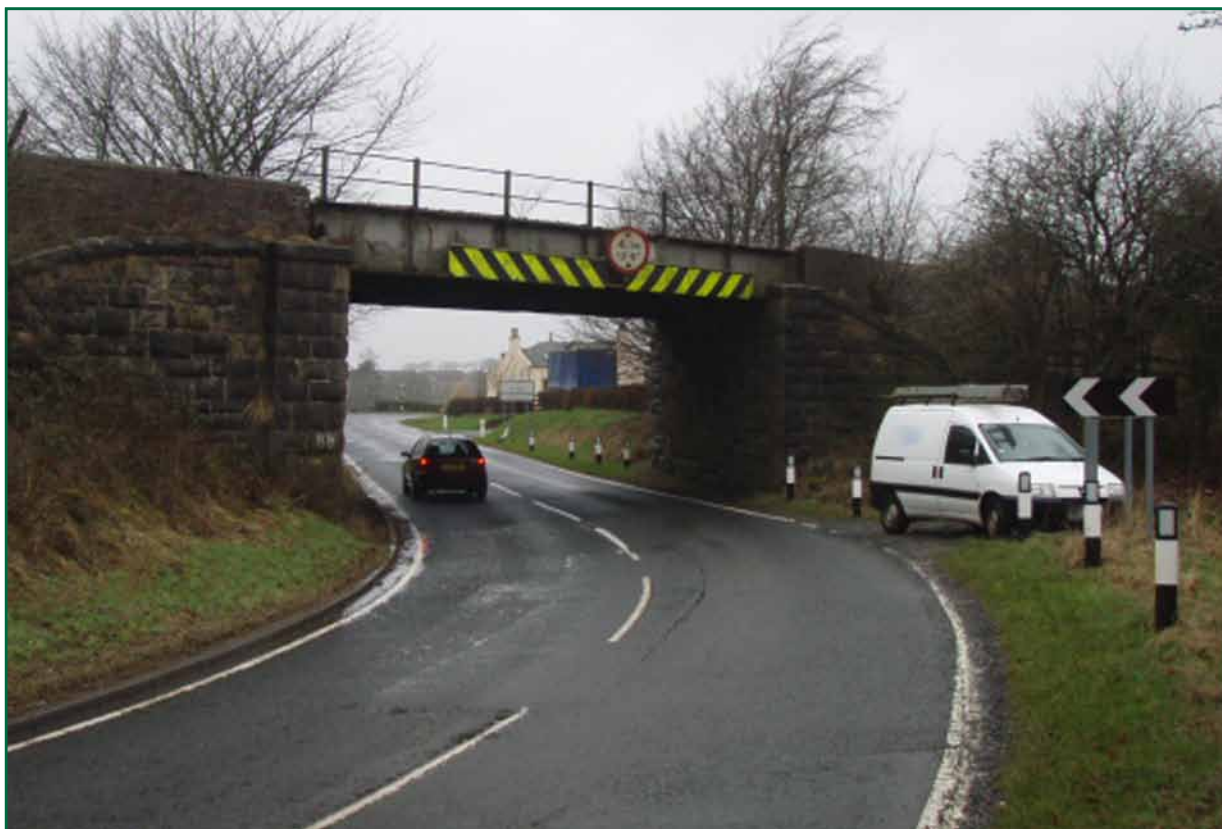
Figure 6: East elevation of Bridge 88 in February 2008 (photograph courtesy of Network Rail)

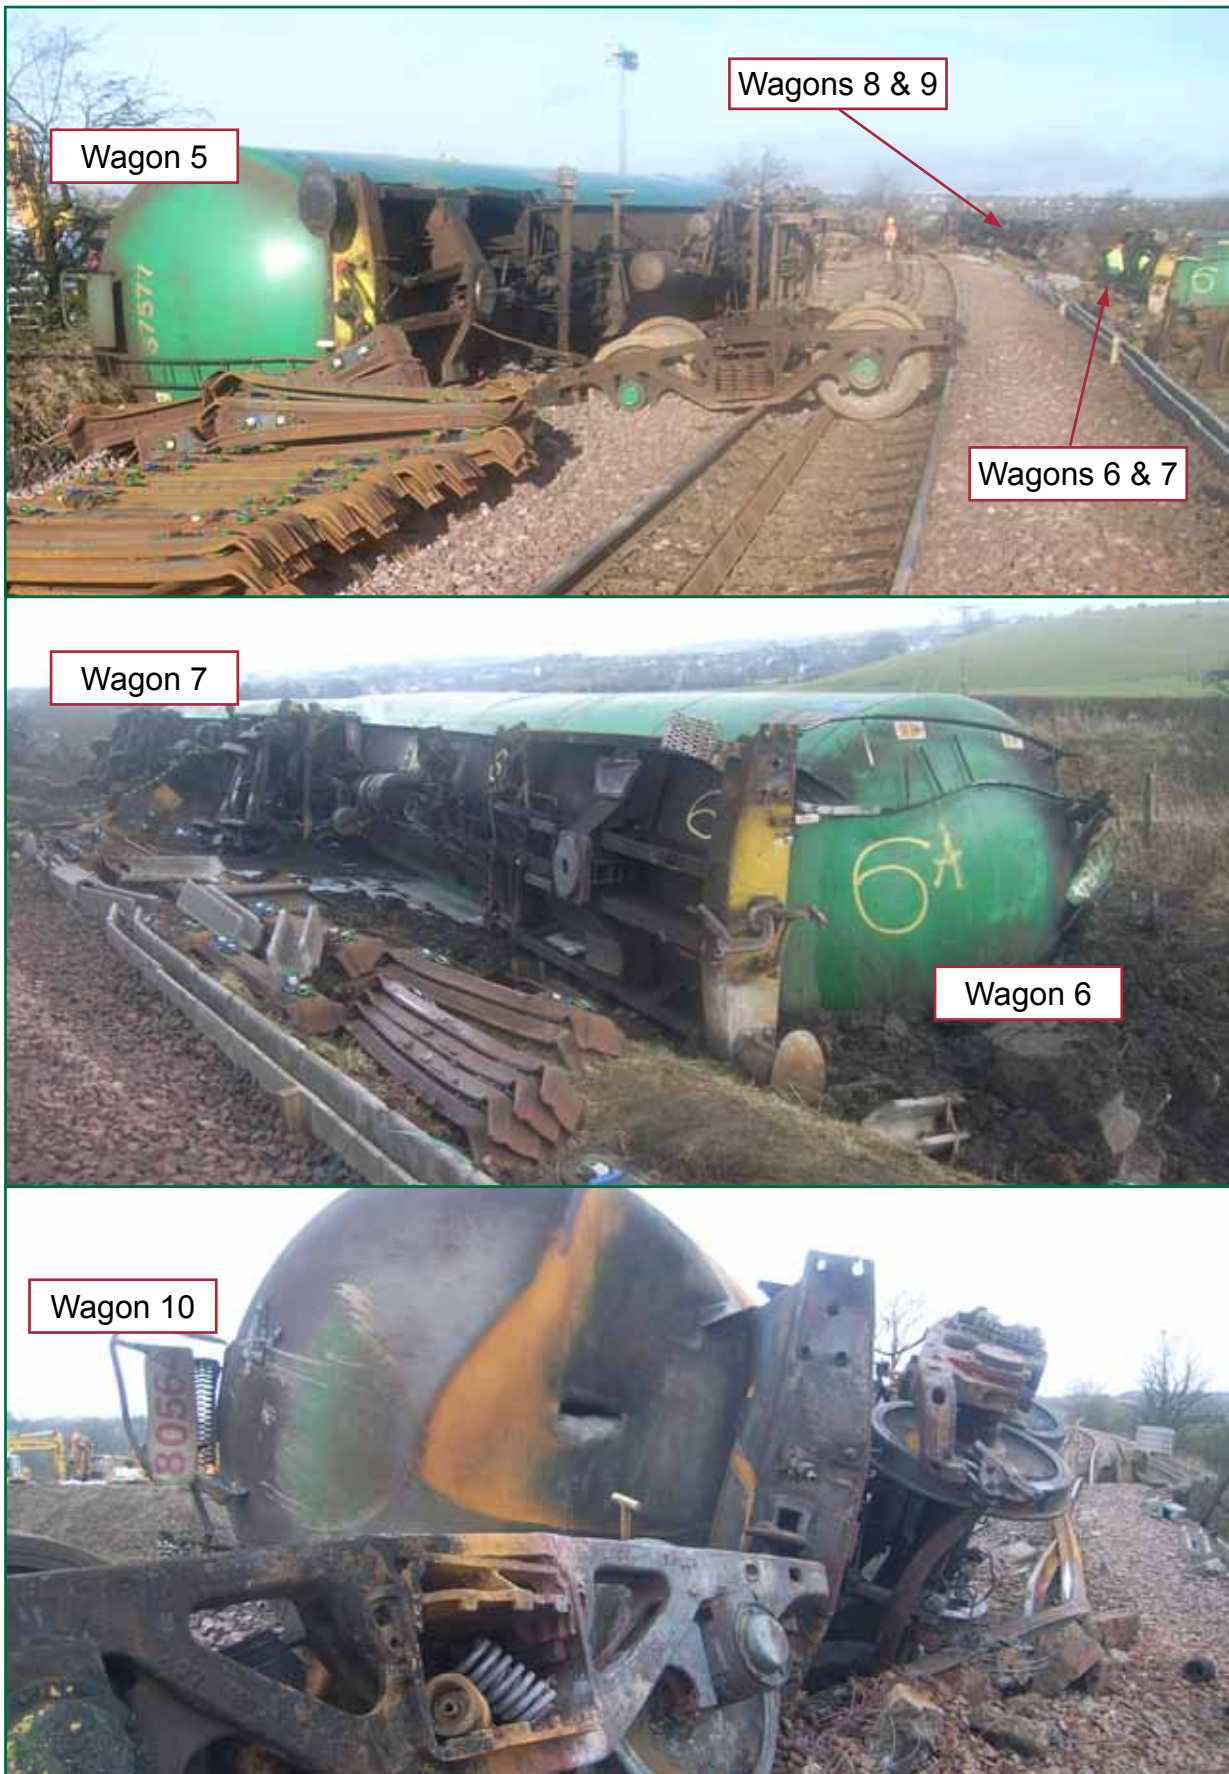
- 83 Wagons 6, 7, 8 and 9 initially followed wagon 5, running derailed and damaging railway infrastructure, but then overturned to the outside of the curve. They came to rest, also after losing bogies, on the east side of the track and embankment. Wagon 10 overturned and came to rest close to the south abutment, in debris that had accumulated in the *four-foot*.

Figure 8: Derailed wagons

242 The wagons made significant override movements as the train passed over the collapsing bridge, causing the tanks on wagons 6, 8 and 10 to be punctured by the drawhooks of adjacent wagons; the punctures on wagons 6 and 10 can be seen in figures 8 and 15. All of the fuel lost from these wagons leaked through these holes.

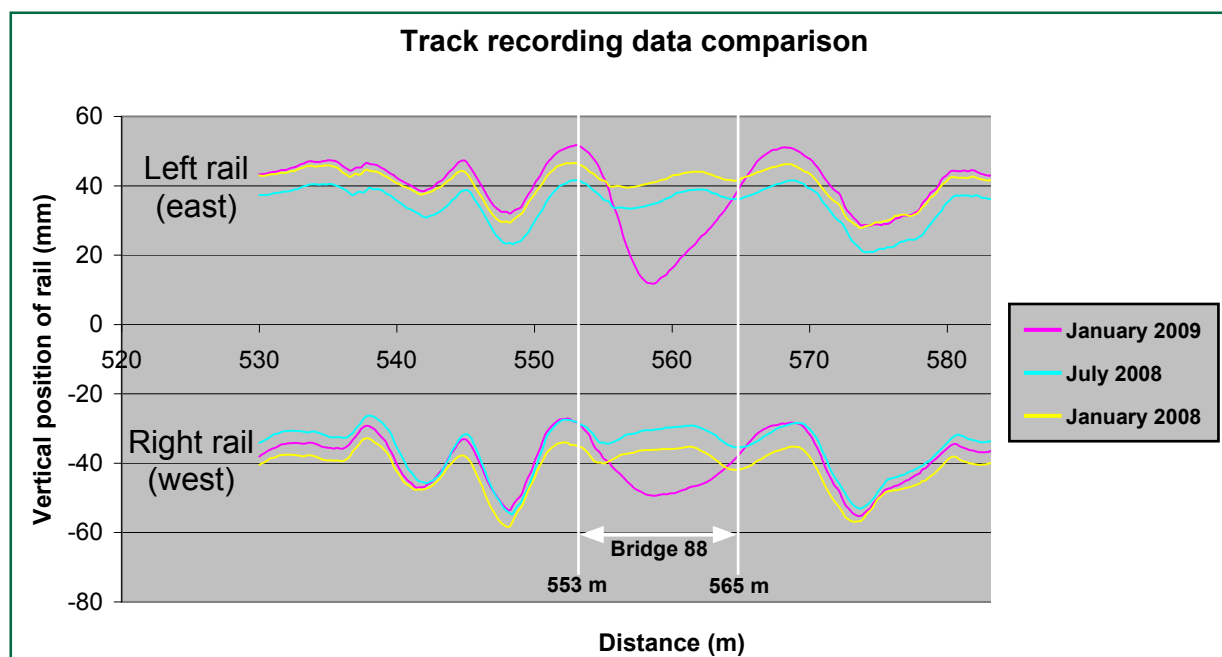
111 Network Rail has a fleet of special trains that regularly run over its network recording the geometry of the track for routine track inspection and maintenance purposes. One of these trains ran over Bridge 88 on 24 January 2009, three days before the accident. It recorded a dip on the bridge, which subsequent analysis showed was not present on runs in July 2008 and January 2008 (figure 13). The extent of the dip is coincident with the bridge span. The relatively rigid make-up of the elements supporting the rails on the bridge deck (concrete sleepers and granite ballast with no obvious source of *voiding*) means that this is likely to be an indication of increased deflection of the bridge superstructure. It suggests that, since the last run in June 2008, there had been a change in the structural performance of the bridge. A loss of web plate integrity would explain this. There is no record of recent track maintenance activity in the area to explain otherwise.

Figure 13: Vertical geometry of the track measured in the vicinity of Bridge 88

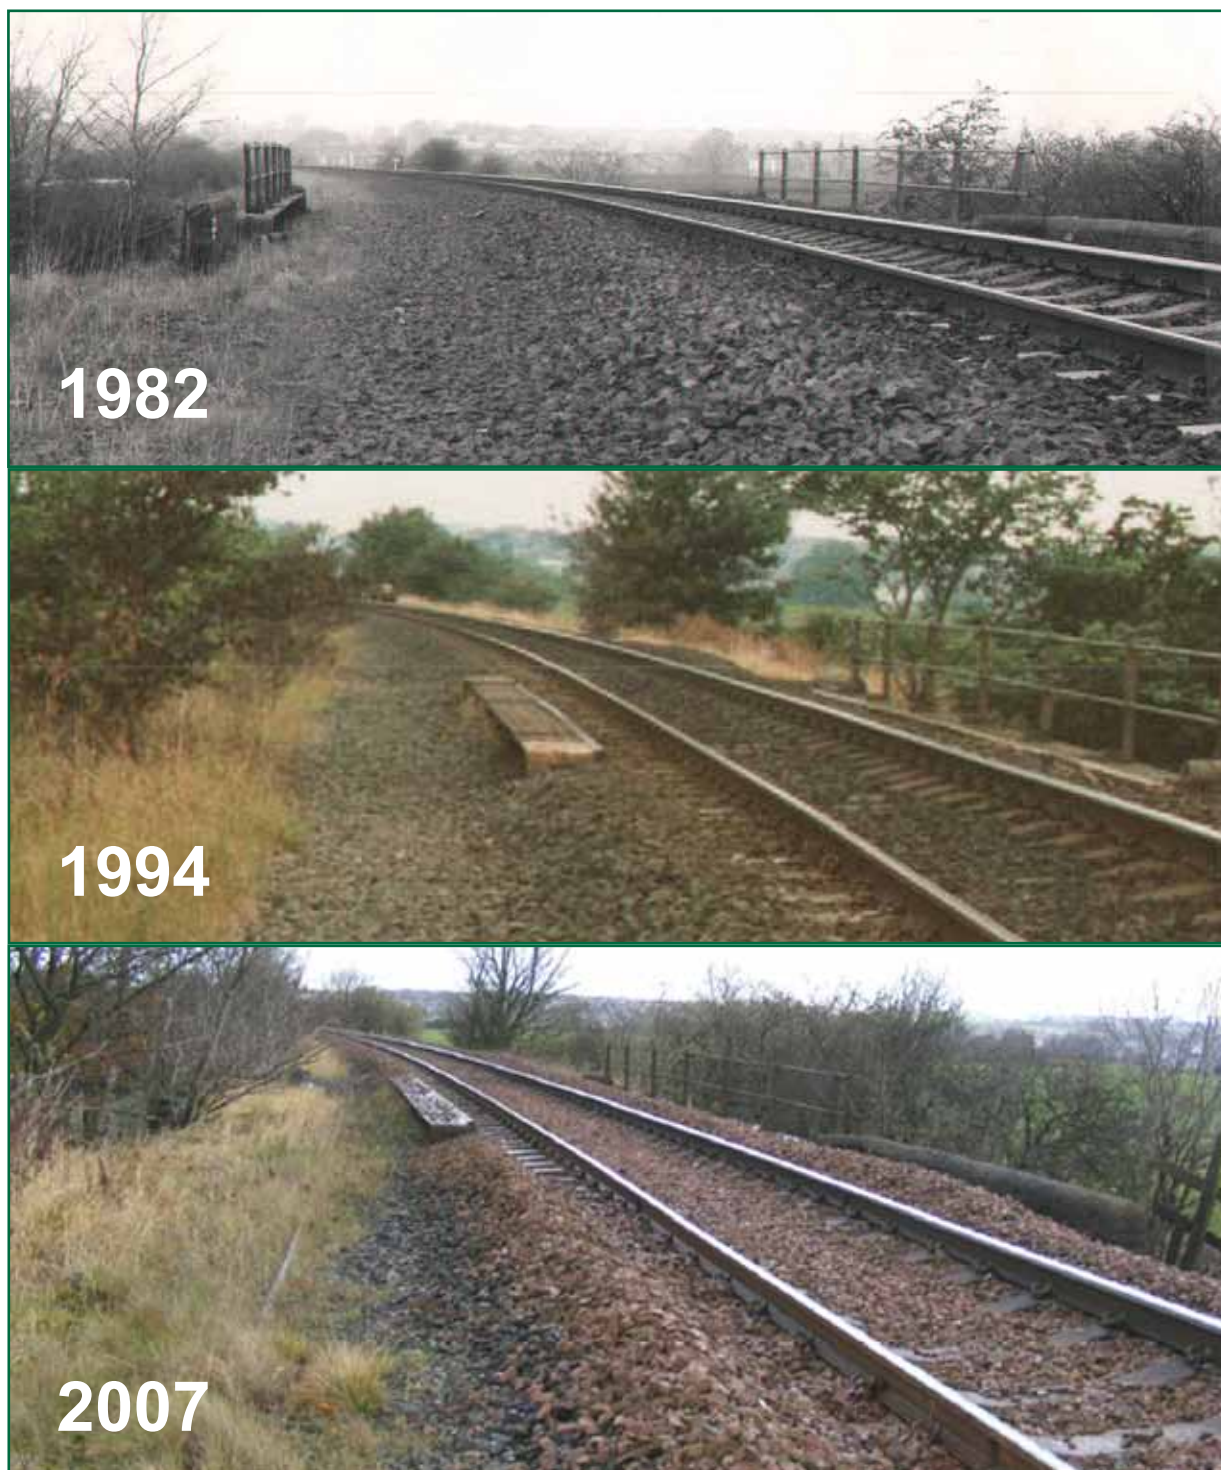
127 Photographs from the routine assessments done in 1982 and 1994, and the inspection done for the 2007 Assessment, show how high the ballast had been on the deck of Bridge 88 (figure 17). In 1982 it buried the centre main girder. The ballast on Bridge 88 would have made the corrosion band very difficult to see from above the deck; the proximity of the timber deck to the web plates would have made the corrosion difficult to see from below.

*Figure 17: The level of ballast on Bridge 88 when photographed for assessments in 1982, 1994 and 2007 (photographs courtesy of Network Rail)*

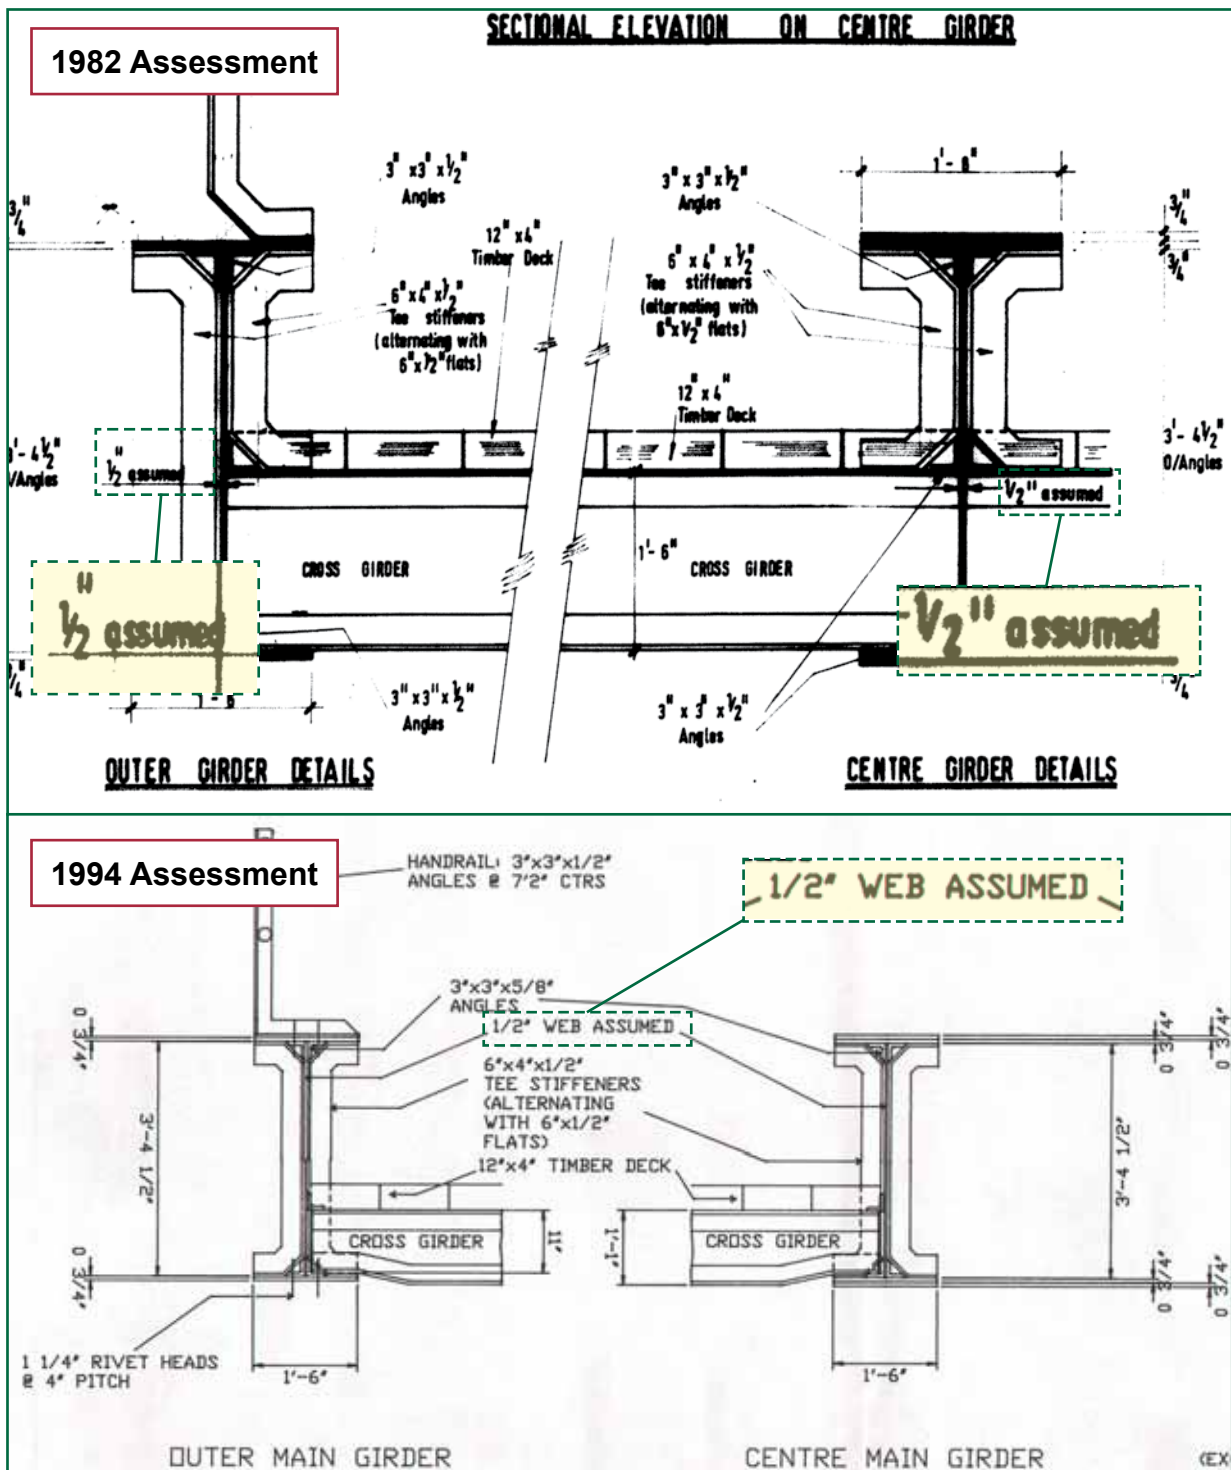
158 The consultants who undertook the assessment inspected the bridge and prepared a drawing of it. This drawing showed the sizes of the structural members that were used in the assessment calculations. The cross section showing the east and centre main girders had the note '1/2" assumed' against the web thickness dimension. Figure 20 includes an extract from the drawing showing the cross section.

Figure 20: Extracts from the drawings prepared for the 1982 and 1994 Assessments showing the cross-section of the main girders (images courtesy of Network Rail)

- 163 Railtrack inspected the bridge and prepared a new drawing of it for use in the assessment. This included a similar note regarding the web plate thickness, ‘1/2” web assumed’, showing that the same assumption had been made (figure 20). However, most of the other incorrect assumptions made in 1982 were amended. Consideration was also given to material lost through corrosion and strike damage from road vehicles, but this was only insofar as it related to the flanges of the cross girders and of the east main girder. All the webs, and all of the centre main girder, were treated as un-corroded.

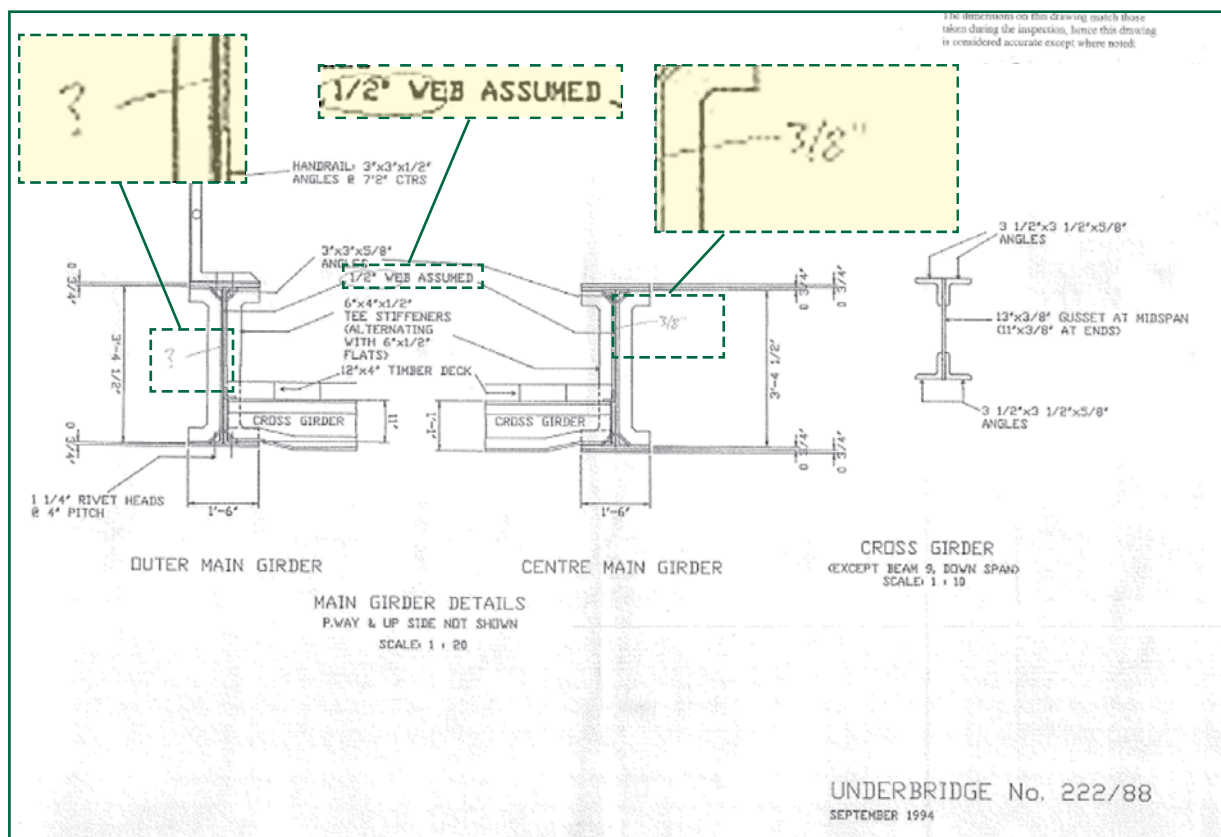
203 The marked-up drawing of the 1994 Assessment that detailed the main girder cross sections in the Inspection for Assessment report correctly recorded the centre main girder web thickness as '3/8" ' (9.5 mm)<sup>30</sup> (figure 22). This was an early indication of a significant inconsistency with the 1994 Assessment – which had assumed 1/2 inch (12.7 mm) (paragraph 163).

Figure 22: Extract from the bridge drawing used for the 2007 Assessment (image courtesy of Network Rail)

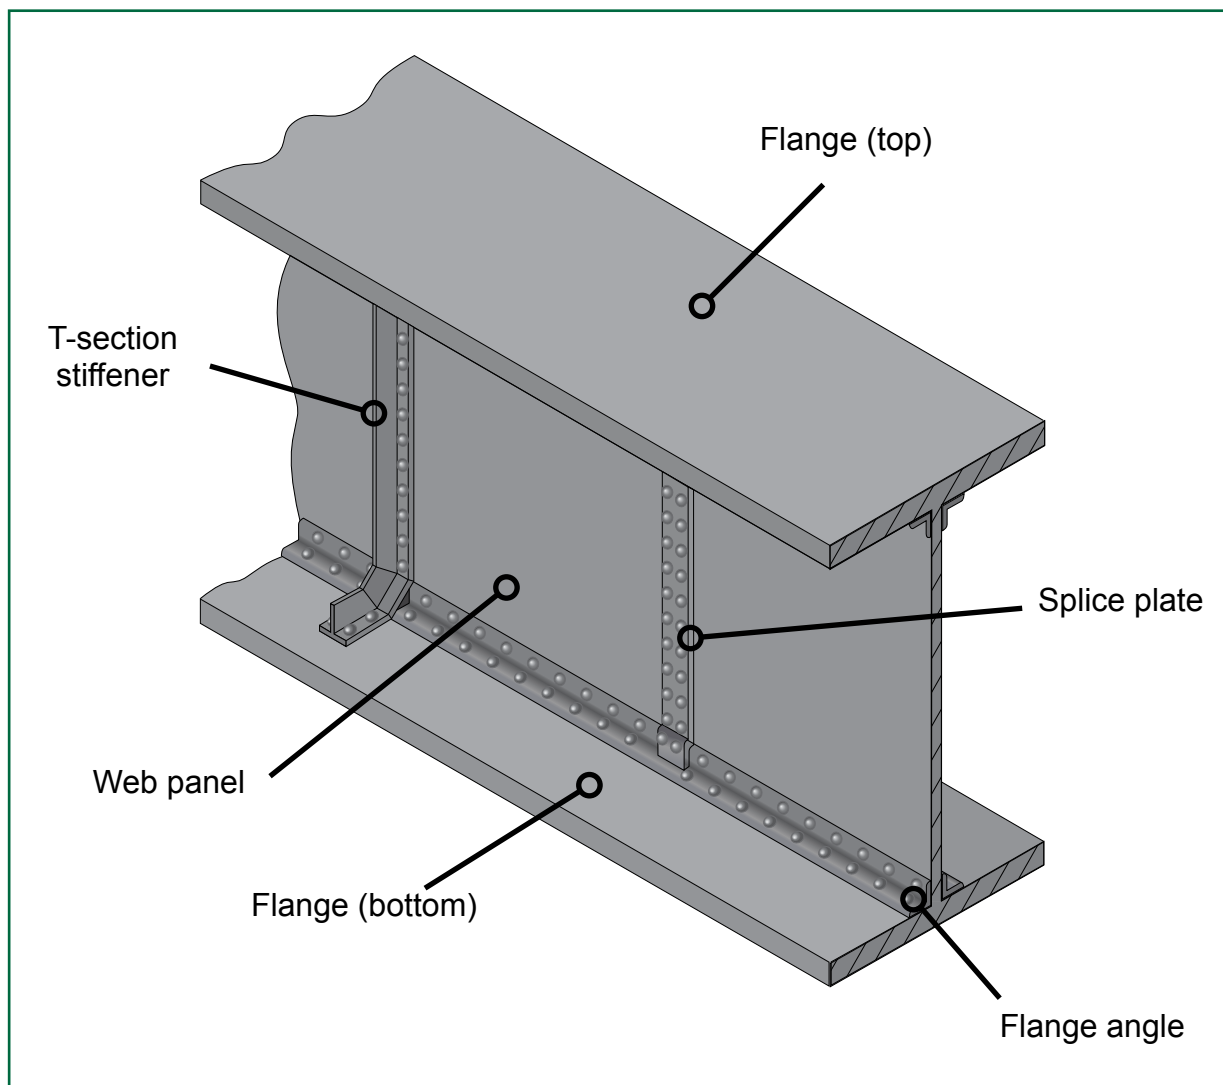
The RAIB surveyed the east main girder and recorded key features found on each web panel (paragraph 102) and the associated parts (figure E1).

Figure E1: Diagram showing a typical main girder web panel and associated parts

Web panel 1 (at the north abutment) was found to be in good condition with only light corrosion along the lower flange angles. It had been repaired at some time by adding a steel repair plate that covered the lower half of the outer face of the panel. This repair panel was welded to the tips of flange angles along two of its sides, to the web splice plate along a third and to the original web panel material along the remaining upper edge.

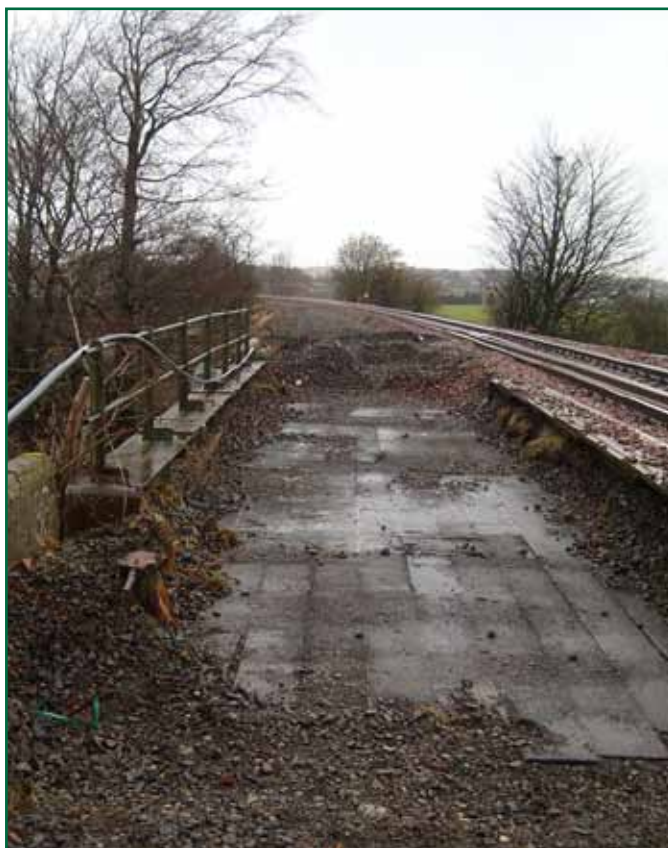
*Figure F3: Site photograph of the west deck after the ballast was removed on 16-17 January 2009 (photograph courtesy of Network Rail)*
