Rail Accident Report

**Collision between an articulated tanker and a passenger train at Sewage Works Lane user worked crossing, near Sudbury, Suffolk
17 August 2010**

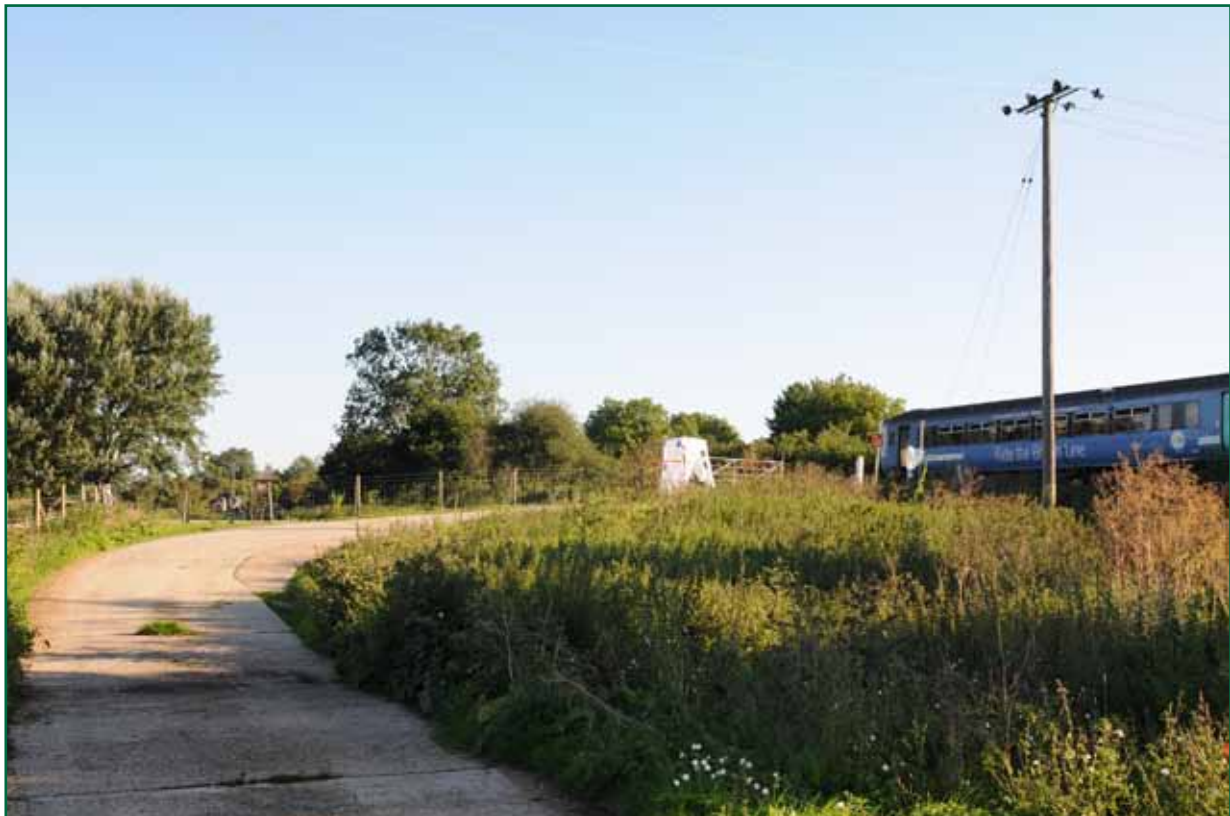
Figure 7: View of the crossing from the exit of the sewage treatment works.

46 The tanker driver had visited the site adjacent to Sewage Works Lane UWC on one previous occasion, two months before the accident. On that occasion, he had read the signs requiring him to call the signaller and had used the telephone before crossing the railway. After crossing the line he did not call the signaller back to advise that he was clear of the crossing. On his return journey he again telephoned the signaller before crossing (figure 7). The signaller explained to the tanker driver that he should also have called once he had negotiated the crossing safely on his inward journey. The tanker driver crossed the railway and called back to advise he was clear. Records held in Liverpool Street IECC do not show that he was subject to any delay on this visit, although the tanker driver said that he waited for a long time before the signaller answered the phone

47 Since the tanker driver had read the signs and called the signaller on his first visit to the crossing, and had then received a specific briefing on other aspects of safe usage of the crossing, the RAIB concludes that the tanker driver was probably aware of how to use the crossing safely.

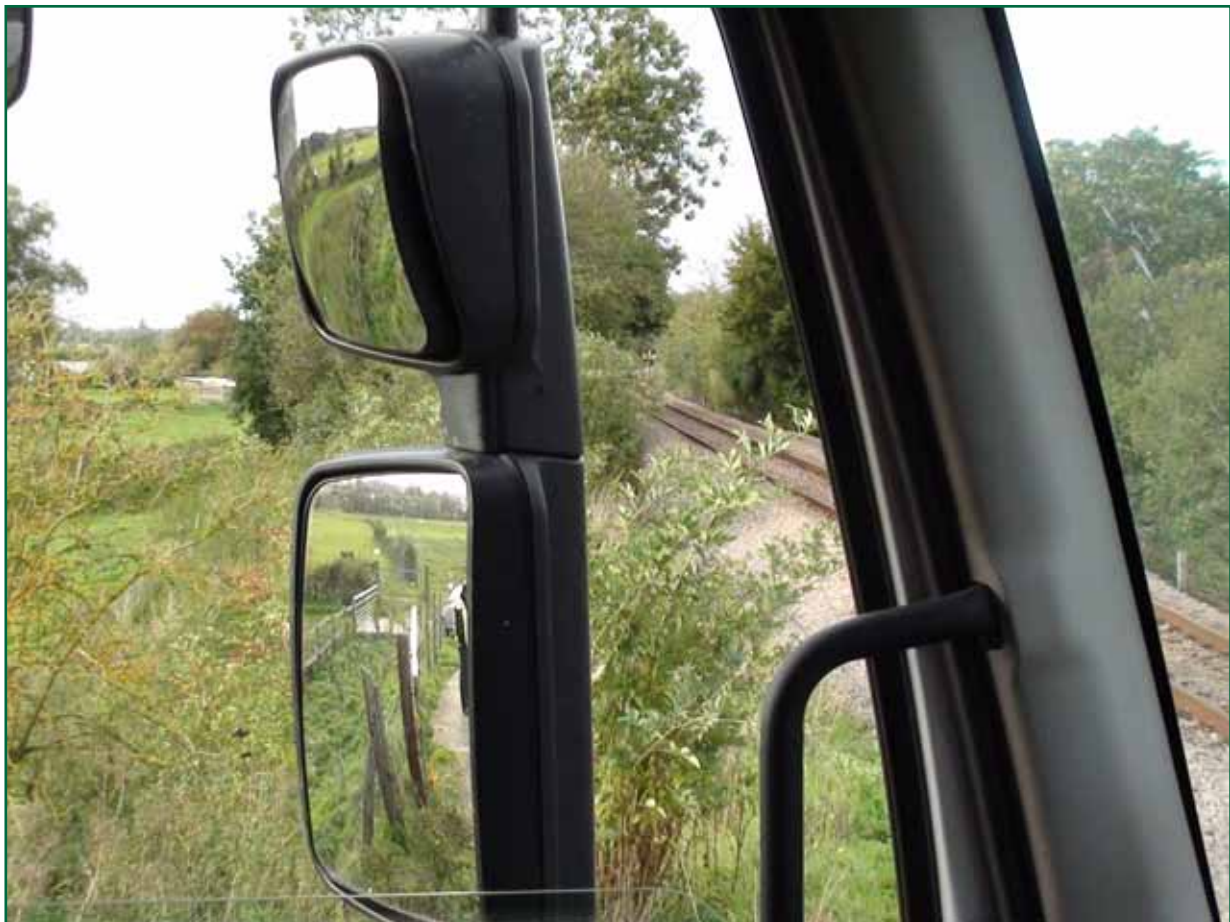
- 89 The tanker driver said that he did not see the approaching train. The RAIB's tests on 3 October 2010 showed that it is possible that the array of mirrors located on the nearside of the tractor unit might obstruct the tanker driver's view of an approaching train (see figures 8 -10). However, the obstruction is easily overcome by the tanker driver moving his head backwards or forwards, an action that he would have been used to performing when joining or crossing a main road from a side road.

Figure 8: View of train taken from the tanker vehicle driving position showing the train beyond Shalfords UWC at around 500 metres (Photograph from the sighting tests on 3 October 2010)

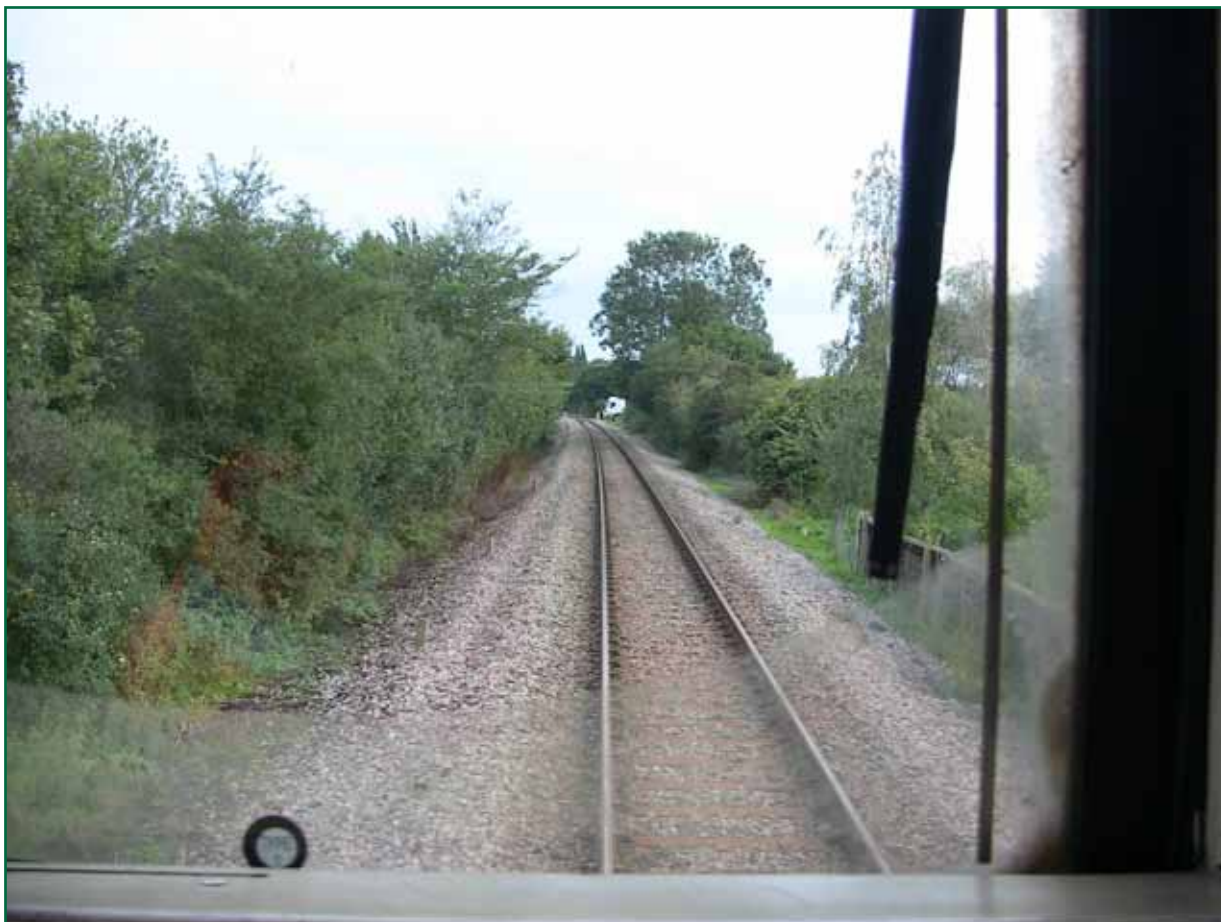
Figure 9: View of tanker from the train driving position at 200 metres (Photograph from the sighting tests on 3 October 2010)
