Rail Accident Investigation Branch

# Rail Accident Report

**Passenger trapped in a train door and dragged a short distance at Newcastle Central station  
5 June 2013**

Report 19/2014  
September 2014

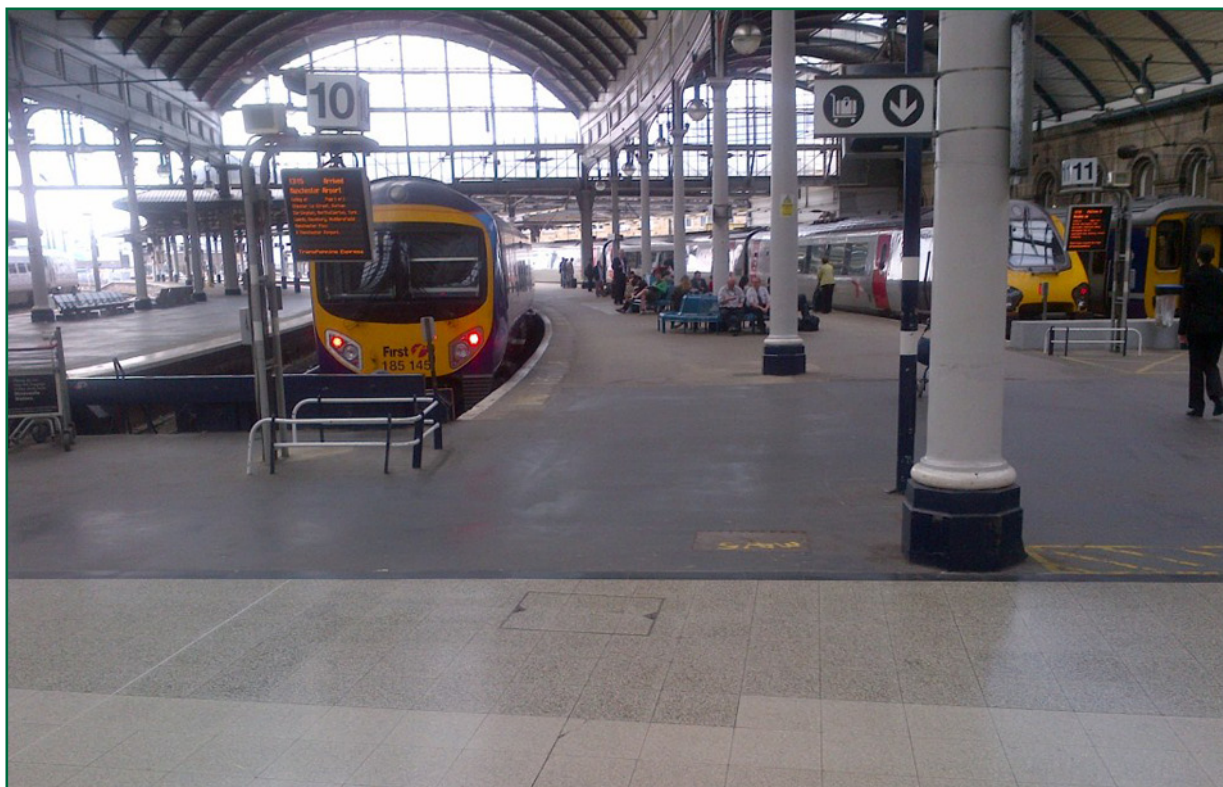
Figure 2: Class 185 unit standing at platform 10 at Newcastle Central station (Image courtesy of First TransPennine Express)

- 8 Platform 10 is a curved terminal platform, as are the adjacent platforms 9 and 11. It has a radius of curvature of approximately 170 metres. When viewed in the direction of a train departing from platform 10, the curve is towards the left with the platform on the right-hand (convex) side of the train (figure 2).

- 24 The accident occurred in daylight and entirely under the station canopy.
- 25 There was a train standing at platform 11 adjacent to platform 10 (figure 2). This service had arrived at 16:45 hrs and was due to depart at 17:32 hrs. The RAIB's subsequent observations suggest that it was likely that there were some passengers on the platform waiting to board this other train, although the conductor has stated that the platform was not particularly busy. There was no train at platform 9. There were no external circumstances that contributed to the accident.

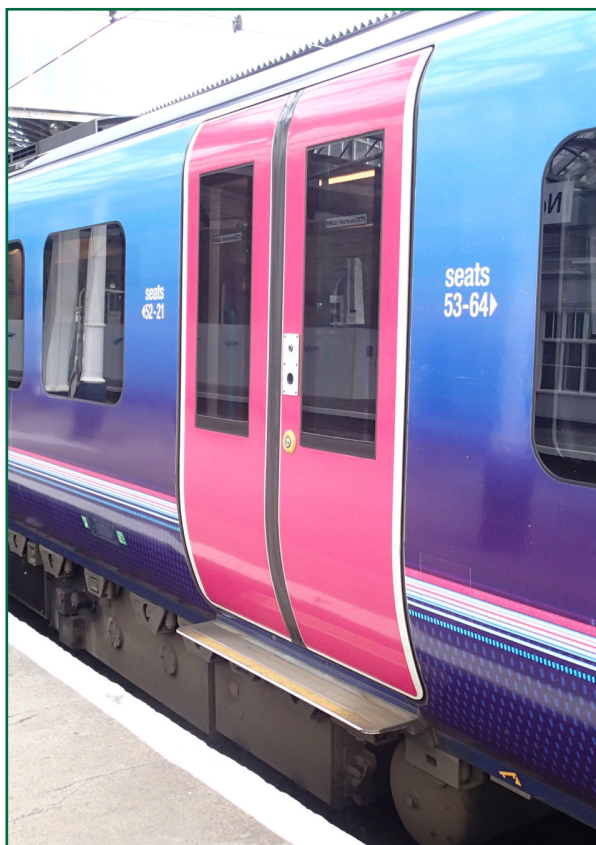
Figure 3: Class 185 double-leaf external passenger door

- 16 Each of the three carriages has two double-leaf passenger doors on each side. Each door leaf is fitted with a rubber leading edge. The leading edges meet in the centre of the doorway forming a seal when the door leaves are closed (figure 3). There is an electrical sensing element within each rubber edge designed to detect obstructions when the leaves are closing. This is known as a sensitive door edge. The control of the doors is such that the door will fully reopen if an obstruction is detected. The operation of the doors is explained more fully in paragraph 47.

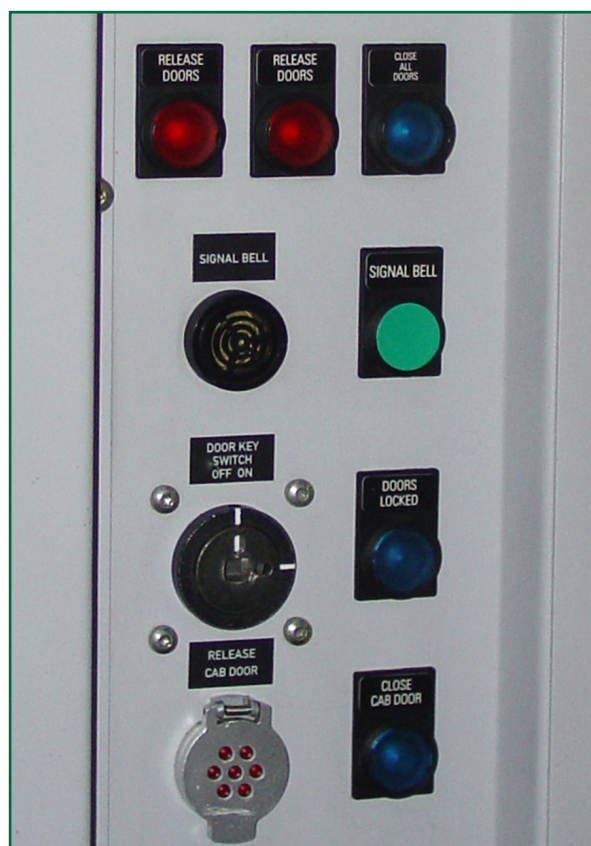
Figure 4: Class 185 rear cab door control panel

- 17 In the cabs of the train are two control panels (one on each side of the train) from which the conductor, when riding in the rear cab, can control the train doors and communicate with the driver (figure 4). The panel has illuminated buttons and indicators which show the status of the train doors. There is a *door key switch* (DKS) on the panel which, when turned to the 'on' position by a key, makes the buttons and indicators active.
- 18 There is a bodyside indicator lamp on each side of every carriage (figure 5). This illuminates orange if the passenger doors on that particular carriage are not closed and locked, and extinguishes if they are. There are also door control panels in the centre carriage known as the guard's operating panel, or GOP. The bodyside indicator lamp will flash on the carriage where the DKS has been turned on to activate the door control panel.

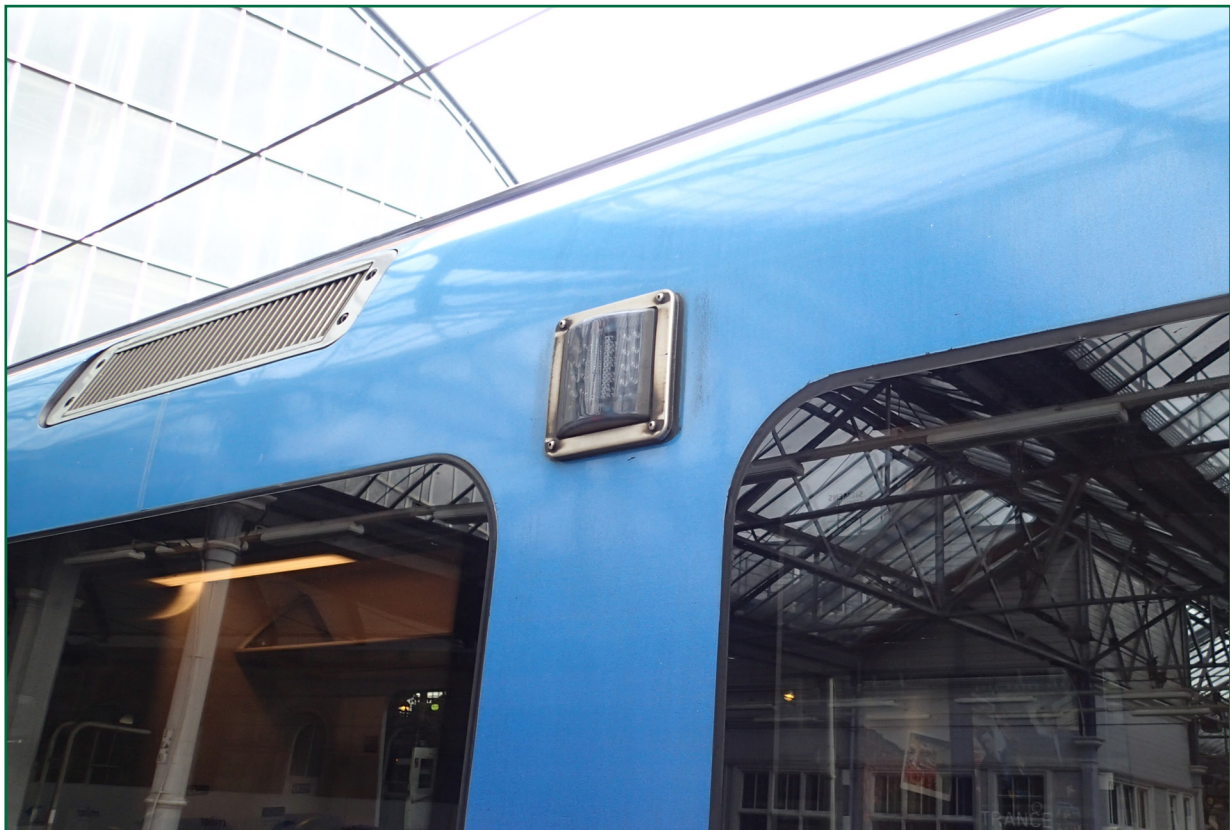
Figure 5: Class 185 bodyside indicator lamp

- g. The conductor should also check the bodyside indicator lamps. When the doors are closed the lamps will be extinguished, except for the one on the rear carriage where the DKS has been turned on and the cab door is open; this will be flashing.

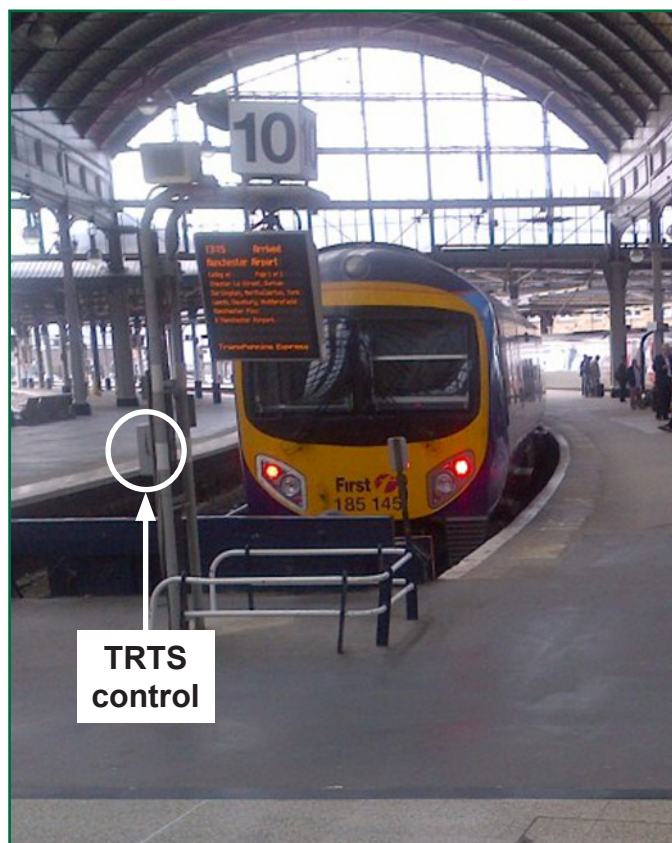
Figure 6: Platform 10 TRTS control (Image courtesy of First TransPennine Express)

- 19 To assist with train dispatch, platform 10 is fitted with a *train-ready-to-start control*, or TRTS (figure 6). The conductor operates this by pressing a button a few minutes before the departure time. This informs the signaller, or the signalling system if *automatic route setting* is in operation, that the train is ready to depart.

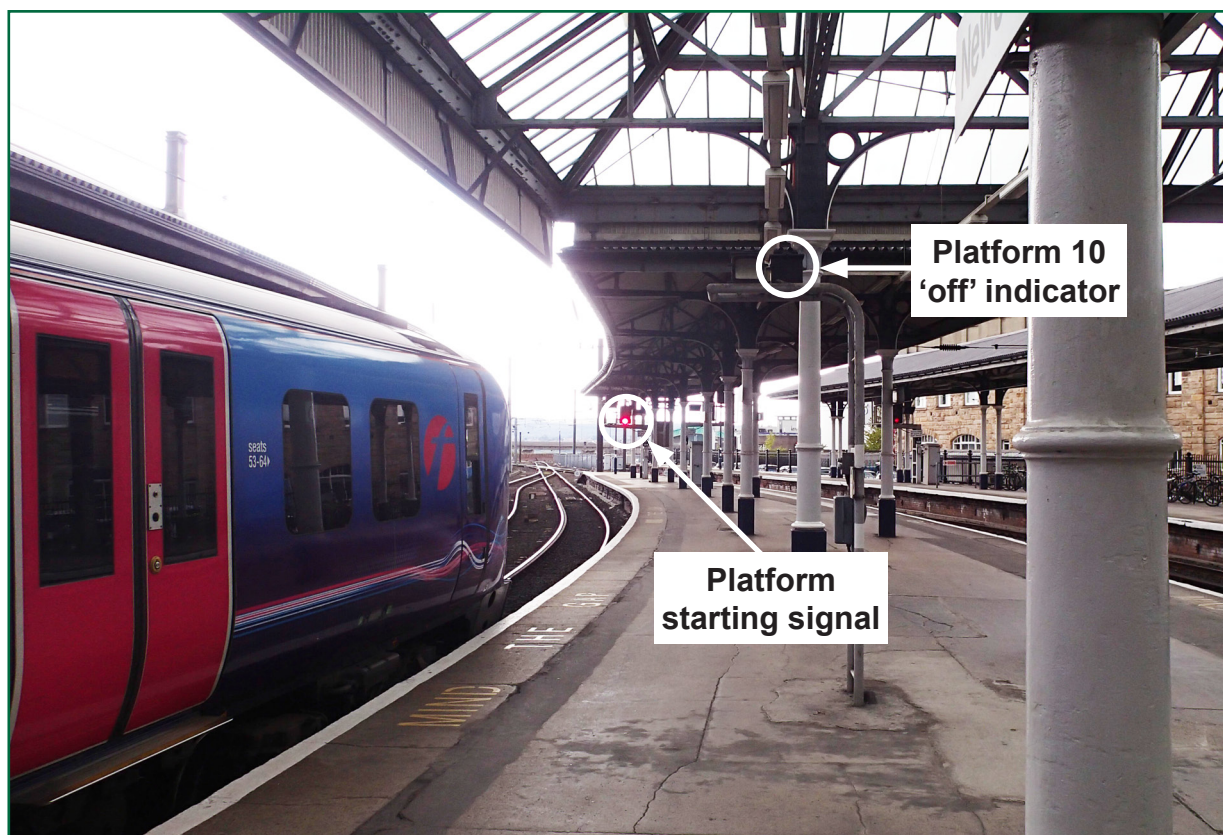
Figure 7: Platform 10 starting signal and 'off' indicator as seen from the rear of front vehicle

- 20 If the route ahead is clear, the signaller or signalling system sets the platform starting signal, which is beyond the front of the train, to a proceed aspect (yellow or green) indicating the train may depart (figure 7). At platform 10, the TRTS control is located on a post close to the terminal end of the platform.

- 21 Approximately two-thirds along the length of the platform from the terminal end, is an *'off' indicator* (figure 7). When illuminated, this informs the conductor that the route ahead is clear for the train to depart. The *'off' indicator* is necessary as the conductor cannot easily see the platform starting signal from the rear of the train because of the curvature of the platform.

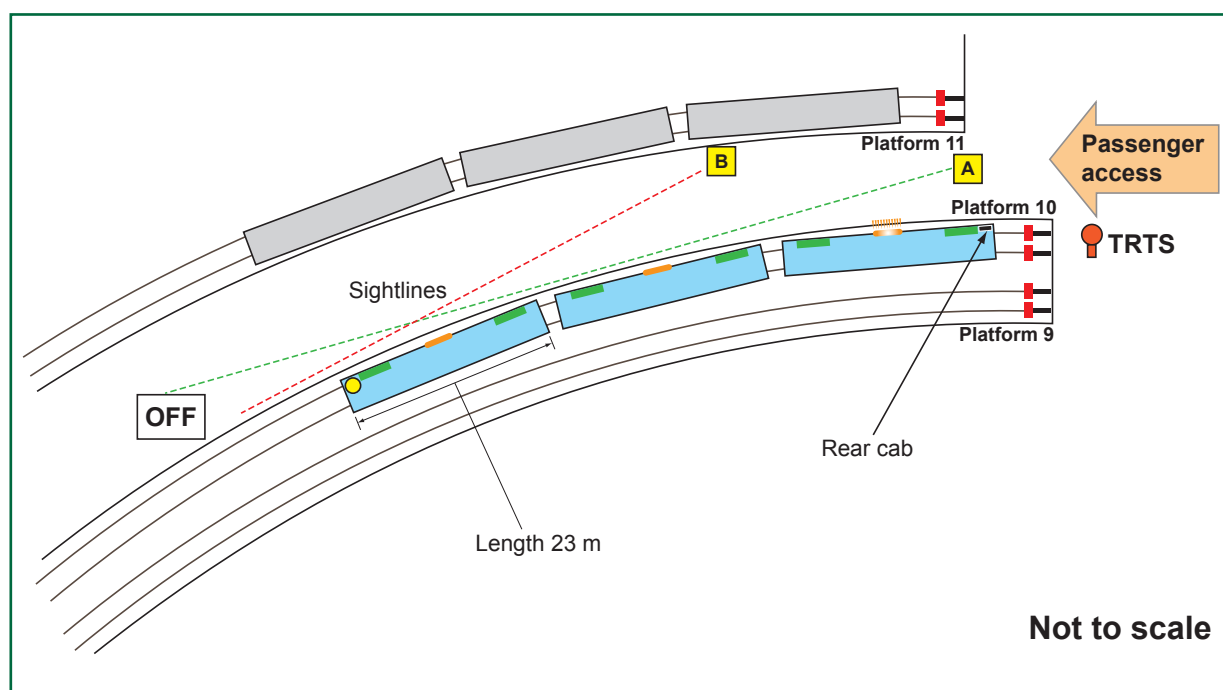
Figure 8: First TransPennine Express model dispatch procedure for self-dispatch from platform 10 from the rear cab

- 44 Figure 8 illustrates FTPE's expected method for conductors dispatching a Class 185 from the rear cab at platform 10 at Newcastle Central. The steps are:
