Rail Accident Investigation Branch

Rail Accident Report

**Near miss involving a track worker at Tinsley
Green Junction
17 March 2007**

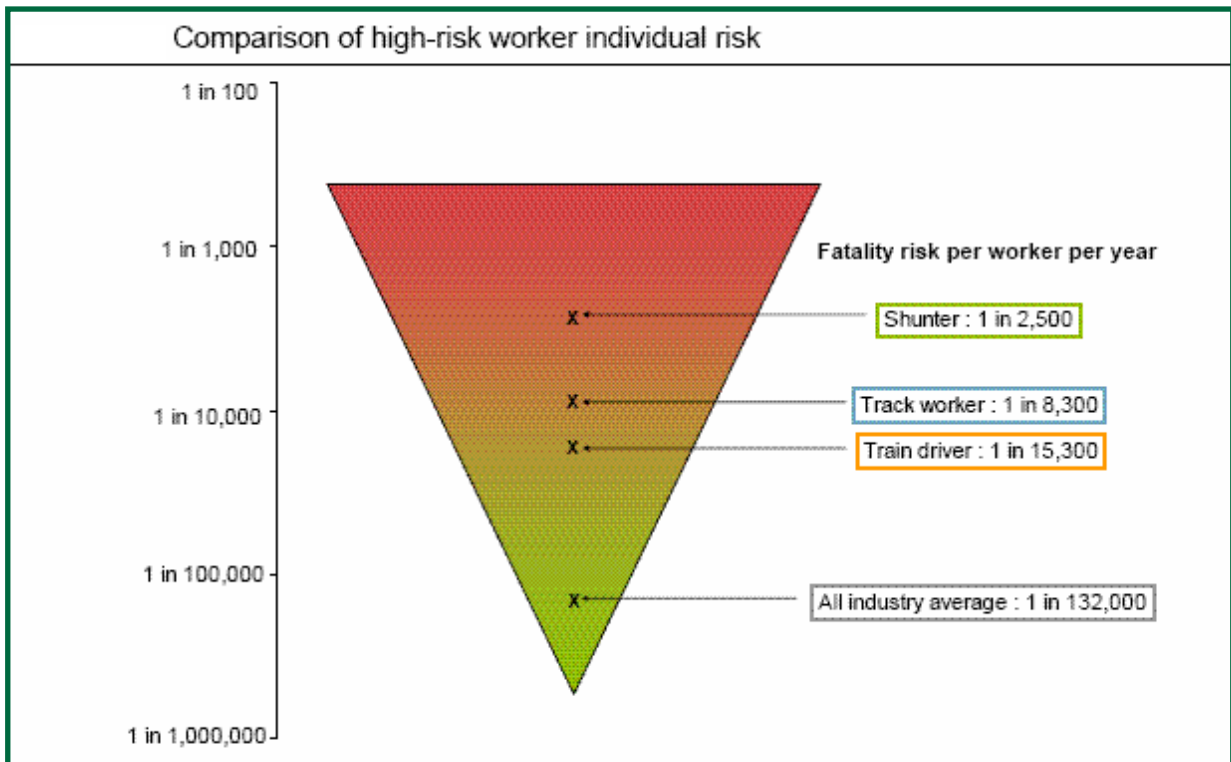
- 53 Track workers are subject to levels of risk well in excess of the average for all workers in the railway industry. The RSSB Annual Safety Performance Report (provisional) for 2006 concludes that the risk of fatality per track worker per year is 1 in 8,300 (see Figure 4). This compares to 1 in 15,300 for train drivers and 1 in 132,000 average for all workers in the industry.

Figure 4: Levels of individual risk (extract from RSSB Annual Safety Performance report)

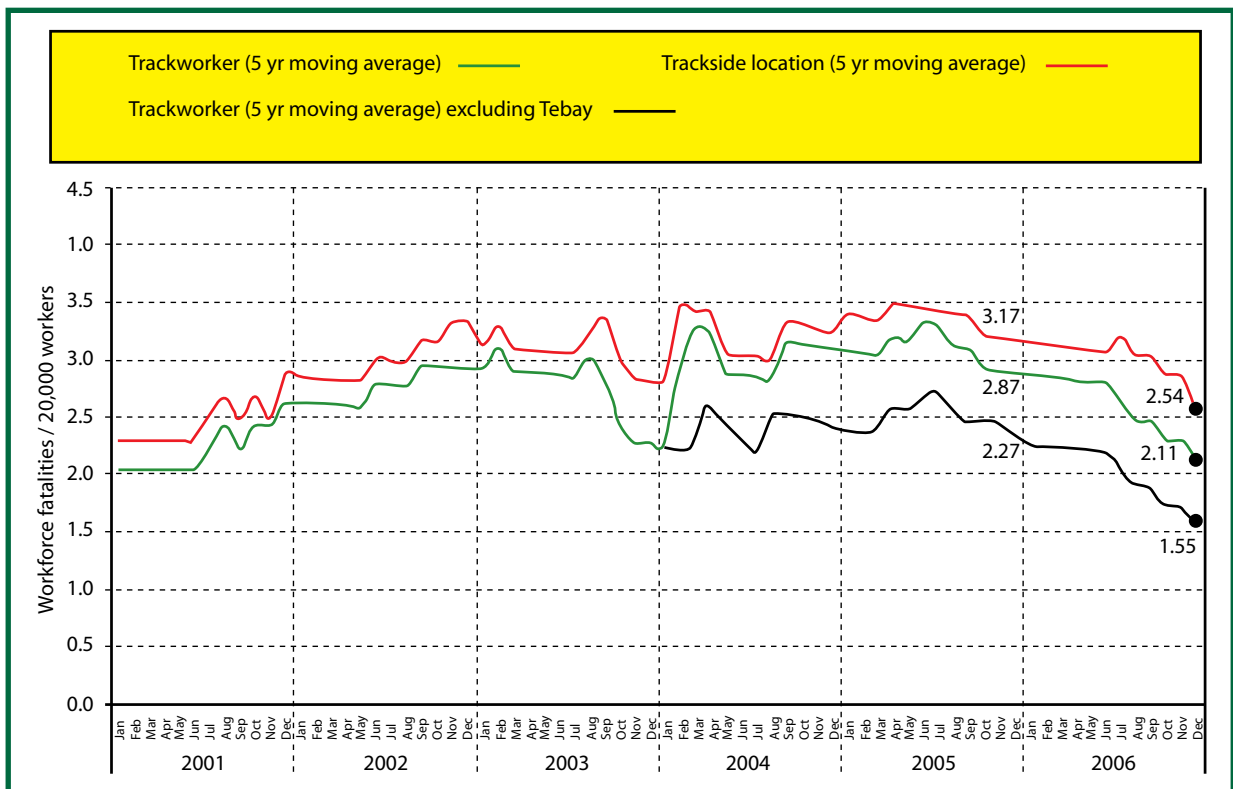
- 54 Statistics provided by the RSSB show that the 5-year moving average track worker fatality rate (normalised by staff numbers) for 2006 was roughly similar to that in 2001 (see Figure 5). However, this average was influenced by the four fatalities that occurred in 2004 as a direct consequence of a criminal act at Tebay. If the impact of this single event is excluded from the data, the track worker fatality rate is calculated to have fallen by 25 percent between 2001 and 2006.

Figure 5: Track worker fatality rates normalised by staff numbers (data provided by RSSB)
