REPUBLIC OF SERBIA
CENTER FOR INVESTIGATION OF ACCIDENTS IN TRANSPORT
SECTOR FOR INVESTIGATION OF ACCIDENTS IN RAILWAY TRAFFIC
AND INTERNATIONAL COOPERATION
Nemanjina 11, 11000 Belgrade

FINAL REPORT ON INCIDENT INVESTIGATION

Type of incident: Train decoupling
Train number: 8011
Place: Belgrade, area of junction and the stop Pančevački Most
Date: August 03, 2017
Time: 07:55

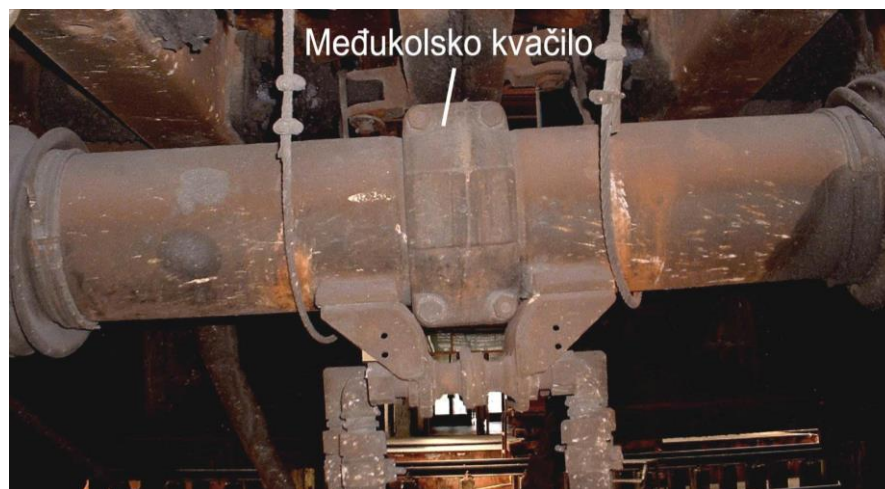
Picture 2.2.2.2: Appearance of the coupling between vehicles installed in EMV series 412/416

One train is consisted of two identical parts. One part is consisted of a power car and the trailer. The vehicles between them as well as the two parts of the train are connected with the coupling, manufacturer *Scharfenberg* type 10, number 40-1075(1). Coupling provides mechanical connections between vehicles and connection of air pipes, while connection of electrical cables is done separately. Technical characteristics of the coupling and the procedures for regular repairs are given in Instruction for repairs of couplings between vehicles, that is drafted in 2004 by the Institute Kirilo Savic from Belgrade within the Project of technical overhaul documentation for the train EMV series 412/416.
