REPUBLIC OF SERBIA
CENTER FOR INVESTIGATION OF ACCIDENTS IN TRANSPORT
SECTOR FOR INVESTIGATION OF ACCIDENTS IN RAILWAY TRAFFIC
Nemanjina 11, 11000 Belgrade

FINAL REPORT ON ACCIDENT INVESTIGATION

Accident type: Trains collision
Train No.: 2990 and 70922
Place: City of Belgrade, municipality Voždovac, settlement Ripanj,
open track between the stations Klenje and Ripanj Tunel
Date: 01.08.2018.
Time: 05:35

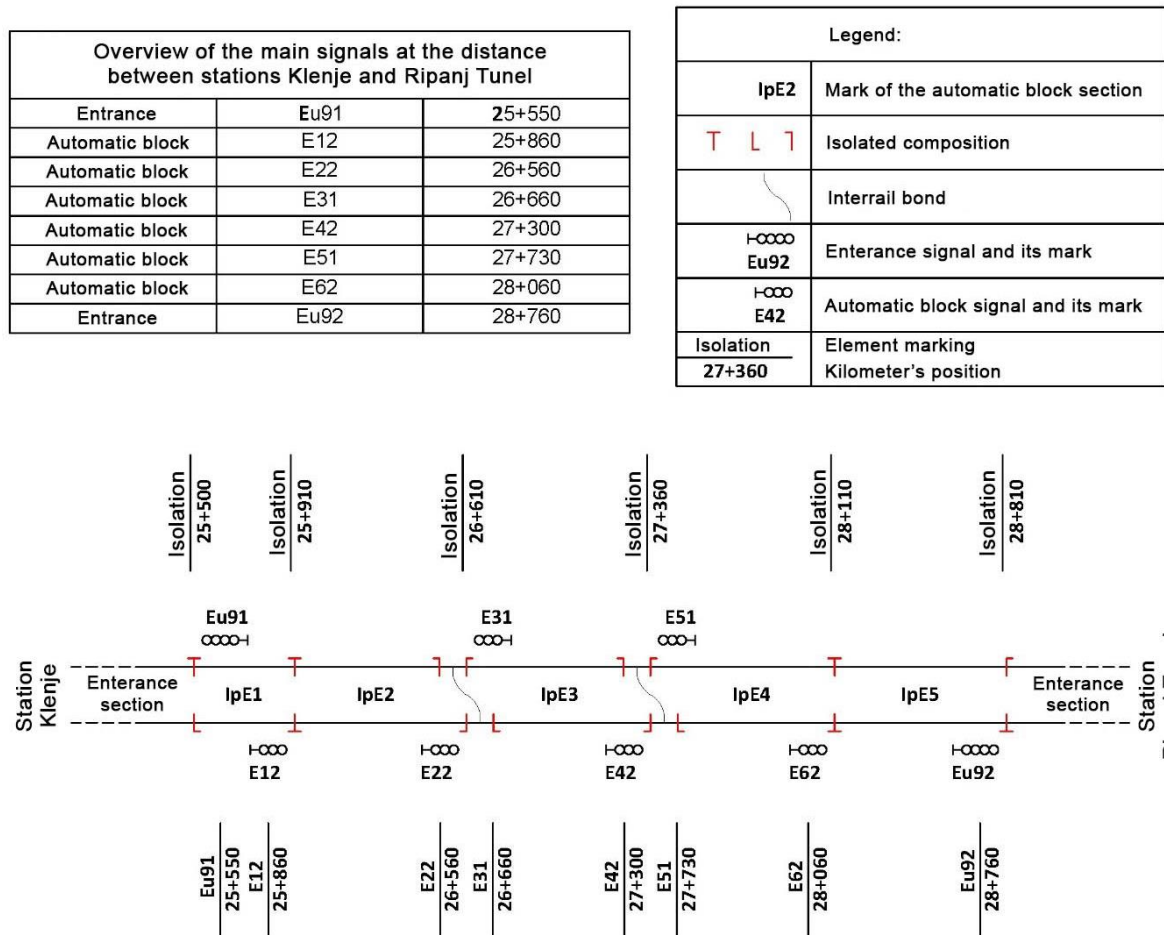
Figure 2.2.3.1: Sketch of arrangement of automatic block sections and signals at distance between stations Klenje - Ripanj tunnel

All mileages shown in Figure 2.2.3.1 are in accordance with the cable layout list, which is part of the valid SS Project on the distance between stations of the Klenje - Ripanj Tunnel, delivered by "IŽS" a.d. by e-mail from 26.10.2018.

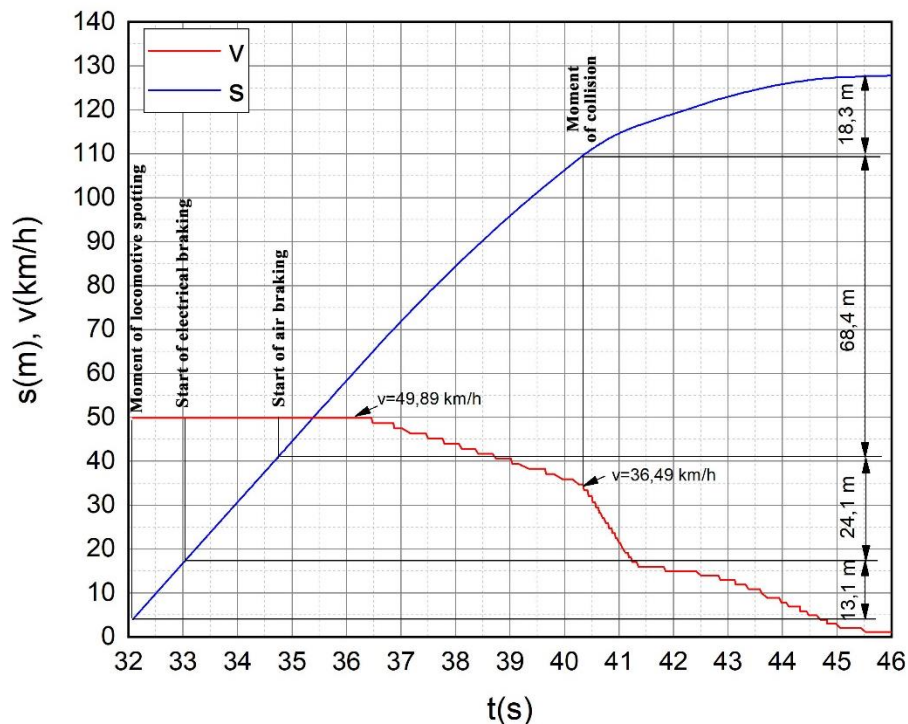
Type of braking	Distance crossed (m)	Note	Stopping path (m)
-	13.1	Path to noticing the locomotive (1s)	110.8
Electric braking	24.1		
Electric and pneumatic braking	86.7		
Total stopping path	123.9

Figure 4.2.3.1: Diagram of braking EMV 413/417-033/034 during a collision

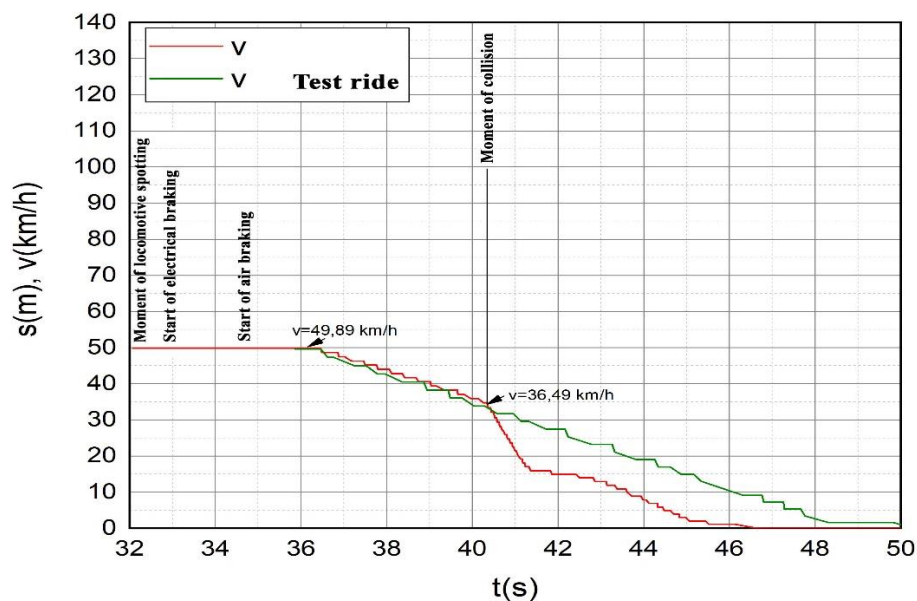
In the part of the deceleration from a speed of 50 km/h to 36.4 km/h, it can be concluded that the curves coincide. The minimal difference of events is evident as a result of the different slope of the track at the crash site and the place of the test drive. At a slowdown of 36.4 km/h to stop, the difference in speed reduction is significant because the deceleration during collision was significantly higher due to collision of EMV 413/417-033/034 to the locomotive 661-162.

Figure 4.2.3.2: Comparative display of diagram of stopping of EMV during the test ride and collision

By comparing the length of the stopping path when braking at a speed of 30 km/h, obtained during the test ride and part of the stopping time from the beginning of the braking to the moment of collision, it can be concluded that if the train No. 2990 was moving at a speed not exceeding 30 km/h, the collision would not have happened.

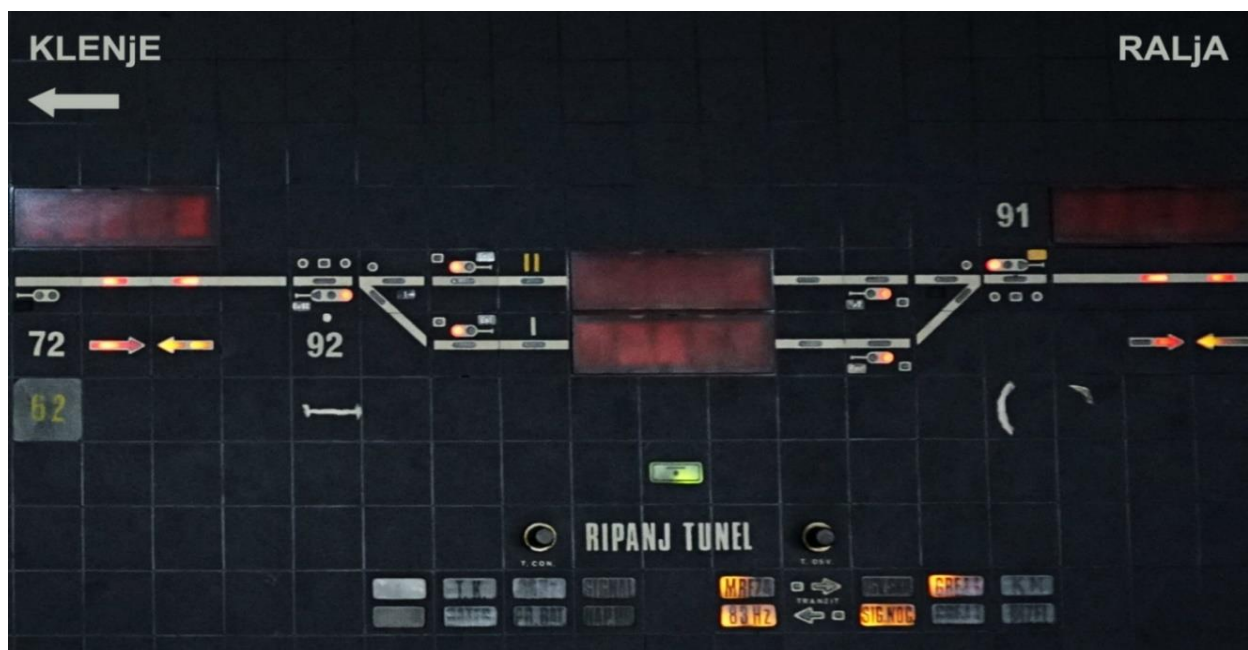
Figure 4.2.4.4.1: Appearance of the part of command-controlling panel at TK Centre, review of station Ripanj Tunel
