Rail Accident Investigation Branch

# Rail Accident Report

**Fatal accident at Tibberton No. 8 footpath  
crossing  
6 February 2019**

Report 13/2019  
October 2019

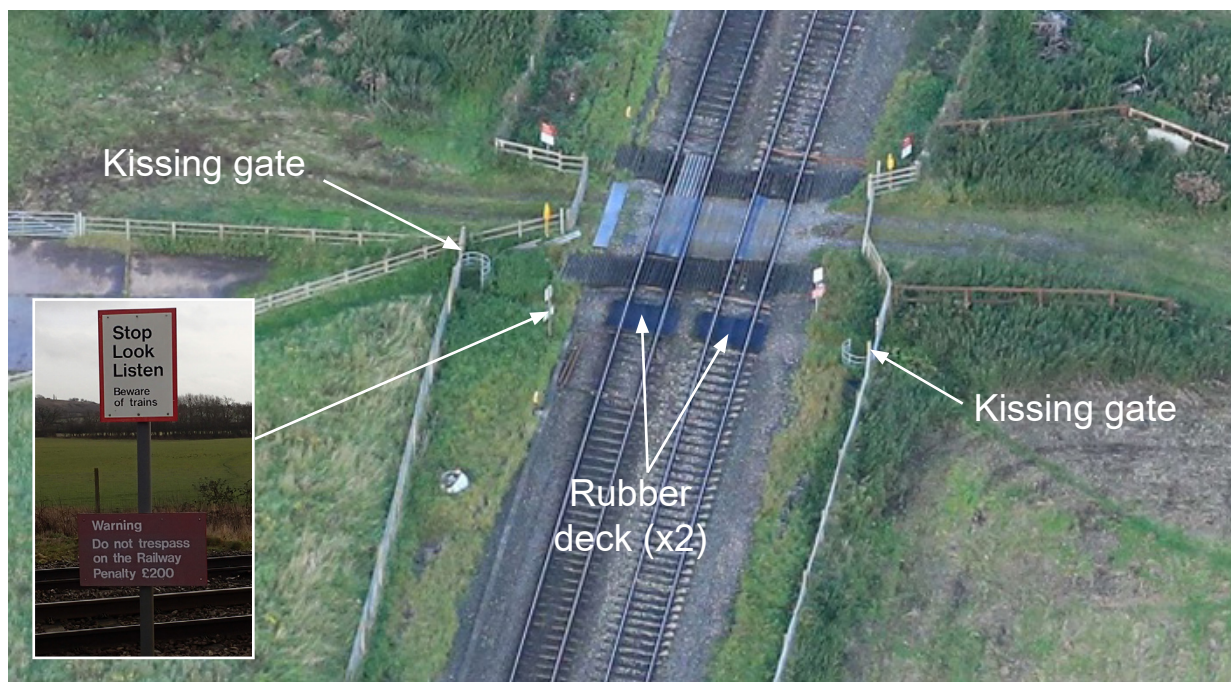
Figure 4: Layout of Tibberton No. 8 footpath crossing (image courtesy of Network Rail)

- 14 Figure 4 shows the general layout of Tibberton No. 8 footpath crossing at the time of the accident. The railway at this location runs approximately north-east to south-west in a relatively wide strip of railway land. Kissing gates at the railway boundary provide access to an open lineside leading to a rubber crossing deck made up of two separate sections, one for each line, with a ballast infill between the lines. Inside the railway boundary, signs instruct users to stop, look and listen, and beware of trains. The pedestrian was crossing the railway from the west (figure 3). Figure 5 shows the significant features when approaching in this direction.

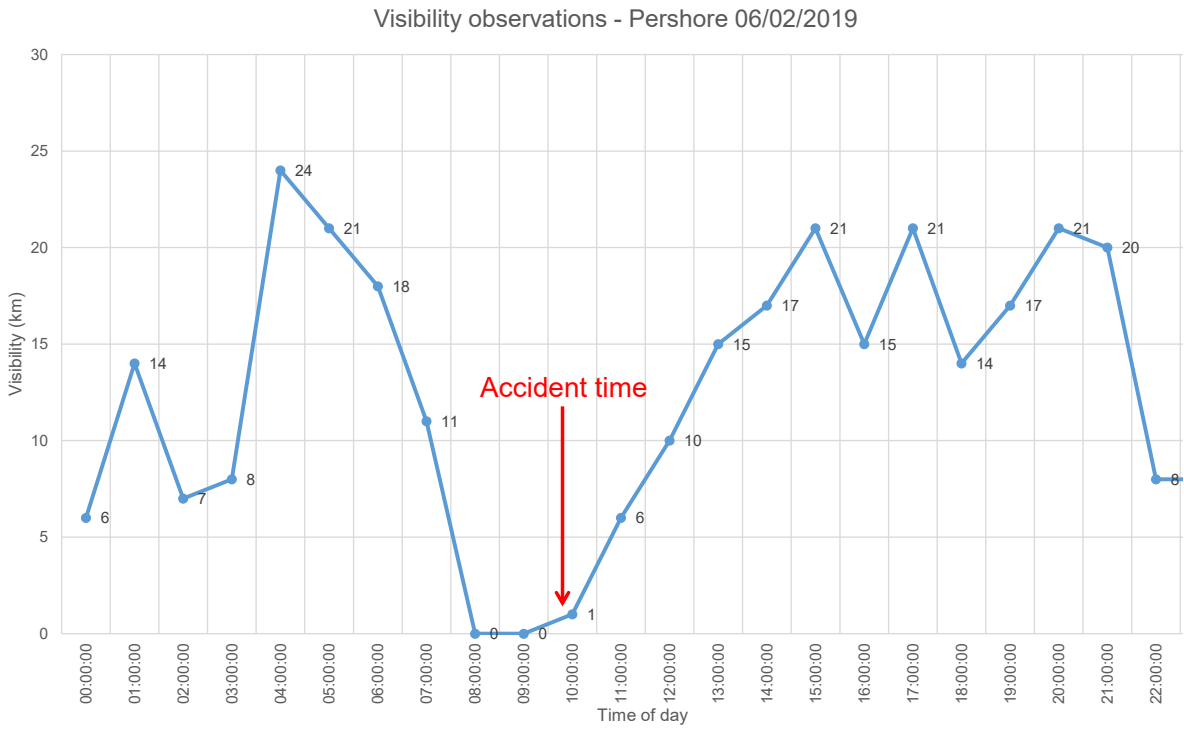
Figure 6: Observed visibility data at Pershore on the day of the accident

17 The weather at the time of the accident was foggy with an air temperature of around 6°C reported at Pershore<sup>4</sup>, approximately 10 miles (16 km) south of Tibberton (figure 2). Visibility at Pershore was recorded as being between 0 and 1,000 metres as shown in figure 6. The weather station at Pershore also recorded a south-south-west wind of 7 mph (11 km/h) at 10:00 hrs. There had been no precipitation over the previous 12 hours.

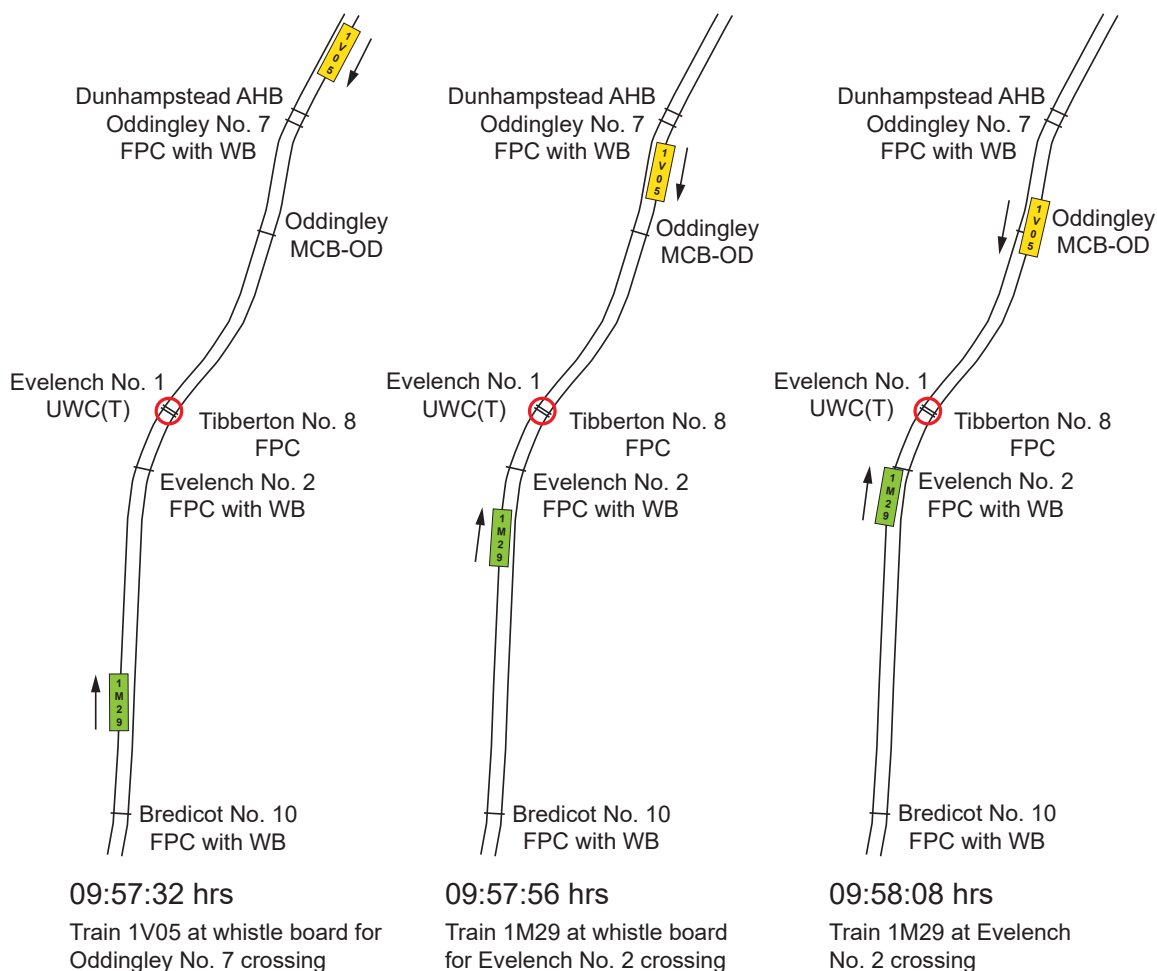
Figure 7: Sequence of events before the accident

- 19 At 09:57:32<sup>6</sup> hrs, train 1V05 (the accident train) was travelling south at around 100 mph (161 km/h) and approaching Oddingley No. 7 footpath crossing, when the driver sounded the train's horn at the whistle board (figure 7). Train 1M29 (the passing train travelling north) was approximately 2 kilometres south of Tibberton No. 8 footpath crossing at this point. It was also travelling at around 100 mph (161 km/h).
- 20 At 09:57:56 hrs, the driver of train 1M29 sounded the train's horn as expected on the approach to the whistle board for Evelench No. 2 footpath crossing. Train 1V05 was over 1.8 kilometres north of Tibberton No. 8 footpath crossing at this point<sup>7</sup>.
- 21 At 09:58:08 hrs, train 1M29 reached Evelench No. 2 footpath crossing. Train 1V05 was approximately 1.3 kilometres north of Tibberton No. 8 crossing at the time.

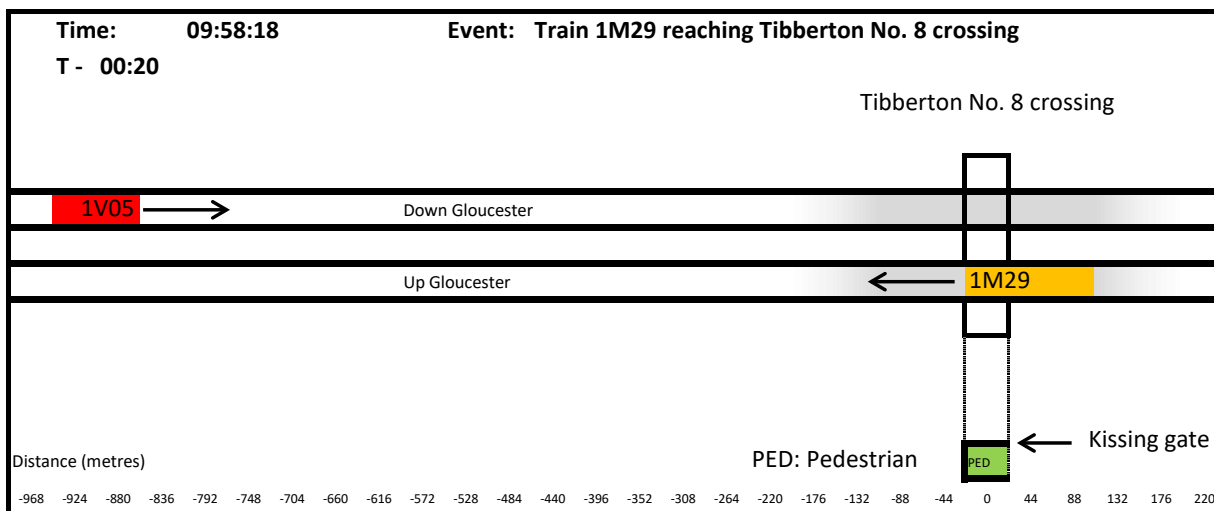
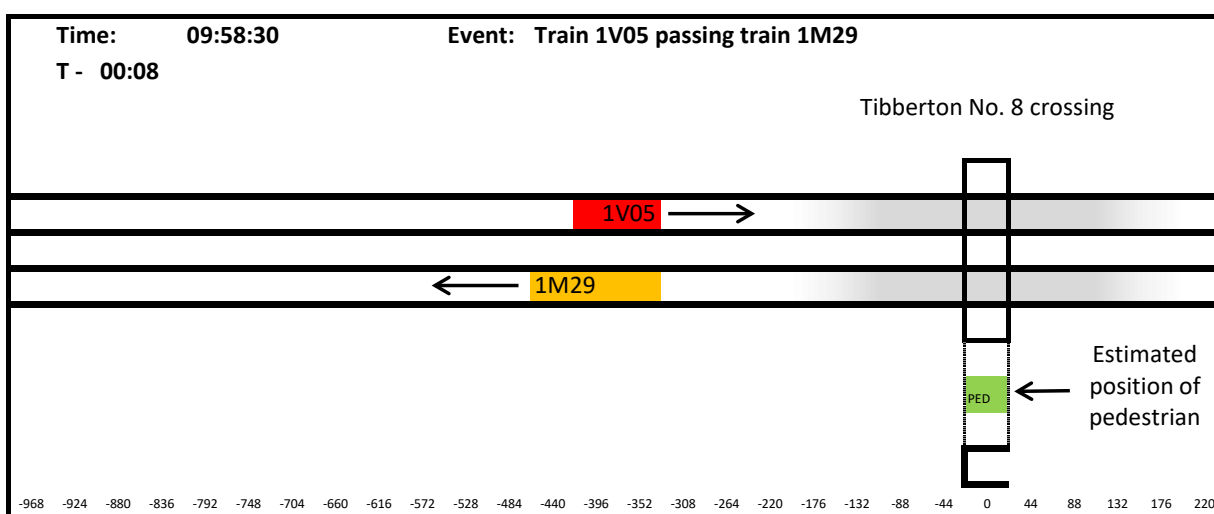
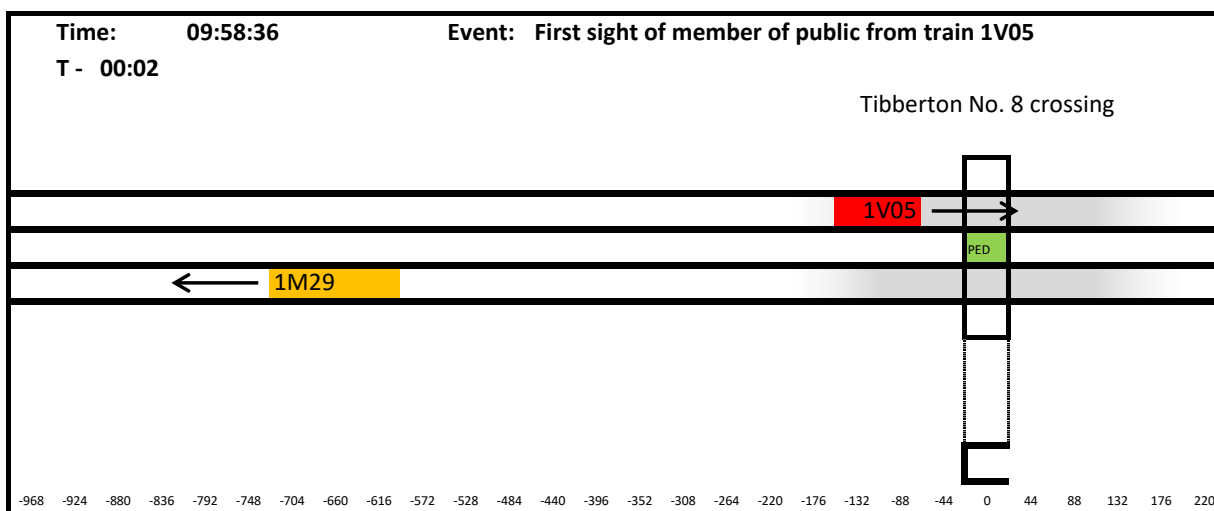
Figure 8: Sequence of events during the accident

- 22 Figure 8 shows the sequence of events during the accident. Train 1M29 reached Tibberton No. 8 footpath crossing at 09:58:18 hrs. The pedestrian can be seen on the FFCCTV from train 1M29. He was standing within the kissing gate on the west side of the railway. At that time, train 1V05 was approximately 880 metres away from the crossing.
