Rail Accident Report

Near miss between a train and a level crossing user at Dock Lane, Melton, Suffolk 14 June 2016

Report 08/2017
May 2017

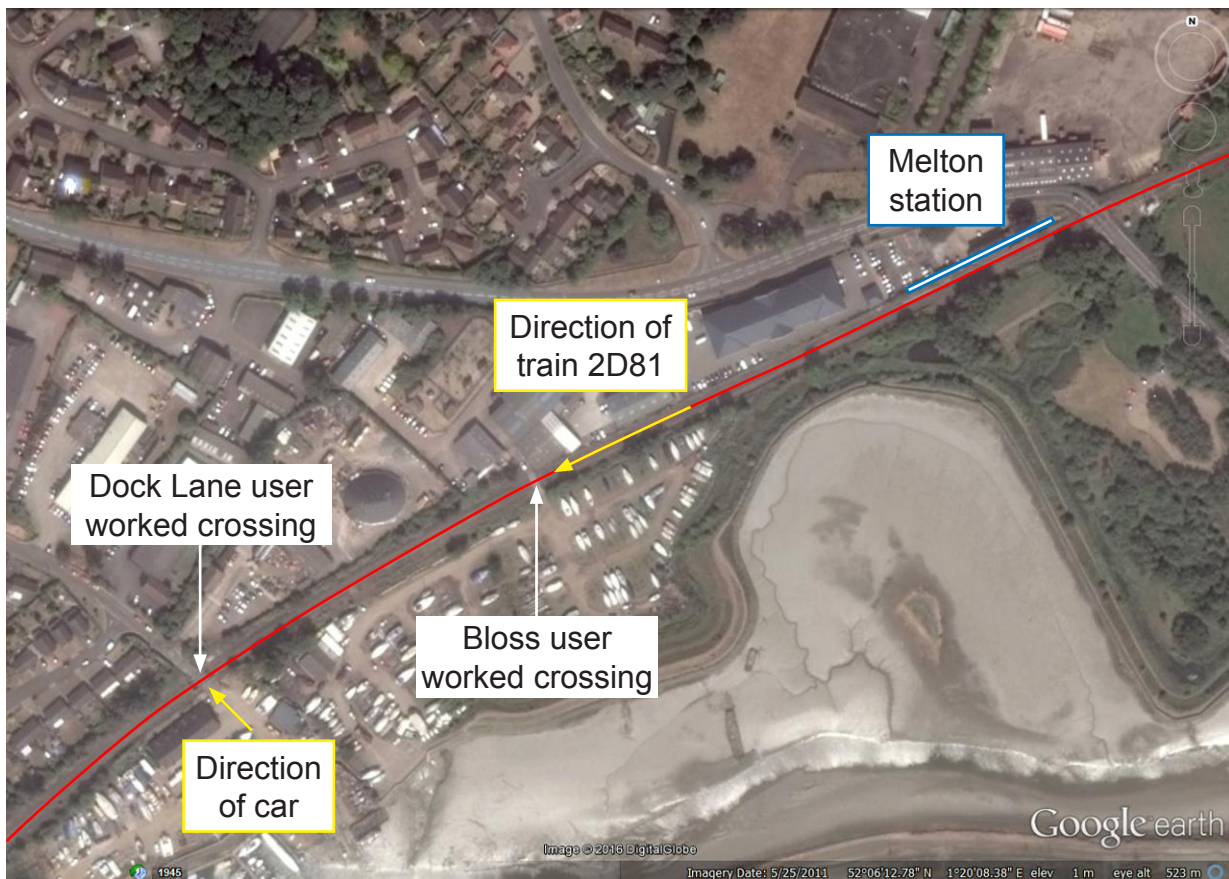
Figure 2: Detailed locations of crossings at Melton

- 7 Dock Lane level crossing provides access to a boatyard and other facilities to the east, between the railway and the River Deben. The crossing is located at 80 miles 6 chains¹ on a single track section of the East Suffolk line between Woodbridge and Melton stations, on which there is generally an hourly passenger train service in each direction. The crossing is approximately 280 metres south-west of Melton station.

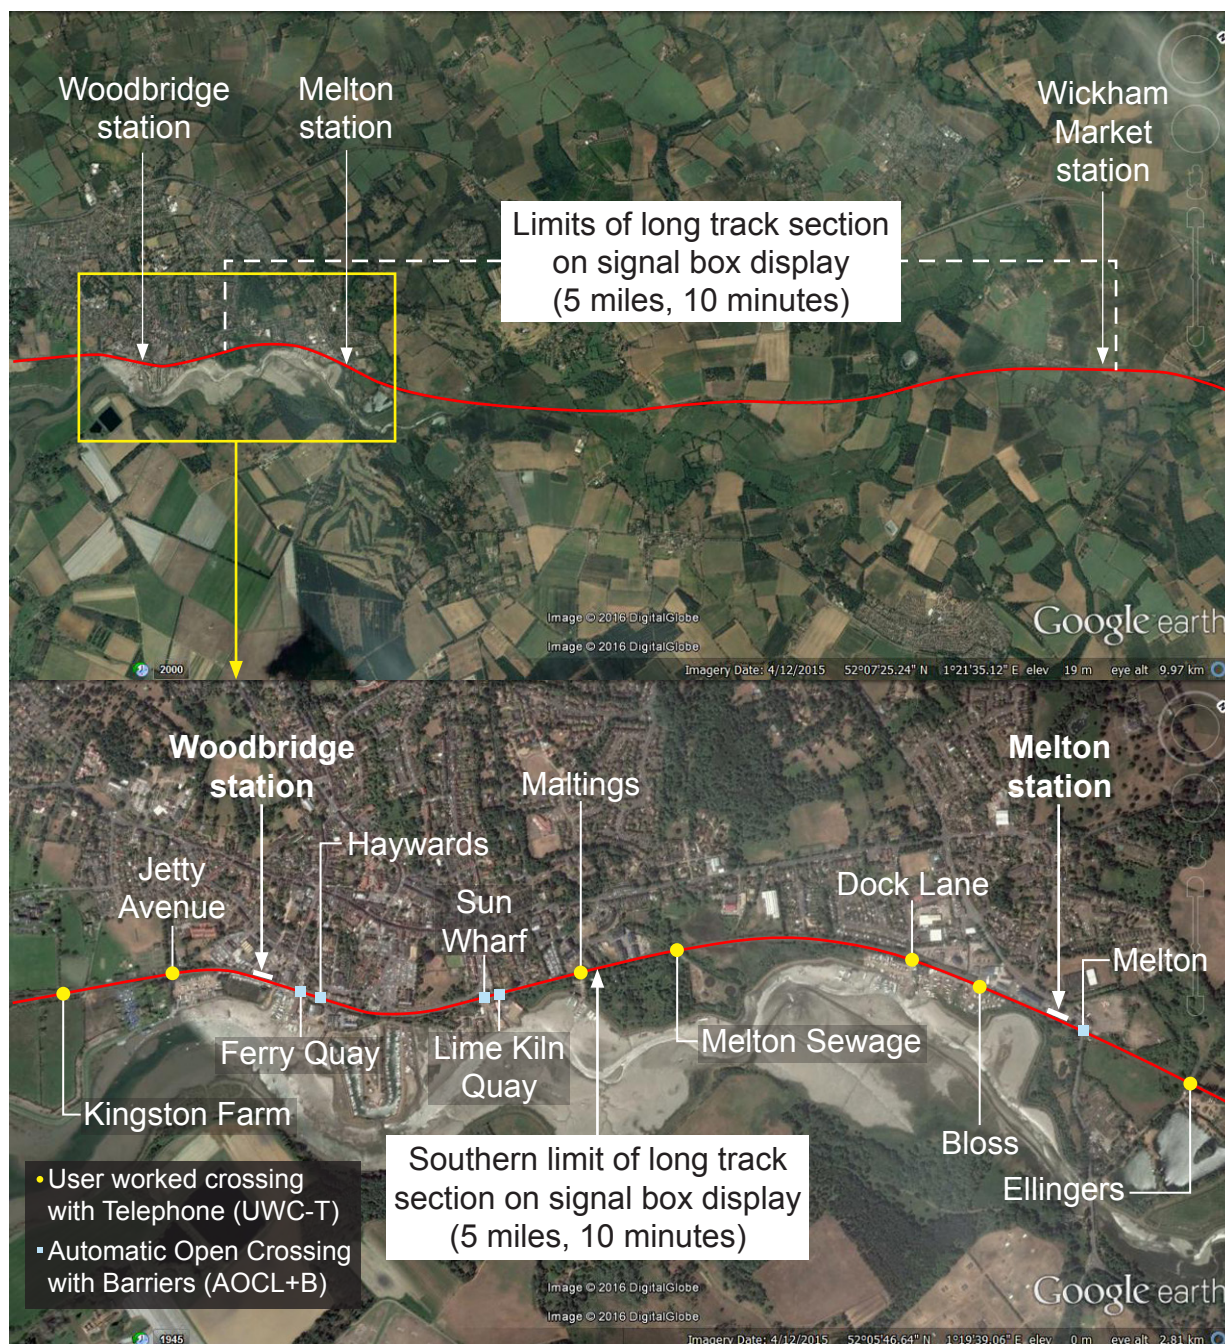
Figure 3: Level crossings in the Woodbridge/Melton vicinity

- 8 Dock Lane is one of a number of user worked level crossings in the Woodbridge/Melton area (figure 3). Another similar crossing, Bloss, is located between Melton station and Dock Lane. There are also a number of *automatic open crossings* that are fitted with both lights and half barriers.

- 13 The railway at this location comprises one non-electrified track. The speed limit for trains travelling in both directions is 55 mph (88 km/h), although passenger trains are unlikely to be travelling at this speed due to the proximity of Melton station, where they are all scheduled to stop.

Events following the incident

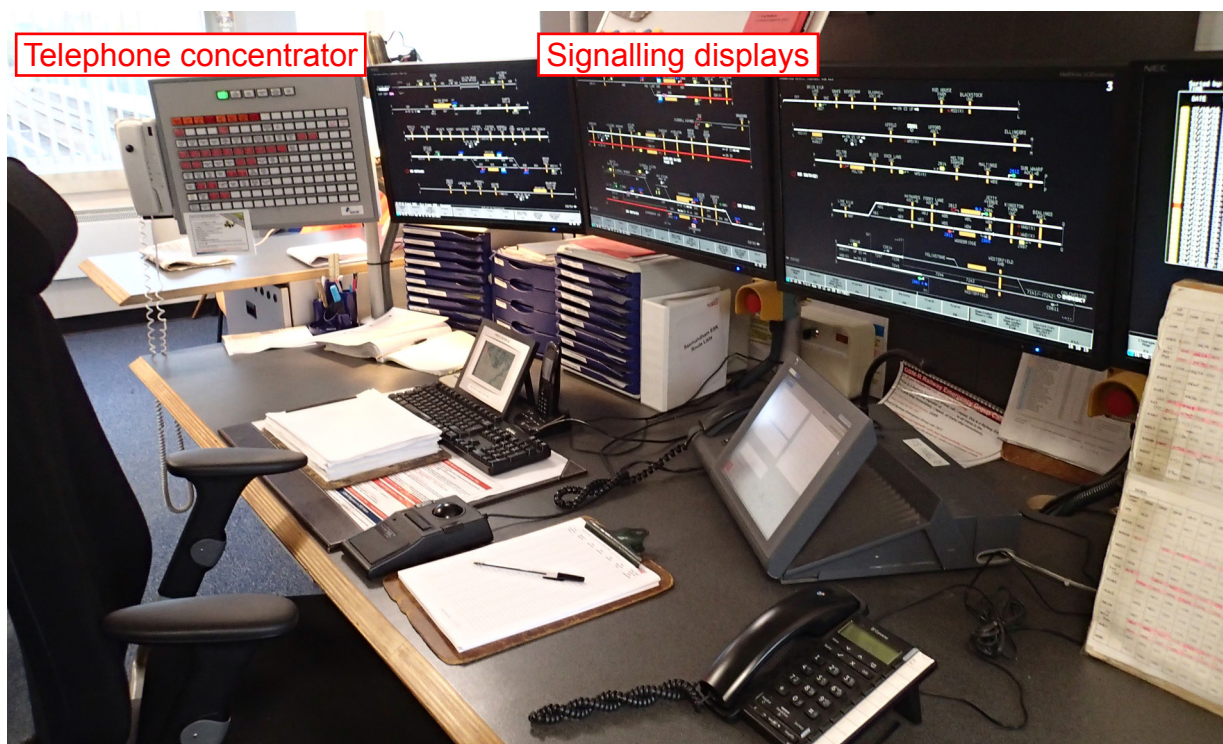
Figure 5: Saxmundham signal box

- 15 Telephones are provided at the crossing for vehicle users to contact the signaller to gain permission to cross, due to the insufficient sighting time of trains for vehicle users (paragraph 33). The signaller is located at Saxmundham signal box, which is approximately 10 miles (16 km) to the north-east of Dock Lane level crossing.

- 16 Saxmundham signal box controls trains on the line between Oulton Broad South, near Lowestoft, and Westerfield, near Ipswich, including those on the freight-only branch line to Sizewell. It has a bank of three display screens on which is displayed a schematic of the railway, showing signals, *track sections* and level crossings. A single signaller uses these screens to monitor the position of trains and to operate the signalling (figure 5). To the left of these screens is a *telephone concentrator* panel, which provides the signaller's interface with the telephones at all of the UWC-T crossings within the signal box's area. Each crossing has a combined button and lamp, which flashes when a user lifts the telephone to call the signaller. The signaller is able to answer the calls by pressing the appropriate button.
