# Rail Accident Report

## **Collision between two trams at Shalesmoor, Sheffield 22 October 2015**

Report 17/2016  
August 2016

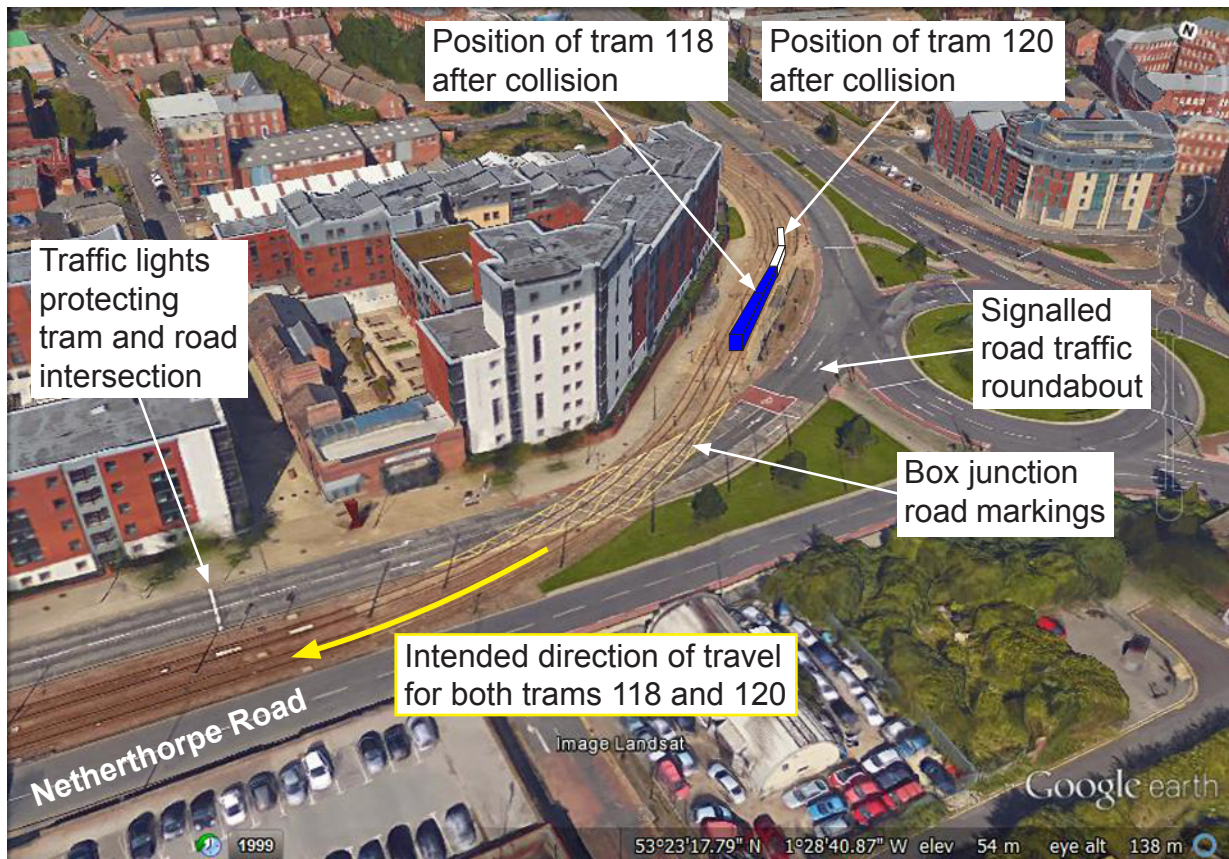
Figure 4: Google Earth view of Shalesmoor tram stop area

- 5 Approaching Shalesmoor from Hillsborough (figure 2), the tramway is an integrated on-street system; this means that trams share the roadway with motor vehicles. At Shalesmoor, the tramway leaves the road and enters a segregated infrastructure, running along the *median strip* of Netherthorpe Road towards Sheffield city centre (figure 4).

- 75 Tram 118 was unable to continue its journey because of queuing road traffic which was occupying a section of the road marked as a box junction (figure 4). The box junction markings are provided to indicate to road vehicle drivers that they must not occupy that section of the road when they cannot proceed further due to queuing traffic at the signalled roundabout. The intent of these markings is therefore to prevent obstruction of the tramway by queuing road vehicles.

- The road vehicles occupying the box junction and obstructing the path of tram 118 were therefore in violation of the Highway Code.
- 77 The driver of tram 118 could have used the VIS system to change the traffic lights protecting the tramway/road intersection in front of him to red. However, this would not have had any effect on the road vehicles obstructing the box junction since those road vehicles had already passed the traffic lights which protected the tramway/road intersection (figure 4).

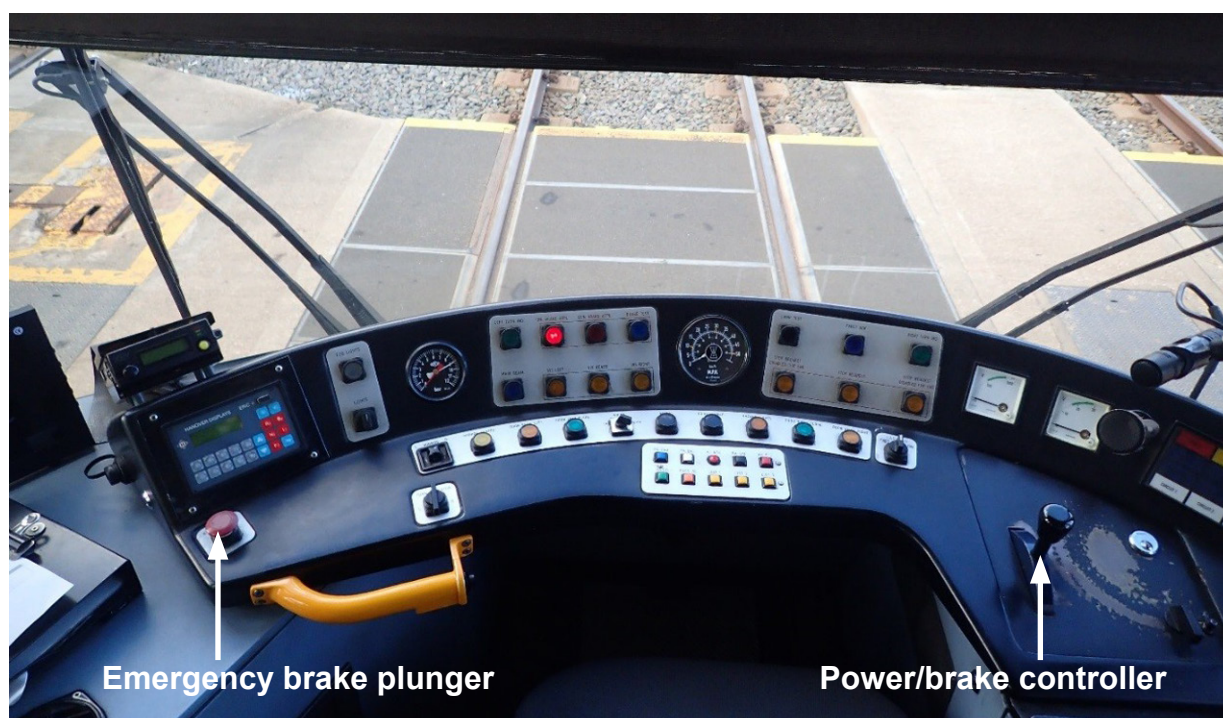
Figure 7: Layout of cab controls

- 39 The driver of a Sheffield tram has three ways in which to apply the brakes (figure 7):
- In normal operation, the driver will use service braking. This is controlled by a combined power/brake controller located on the cab desk. Service braking uses only the electrodynamic brake for speeds greater than 7.5 mph (12 km/h). Below this speed, the electrodynamic brake becomes ineffective, and therefore the pneumatic brake is also applied. The blending of the pneumatic brake with the electrodynamic brake is fully automatic; no action is required by the driver.

- In the event that the driver needs to rapidly brake the tram, he has the option to use the hazard brake. Use of the hazard brake applies the electrodynamic brake, makes a full application of the pneumatic brake, and also deploys the magnetic track brake. Sanding will also take place. The hazard brake operation is commanded from the same power/brake controller (figure 7) as the service brake by the driver moving the controller backwards through a *detent*.

- The driver also has the option to use the emergency brake. This is initiated by pressing an emergency plunger located on the driver's desk in the cab (figure 7). The emergency brake commands the operation of the electrodynamic, pneumatic and magnetic track brakes, and also operates the sanding system. The emergency brake function is independent of the microprocessor system controlling the tram and is provided to mitigate the risk of a failure of the microprocessor system.

- 40 In the circumstances of the accident at Shalesmoor, application of the hazard brake (paragraph 45) would have had the same braking effect as application of the emergency brake.
