FINAL REPORT ON SERIOUS ACCIDENT INVESTIGATION

Serious accident type: Train derailment

Train No.: 45010

Place: City of Pirot, outskirts of the village of Sopot, open track
between the Staničenje crossing point and the Pirot station

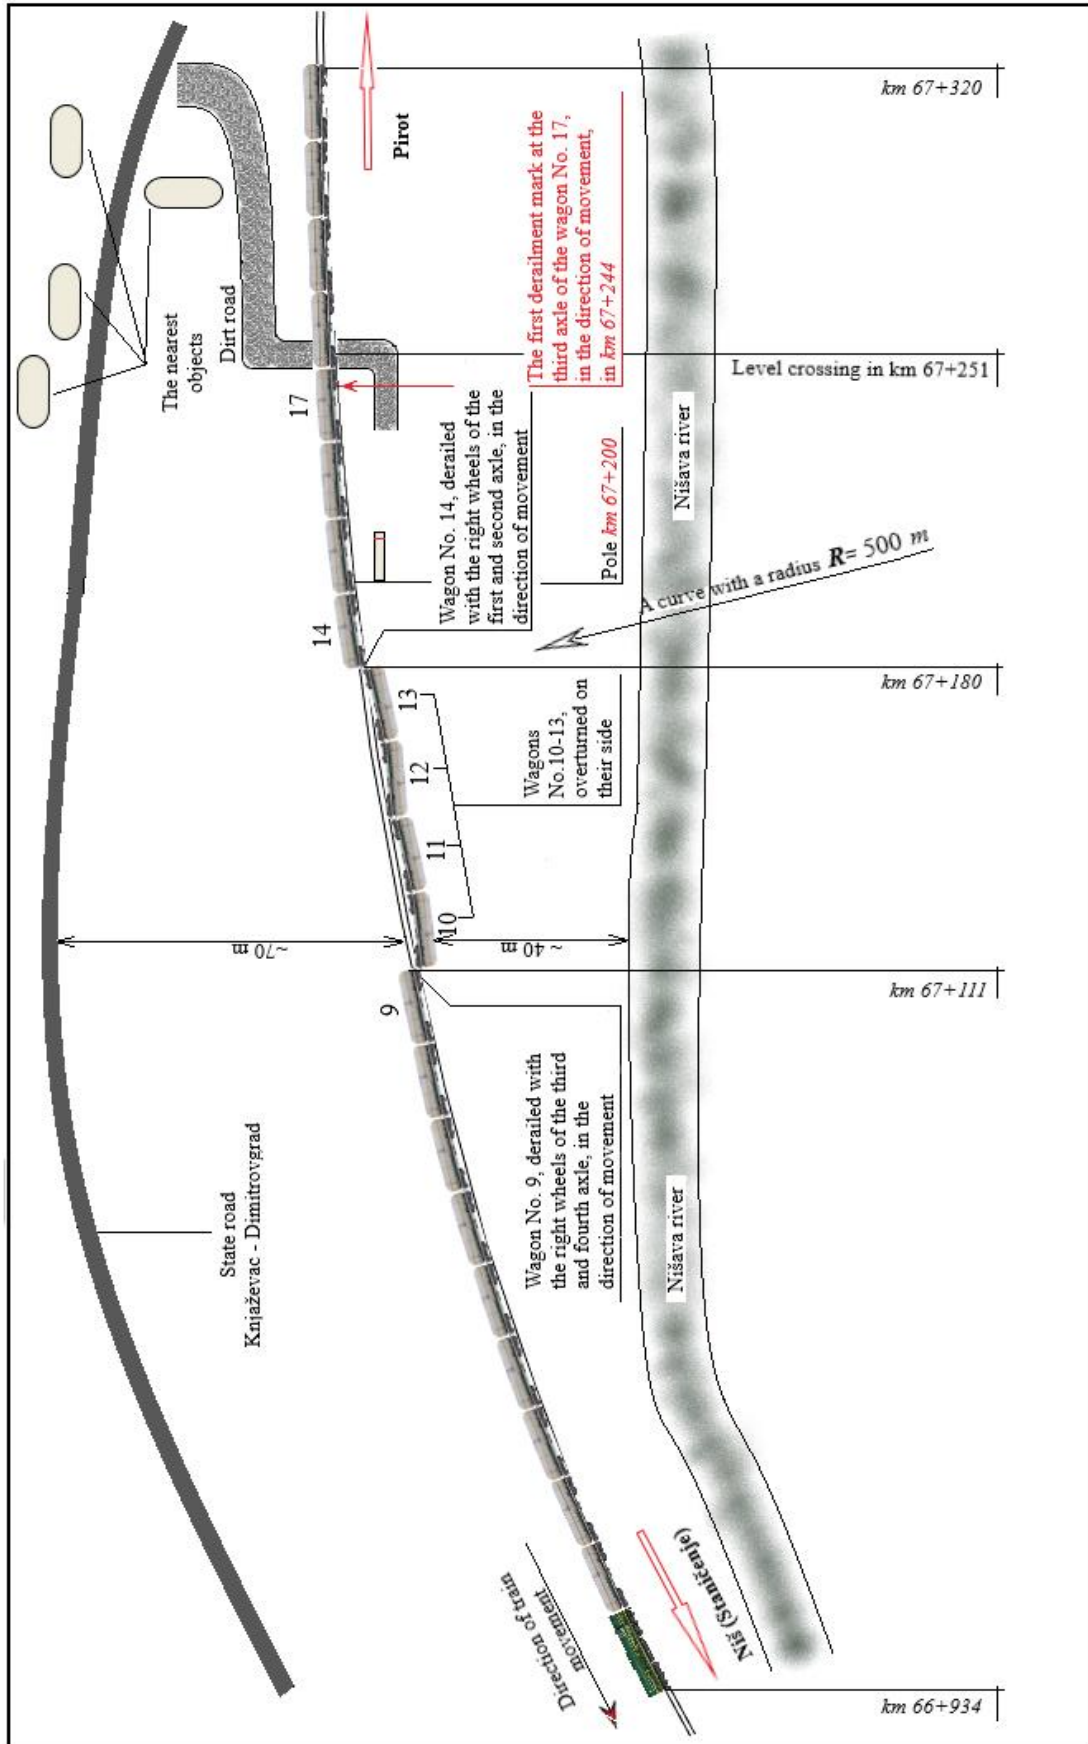
Figure 2.1.2.3: The scheme of the serious accident site (CINS)

In Figure 2.1.2.3. a schematic view of the mutual position of the wagon-tanks in the train, after the serious accident, is shown.

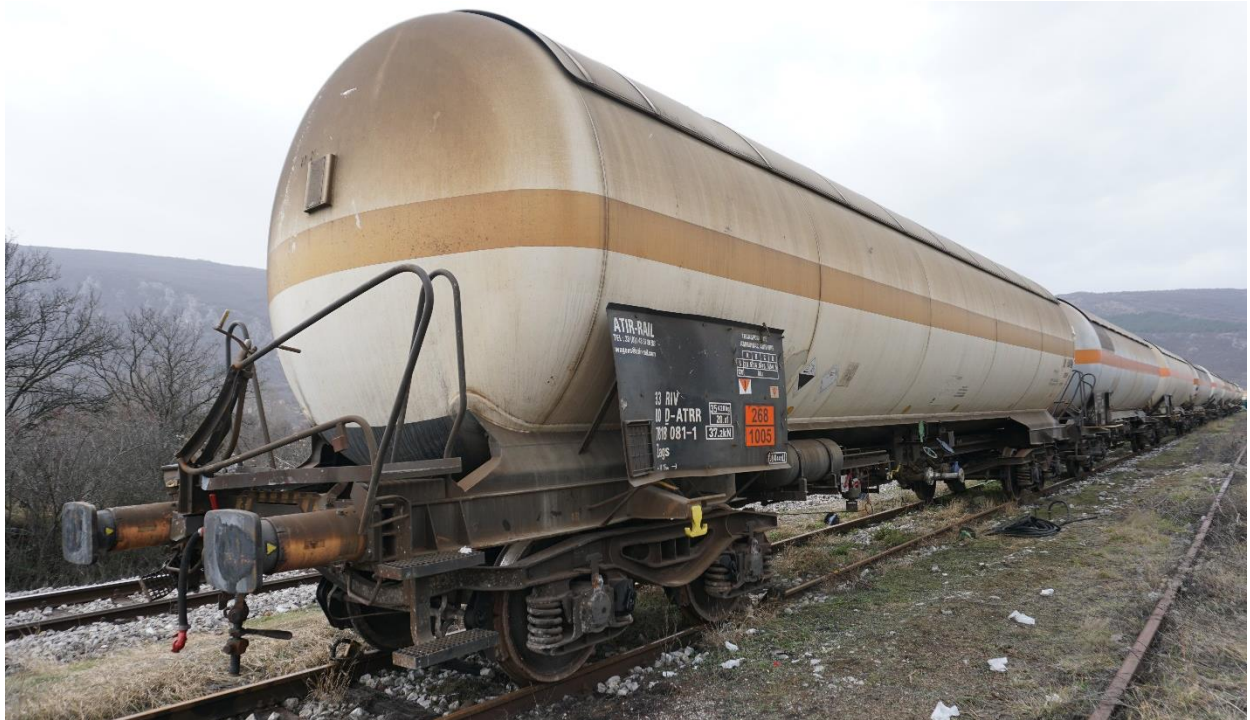
Figure 2.2.2.1: Appearance of Z-series derailed wagons

A total of 6 (six) Z series wagon-tanks derailed from the train composition.

The appearance of the Z series wagon-tanks that derailed in the serious accident is shown in Figure 2.2.2.1.

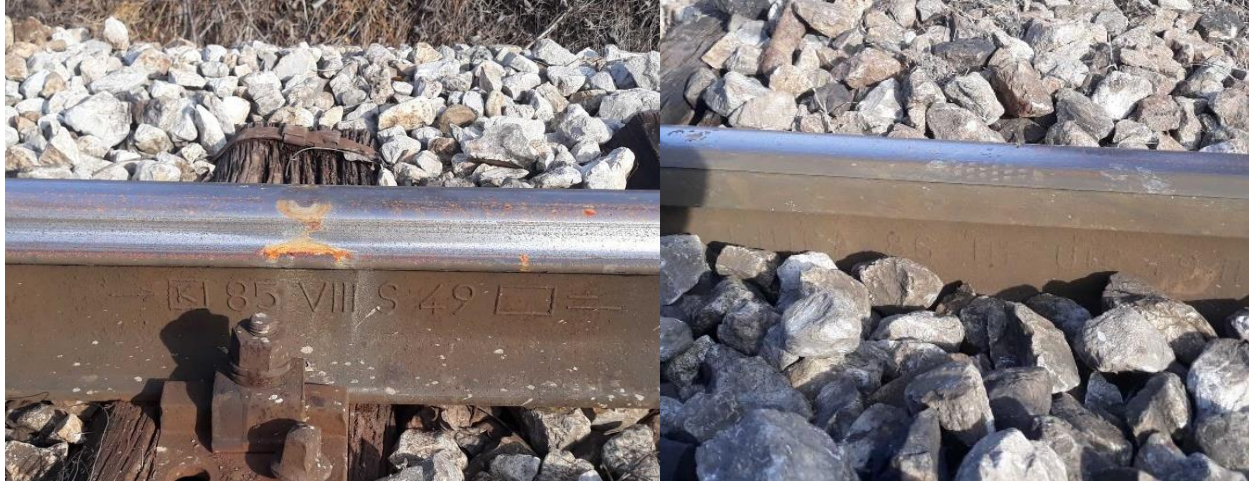
Figure 3.4.2.1: Appearance of the rails type "49E1" ZENICA 85 and 86 UIC 49 (source: "IŽS" a.d.)

At the site of the train derailment of train No. 45010, it has been determined that type 49E1 rails (ZENICA 85 and 86 UIC 49) have been installed, which are connected by rail joints. According to the Letter from the Section ZOP Niš, reference No. 20/2023-1.20-112/1 dated 26.01.2023, it is stated that a section of the Staničenje - Pirot track has welded in DTŠ. In the Letter No. 20/2022-1.20.4-100 dated 31.07.2022, regarding the railway section Bela Palanka - Dimitrovgrad, it is mentioned that a weld in DTŠ has never been formed on the aforementioned section.

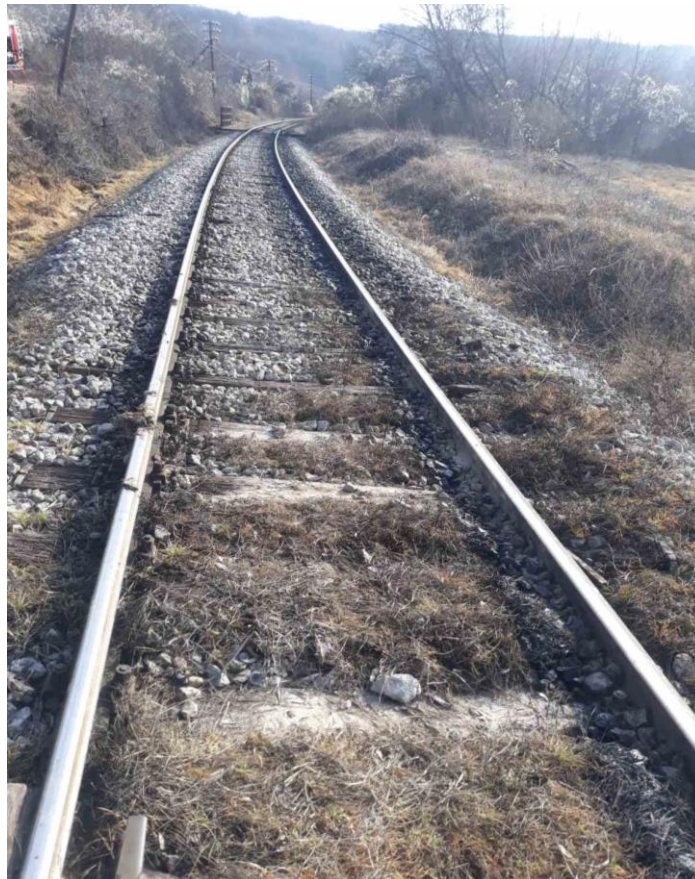
Figure 3.4.2.4: The track grid made of crushed limestone (source: “IŽS” a.d.)

The track grid is covered with crushed limestone. The appearance of the track grid is shown in Figure 3.4.2.4.

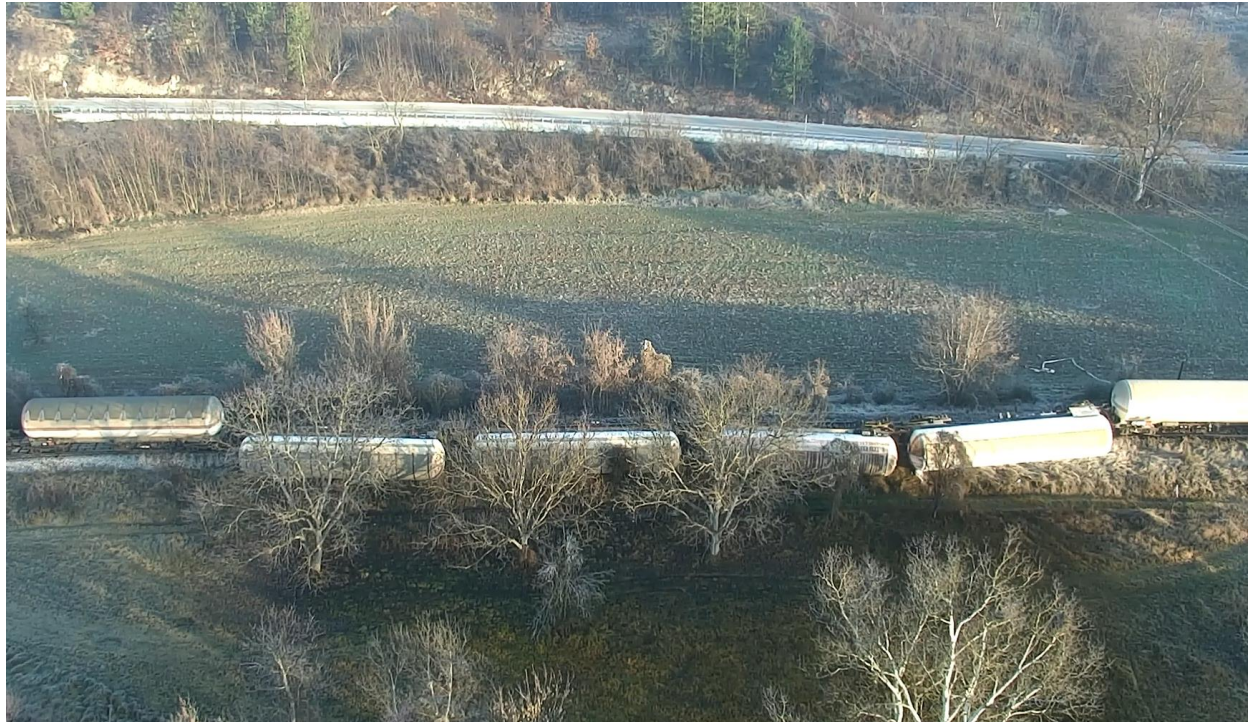
Figure 4.2.1.1: Overview of the derailed wagons (source: MUP, Sector for Emergency Situations)

The position of the derailed wagons in the train after the serious accident is shown in images 2.1.2.3. and 4.2.1.1.

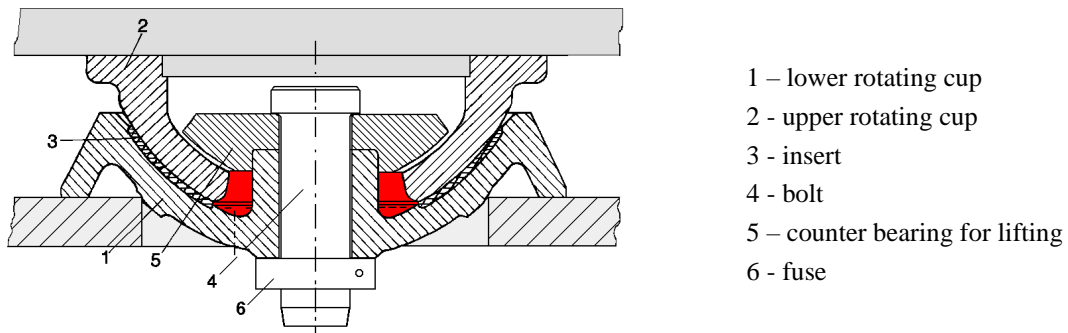
Figure 4.2.2.2: Cross-section through the center bowl assembly

Figure 4.2.2.1. does not show the initial condition before the removal of the deposits. Judging by everything, the dirt was packed in the gap between the upper and lower center bowl, as illustrated in red on Fig.4.2.2.2. It is unclear how such a quantity of material could have entered the center bowl through the small gap between the brackets and the opening in the lower center bowl.

Although there is red soil present in the wider area of the serious accident, similar to the one in Figure 4.2.2.1, photographs from the scene of the serious accident show that the overturning of the tenth wagon occurred on the ballast without visible traces of excavated red soil. Therefore, it is unlikely that the soil entered the center bowl during the serious accident. On the other hand, the probability of this happening during normal operation is even lower, especially since similar occurrences were not observed in the other center bowl. The third possibility is that soil entered the center bowl during the unfastening of the bogies in some workshop, which is also unlikely since the previous revision was performed only three months before the serious accident (on 26.9.2022) in Smederevo, and according to the provided data, there was no extraordinary maintenance from that time until the serious accident.

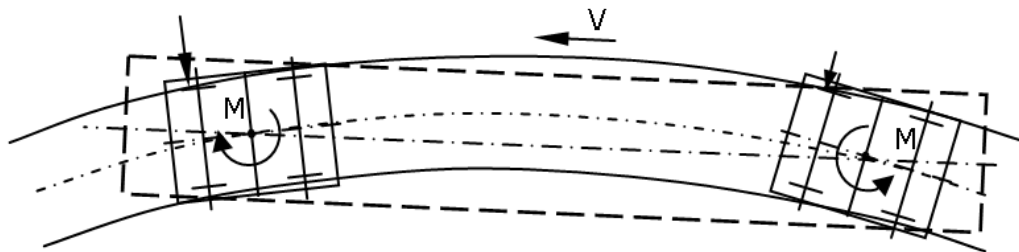
Figure 4.2.2.3: The action of the swivel torque on the guiding force of the front and rear bogie

The presence of soil in the center bowl, regardless of other factors, could have increased friction within the center bowl and the swivel torque of the bogie. In Figure 4.2.2.3, firstly the effect of the swivel torque on the lateral force on the leading wheels of the front and rear bogie is shown. The direction of the swivel torque on the rear bogie (as was the case with the tenth wagon in the serious accident) is such that it reduces the guiding force and, consequently, the rail spread, while on the front bogie, it increases it.

In this sense, the increased swivel torque on the rear bogie does not have a significant impact on the specific case of the non-guiding (inner in relation to the curve) wheel entering the rail.

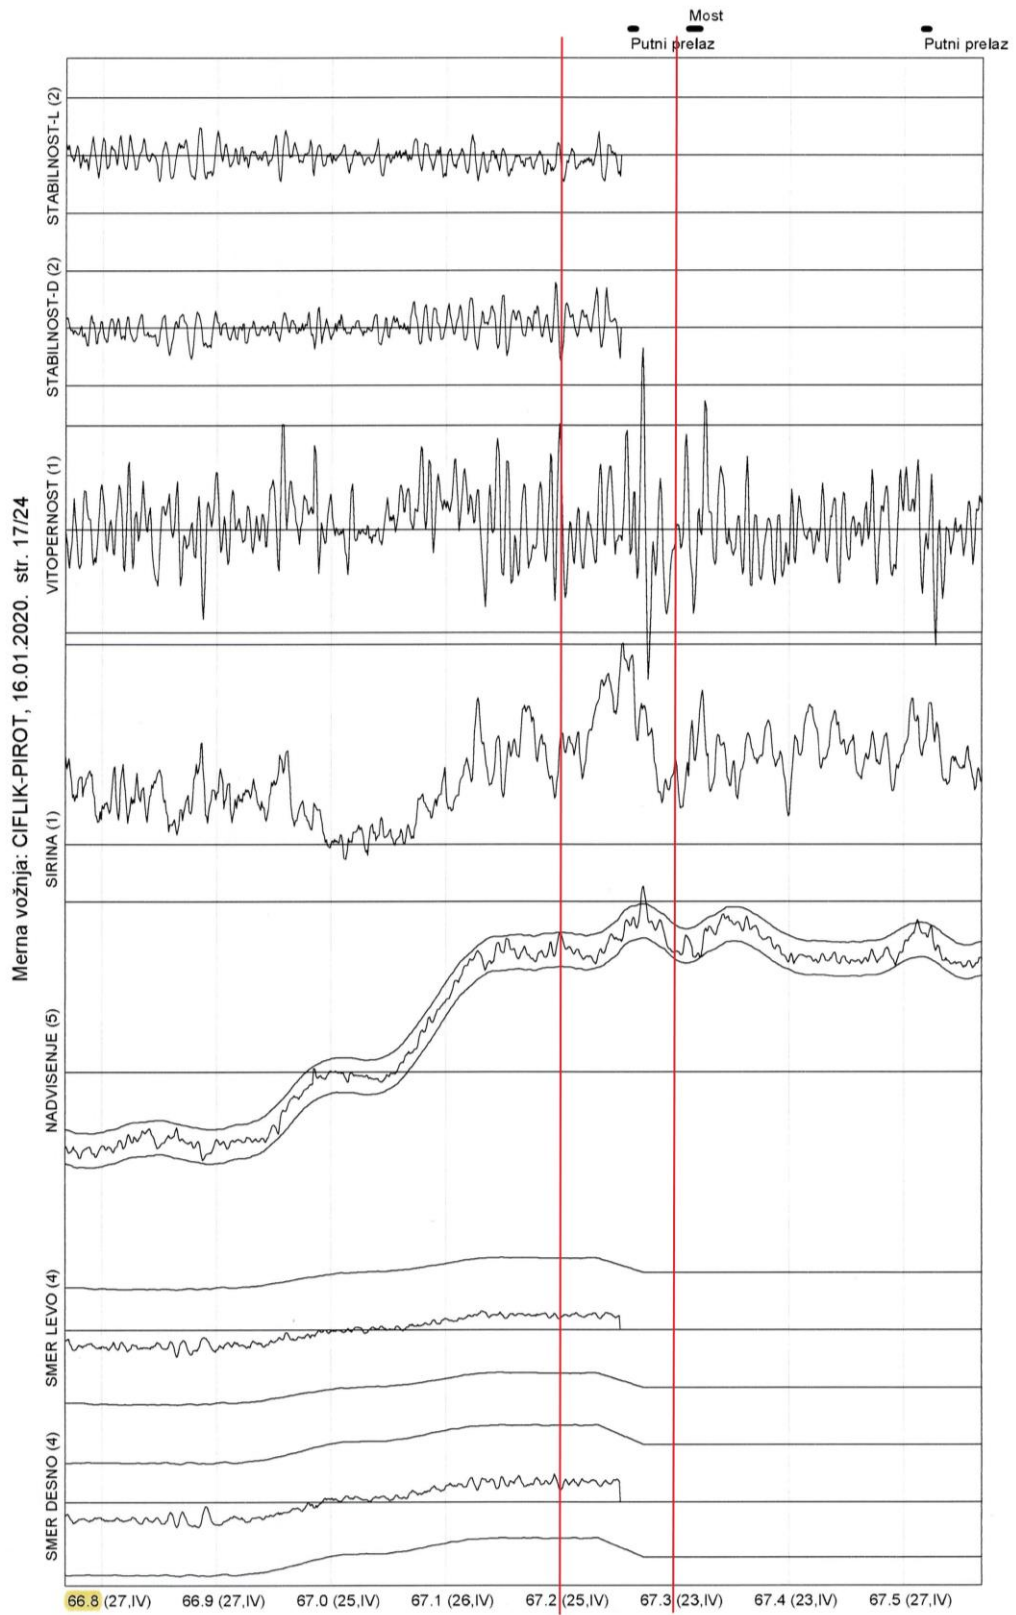
Figure 4.2.7.1: Track inspection coach graphic representation excerpt from 16.01.2020.

Serial No.	<i>km position</i>		Error type	Size	Deadline for removal
	From <i>km</i>	To <i>km</i>			
92	66+720	6+725	CROSS LEVEL	-21 <i>mm</i>	20.02.2020.
93	66+957	66+959	TWIST 3.5 <i>m</i>	18 <i>mm</i>	Immediately
94	67+271	67+274	TWIST 3.5 <i>m</i>	31 <i>mm</i>	Immediately
95	67+271	67+276	CROSS LEVEL	30 <i>mm</i>	20.02.2020.
96	67+271	67+276	CROSS LEVEL > 150 <i>mm</i>	163 <i>mm</i>	Immediately
97	67+276	67+279	TWIST 3.5 <i>m</i>	-26 <i>mm</i>	Immediately
98	67+326	67+328	TWIST 3.5 <i>m</i>	22 <i>mm</i>	Immediately
99	67+511	67+514	CROSS LEVEL	17 <i>mm</i>	20.02.2020.

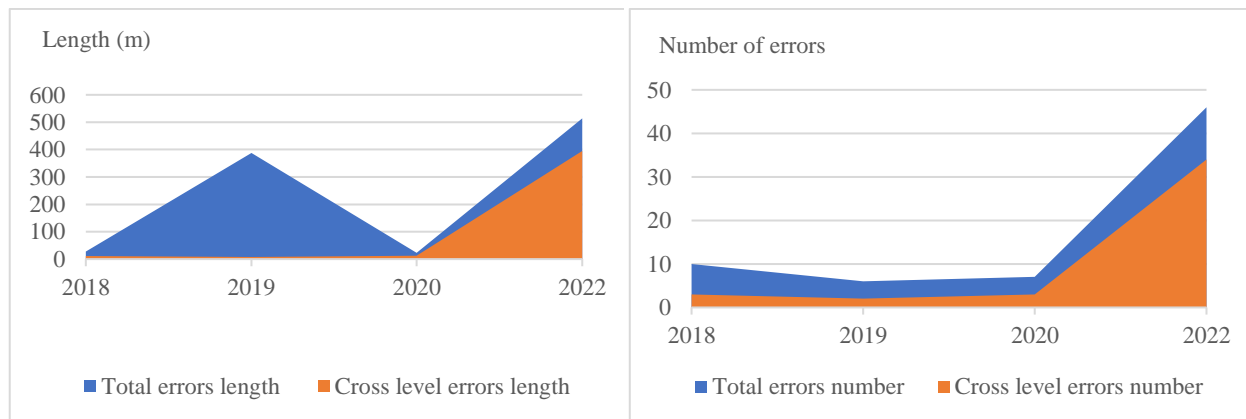
Graph 4.2.7.1: Overview of the length and number of “C” type errors from km 66+700 to km 67+700

The participation of “C” type errors in relation to the total number of “C” type errors in the zone of train derailment No. 45010 (from km 66+700 to km 67+700) is shown on Graph 4.2.7.1.

Based on the provided analytical presentation and graphic records from the last measurement of the track condition No. 106: Niš - Dimitrovgrad - state border - (Dragoman) with track inspection coach Sever 1435, on 20.10.2022 (approximately 2 months before the serious accident occurred), it can be concluded that in the zone of train No.45010 derailment, from km 66+700 to km 67+700, according to defined parameters in the Instructions on Uniform Criteria for the Inspection of Track Condition on the JŽ Railways Network, Instruction 339 (“Official Gazette of ZJŽ”, No. 2/2001, 4/2004, and “Official Gazette of ŽS”, No. 14/22), the condition of the observed kilometer of the track was unsatisfactory. **The length of “C” type errors exceeded 20 times the maximum prescribed length of “C” type errors**, which is 25 m for a satisfactory condition. Furthermore, out of the total number of “C” type errors, **more than 76% were errors related to excess rail cross level**, where on some parts of the track, the values of outer rail cross level in curves exceeded 150 mm, resulting from the poor condition of both the super and sub track

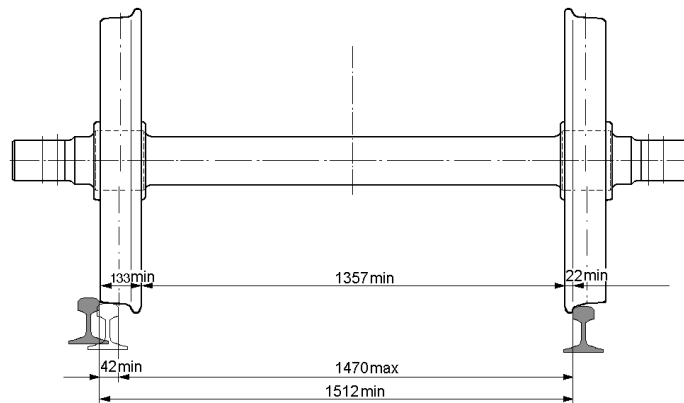
Figure 4.2.9.1: Conditions for wheel derailment

The derailing of a wheel from the track can occur due to the shifting of the wheels on its axis (loosening of the pressed assembly) in the direction of reducing the inner distance between the wheels or due to the spreading of the rails.

Figure 4.2.9.1 illustrates the necessary relationship between the dimensions of the track and the wheelset to cause a wheel to derail from the track when the relevant dimensions are within the allowed limits. It can be observed that the rails need to spread apart by at least 42 mm beyond the permitted limit of 1435+35 mm, due to loose or missing track fasteners or rottenness of sleepers. Considering that the measurements from the track inspection coaches (point 4.2.7.) show that in several places, the track expansion exceeds the operational limit of +35 mm, it is possible for a wheel to derail in such locations even with a smaller additional rail spacing.

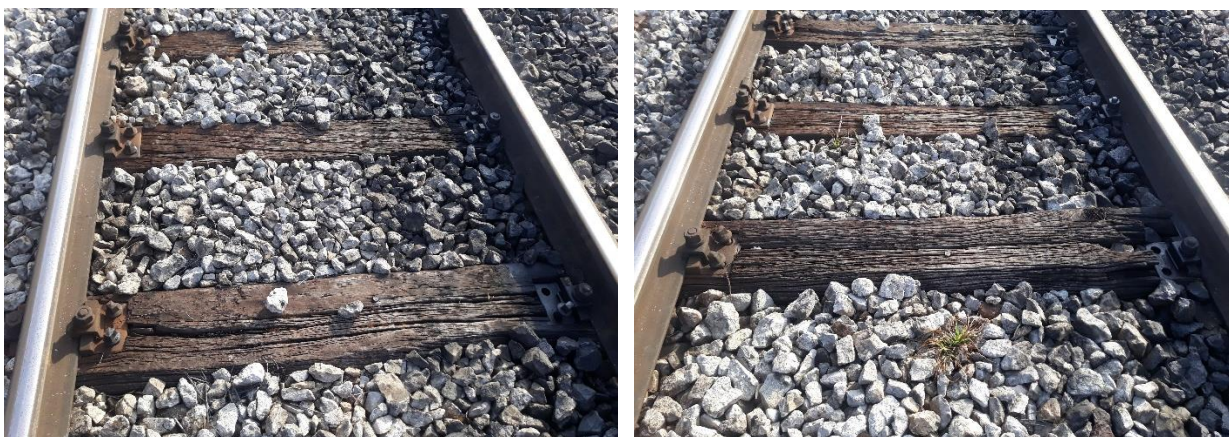
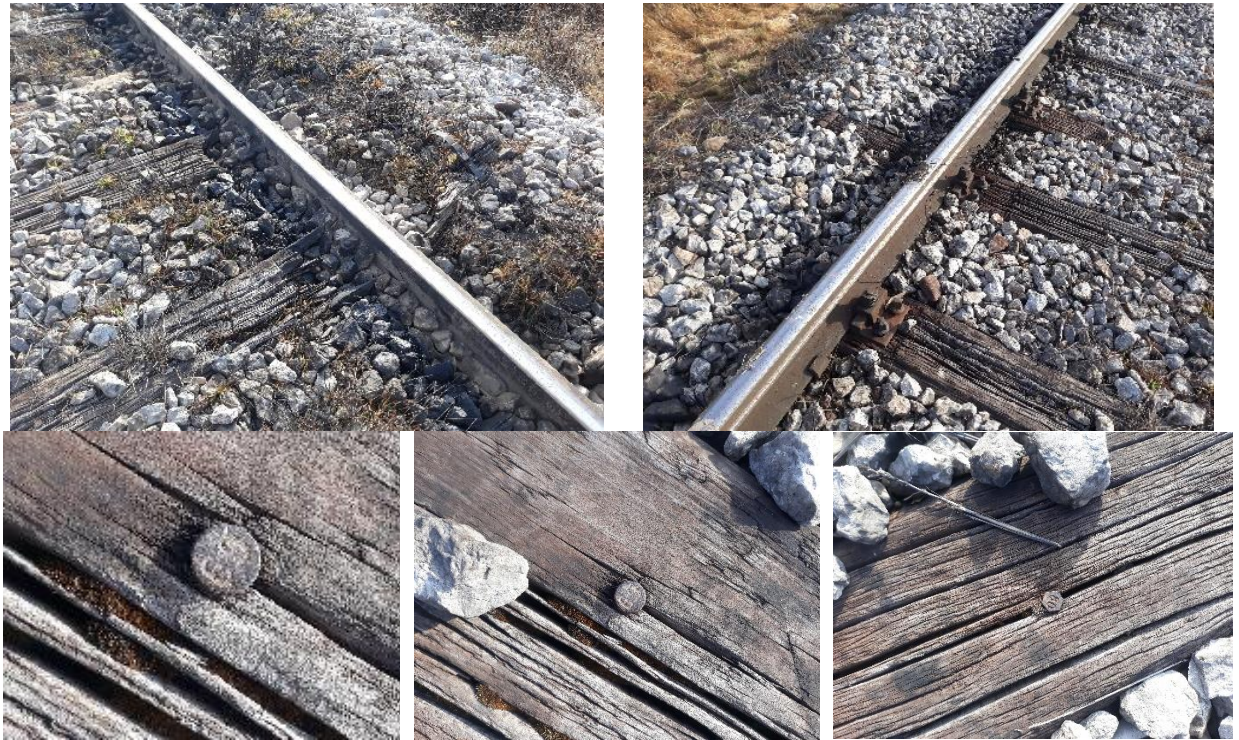
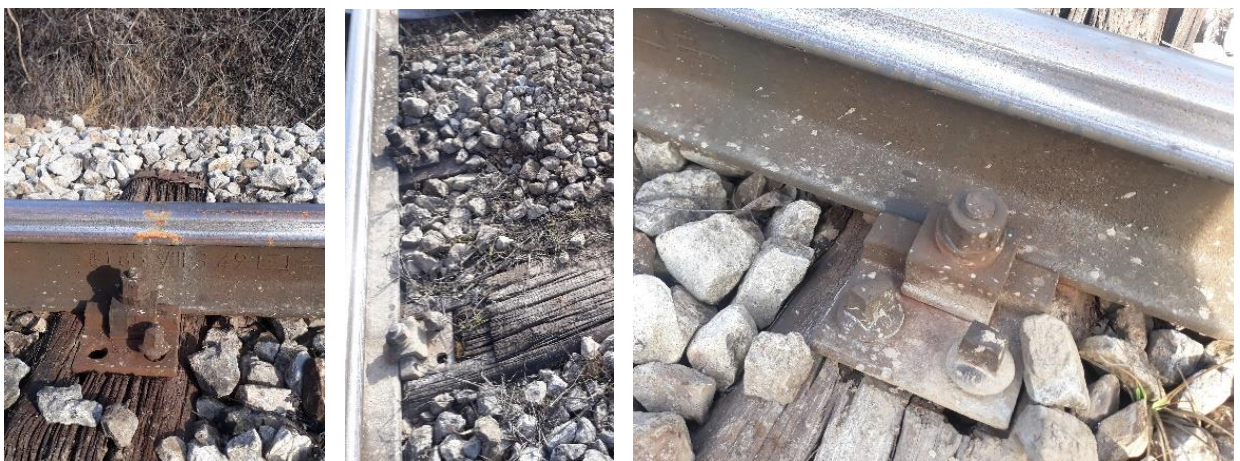
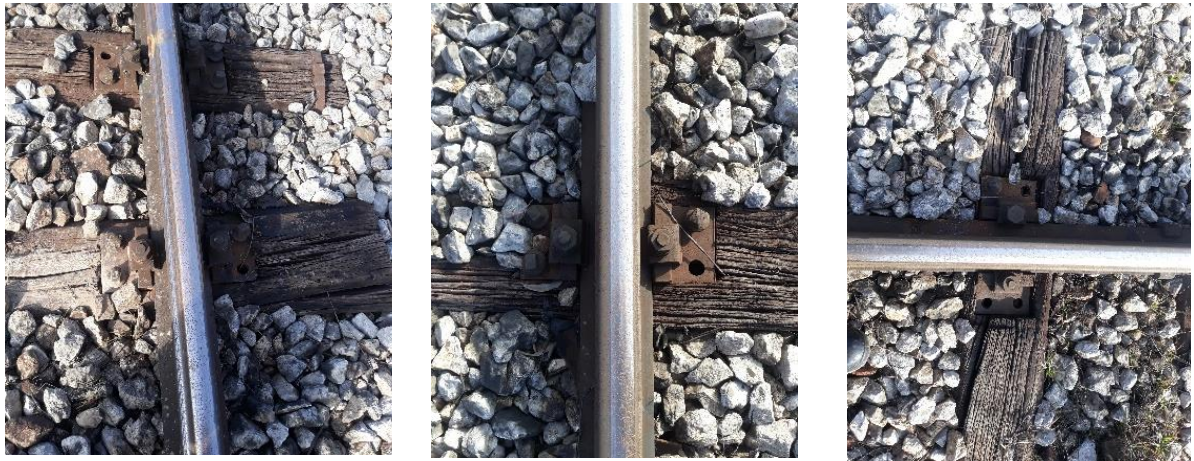
Upon inspecting the condition of the sleepers and fastening equipment, it was found that in the broader area around the wheel derailment site, the track was in a faulty condition due to loose or missing fastening equipment, shifted fastening plates, or rotten and cracked sleepers. It should be noted that the railway was put into operation on 01.08.1888, with the last repair carried out in 1985. On-site inspection revealed that some rails were over 40 years old, and some sleepers were over 50 years old in the wider area of the wheel derailment site.

The condition of the sleepers and fastening equipment in the wheel derailment zone is illustrated in Figure: 4.2.9.2, 4.2.9.3, 4.2.9.4. and 4.2.9.5.
