**Railway Accident
Investigation Unit
Ireland**

**Broken Rail near Emly,
County Tipperary, 22nd February 2023**

RAIU Investigation Report No: 2024-R002

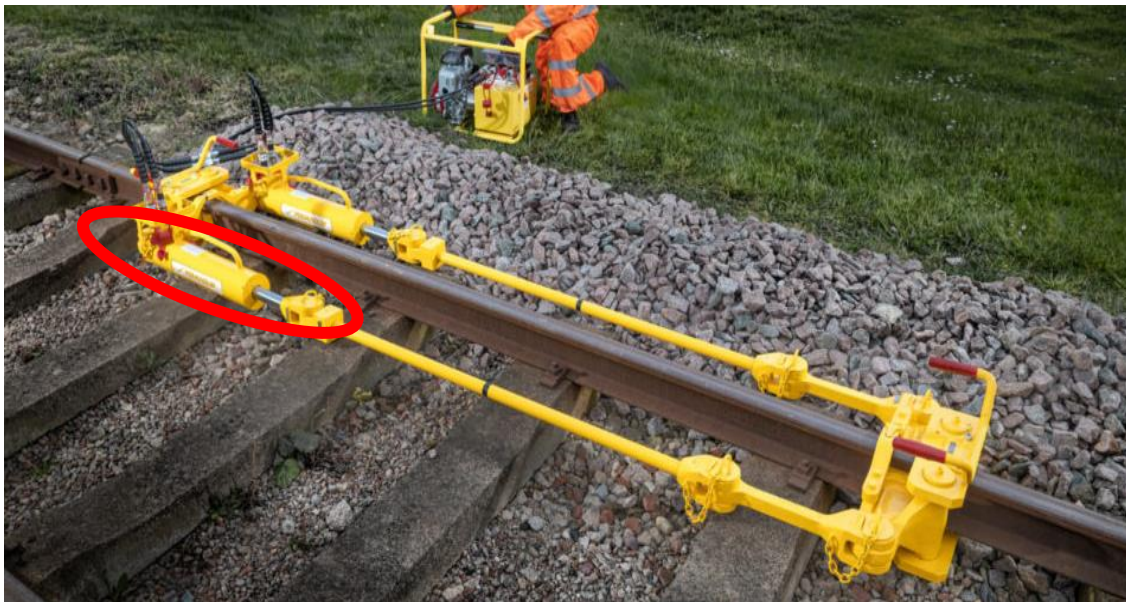
Figure 5 – Rail Tensors attached to rail

67 Using the Rail Tensors, both rails are stretched (i.e. stressed) using hydraulic rams (circled Figure 5) and *anchored* at the same time to ensure the equal *Stress Free Temperature* (SFT) in both rails (the permitted SFT in CWR is between 23°C and 27°C, with three rail thermometers placed on the rail to monitor temperature. This is to ensure that the temperature is not below the absolute minimum rail temperature for stressing which is -7 °C. In addition, both rails must be stressed during the same shift to ensure that the forces remain balanced in both rails.

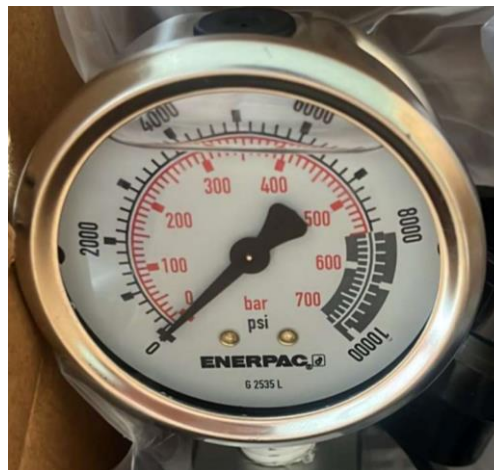
Figure 6 – Pressure gauge

68 The Rail Tensors are checked for slippage of the clamps or for defects in the pressure gauge dial (see Figure 6 example of a pressure gauge). There is a *valve* on the hydraulic pump that is used to close off the flow of hydraulic fluid (oil) when the rails have been pulled to the required welders gap; this is to safeguard against rail movement.

69 Pulling force is then applied by the Rail Tensors, which is displayed on the pressure gauge (displayed as pound-force per square inch (psi))³. The pressure gauge is monitored by the Person in Charge of Stressing during tensioning to ensure no loss of force occurs. CCE-TMS-323 states that the maximum pulling force applied by the Rail Tensors shall not exceed 6553 psi.
