# JNS Normal Procedure

## “Accident Gotthard base tunnel - broken wheels”

Final report | version 2.0 | 11.07.2024

**Outcome of the Joint Network Secretariat Normal Procedure**  
**“Accident Gotthard base tunnel - broken wheels”**

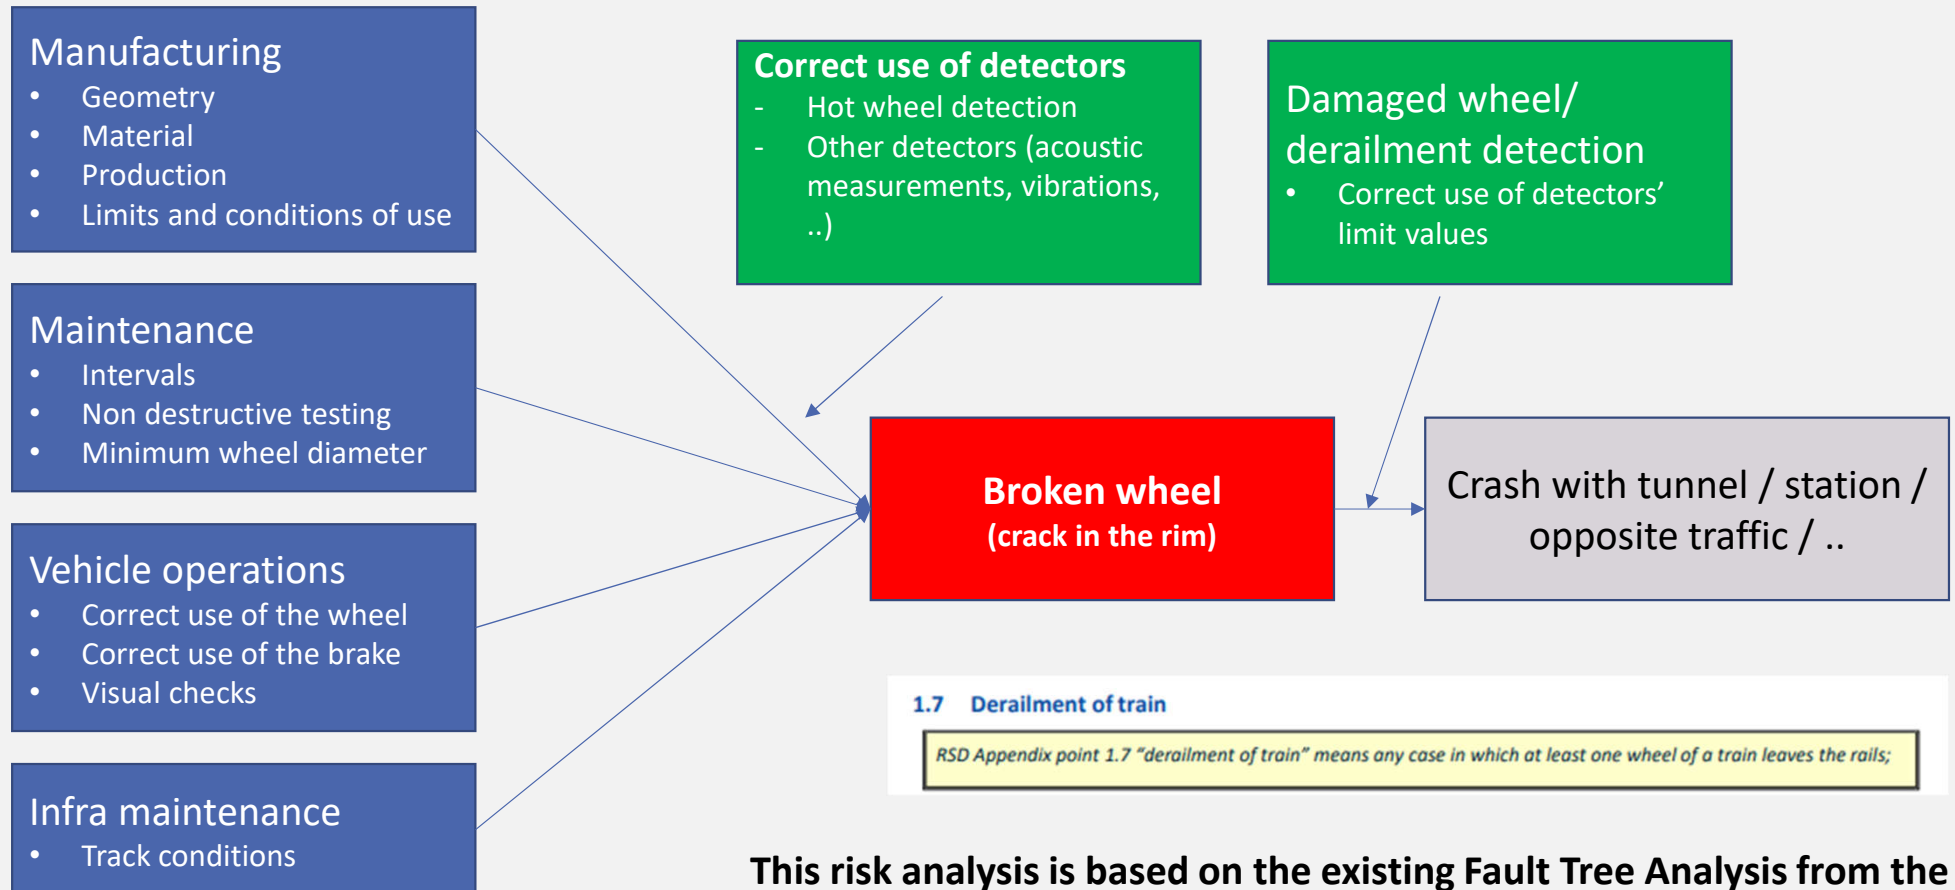
### Risk to be tackled in the Normal Procedure

**This risk analysis is based on the existing Fault Tree Analysis from the JNS NP Broken Wheels 2017-2019 (for "crack in the rim" cases)**
