**STATE COMMISSION ON RAILWAY ACCIDENT INVESTIGATION**  
**Ministry of the Interior and Administration**

**REPORT No. PKBWK 5/2024**

**on the investigation of a railway accident  
that occurred on 12 April 2022 at 09:22 hrs at Poznań Główny station  
at turnout no. 140 in track 51, at km -0.181 of railway line no. 351  
Poznań Główny - Szczecin Główny,  
the area the infrastructure manager PKP PLK S.A. Railway Line Plant in Poznań**

**WARSAW, 10 June 2024**

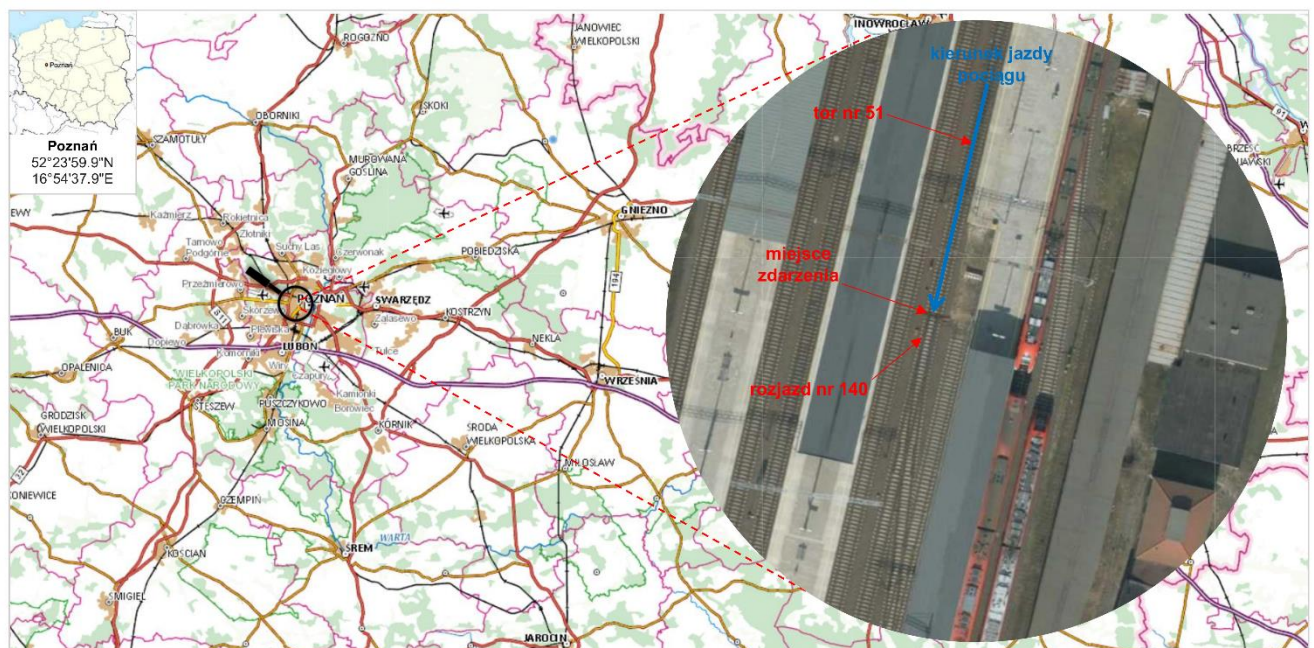
Figure 1 - A general view of the incident site (source: Geoportal)

Track 51 where the occurrence took place is located on the station plane of line no. 351. The beginning of turnout no. 140, where the derailment occurred, is at km -0.181 of that line. The turnout allows passage from track 51 onto track 55 via turnout route 140/141 and vice versa. Ahead of turnout no. 140, on the right, there is a dwarf shunting disc Tm60 relating to track 51.

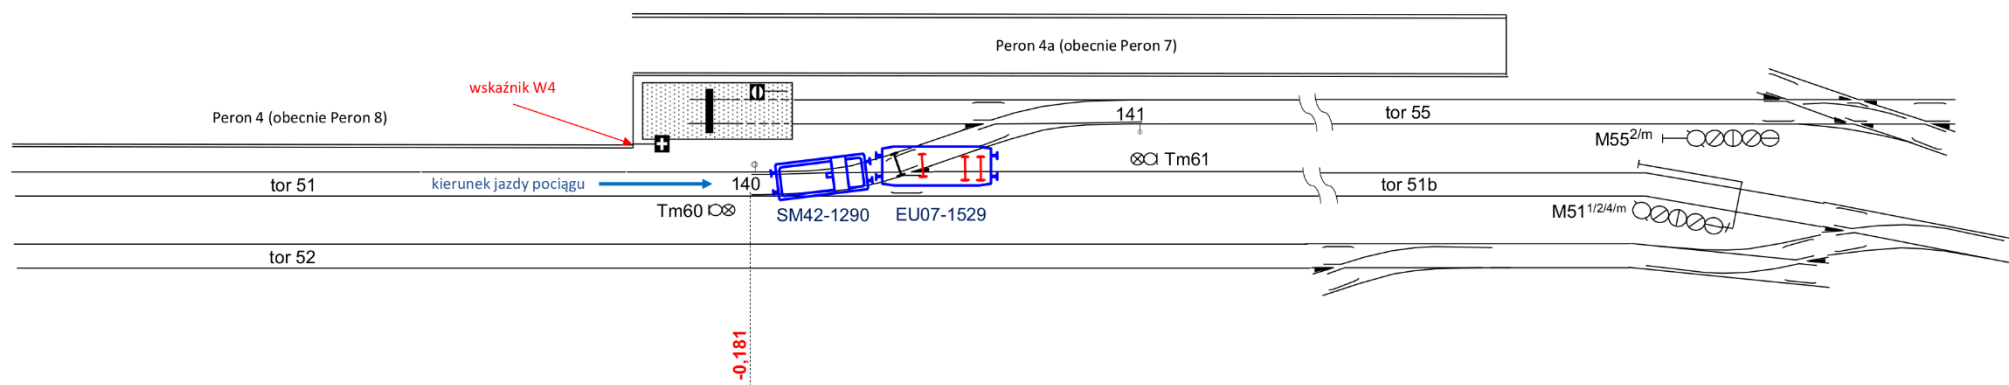
Figure 2 - A sketch of the accident scene

As a result of the derailment of locomotive EU07-1529 leading train THE 575001, the rolling surfaces of three wheelsets were damaged. The locomotive was sent for wheelset reprofiling. There was no other damage to the train set.

The half switch of turnout no. 140, the wheel detector and 35 alloy bolts were damaged.

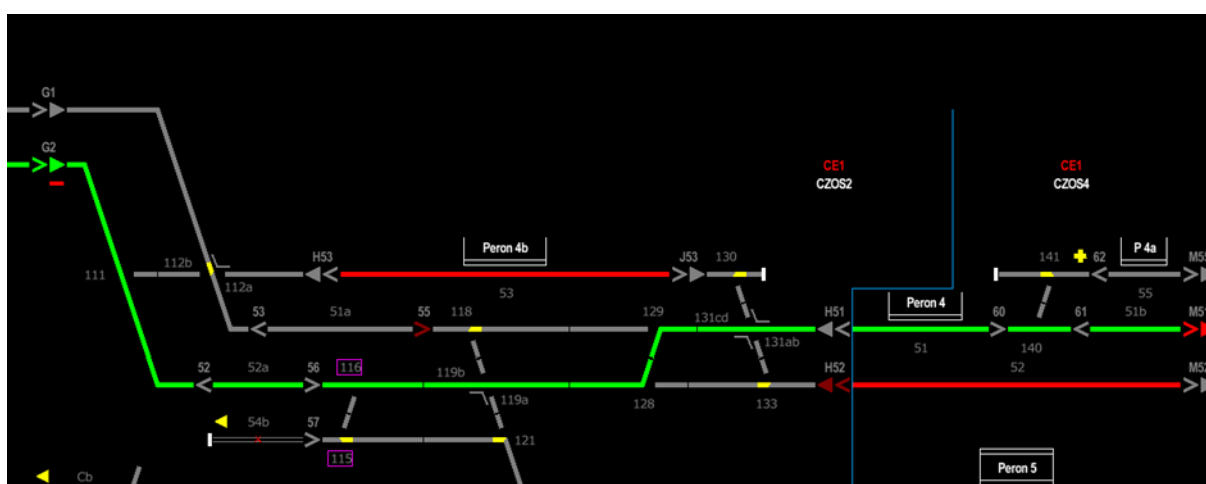
**Figure 3 - Computer mapping of train route from the G2 signal to the M51 signal, 09:18:37 hrs (source: Thales)**

At 09:18:37 hrs, route  $G2_{51b}^2$  was fixed on intermediate signal  $G2^{1/2/m}$  of Poznań Główny station with the aspect S13 "Proceed at a speed not exceeding 40 km/h, and Stop at the next signal" (track 55 free, see Figure 3).

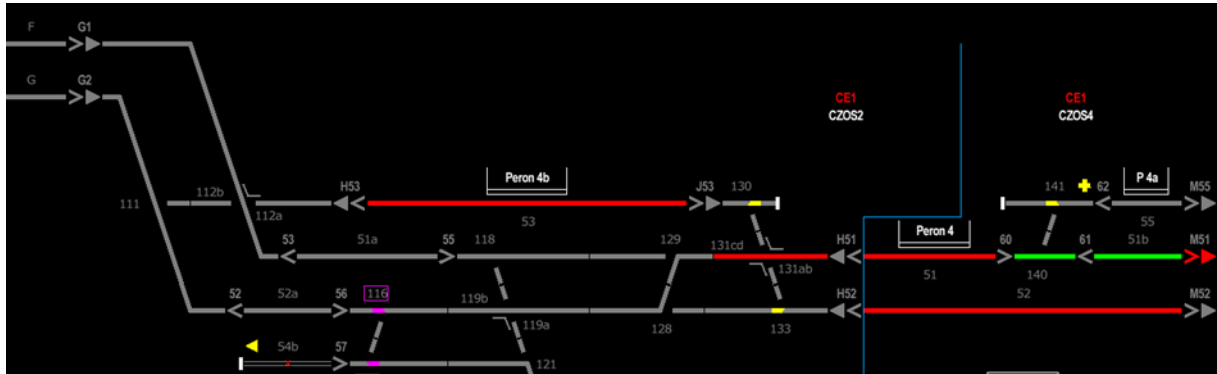
Figure 4 - The train's entry on track 51, 09:21:32 hrs (source: Thales)

At 09:21:32 hrs, the train entered track 51 at the speed of approximately 26 km/h.

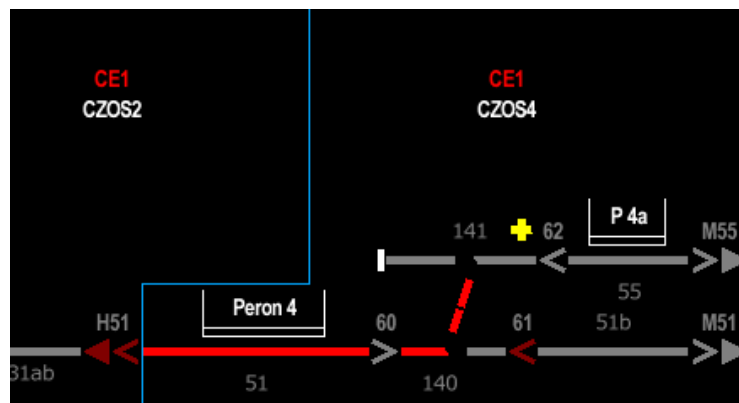
Figure 6 - The train's entry to switch isolation Iz140, 09:22:22 hrs (source: Thales)

At 09:22:22 hrs, the "station D" signaller gave the order to set the shunting route from shunting disc Tm60 to exit signal M55.

At 09:22:25 hrs, the train occupied switch isolation Iz140, i.e. it drove two axles of the first bogie onto the switch of turnout no. 140 directing straight ahead (plus (+) position) at the speed of 19 km/h.
