STATE COMMISSION ON RAILWAY ACCIDENT INVESTIGATION
Ministry of the Interior and Administration

REPORT No. PKBWK 06/2024

**on the investigation of a railway accident that occurred on 24 August 2023 at 12:05 hrs
at Skierniewice station, at turnout no. 13, at km 64.282
of railway line no. 1 Warszawa Zachodnia - Katowice
the area of the infrastructure manager PKP Polskie Linie Kolejowe S. A.
Railway Line Plant in Łódź**

WARSAW, 1 August 2024

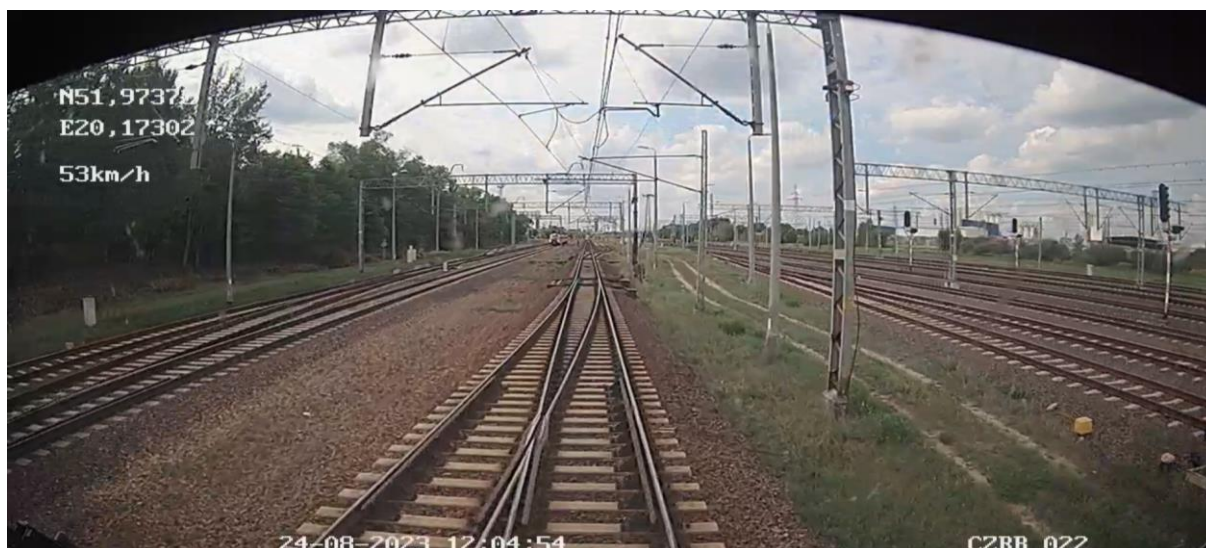
Photograph 2 - A view from the front view camera of train no. 93965 at the time of the collision

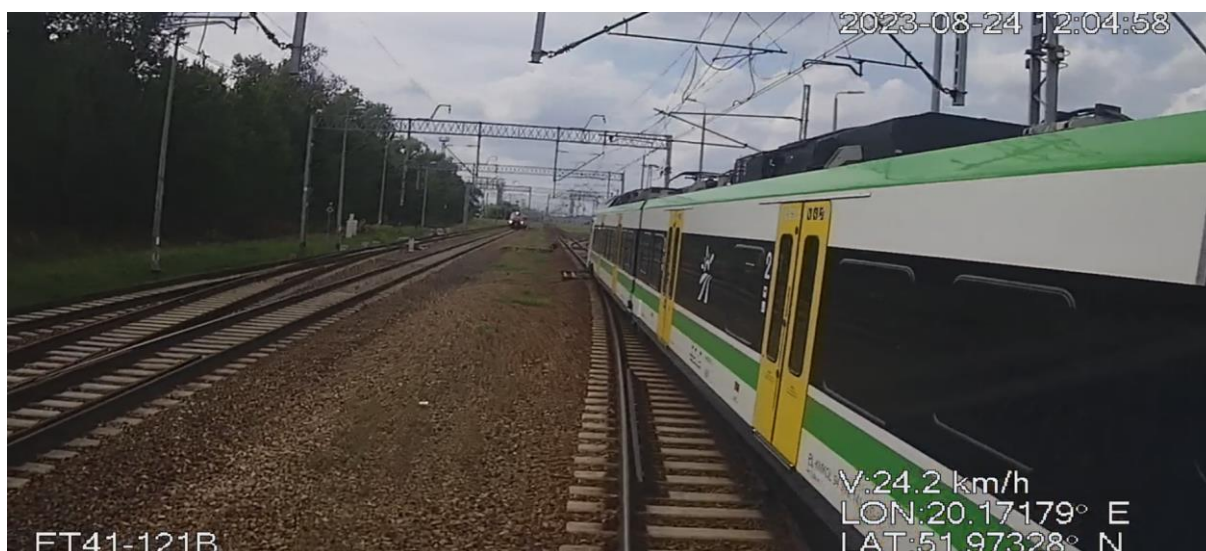
Photograph 3 - A view from the front view camera of train no. 524009 at the time of the collision

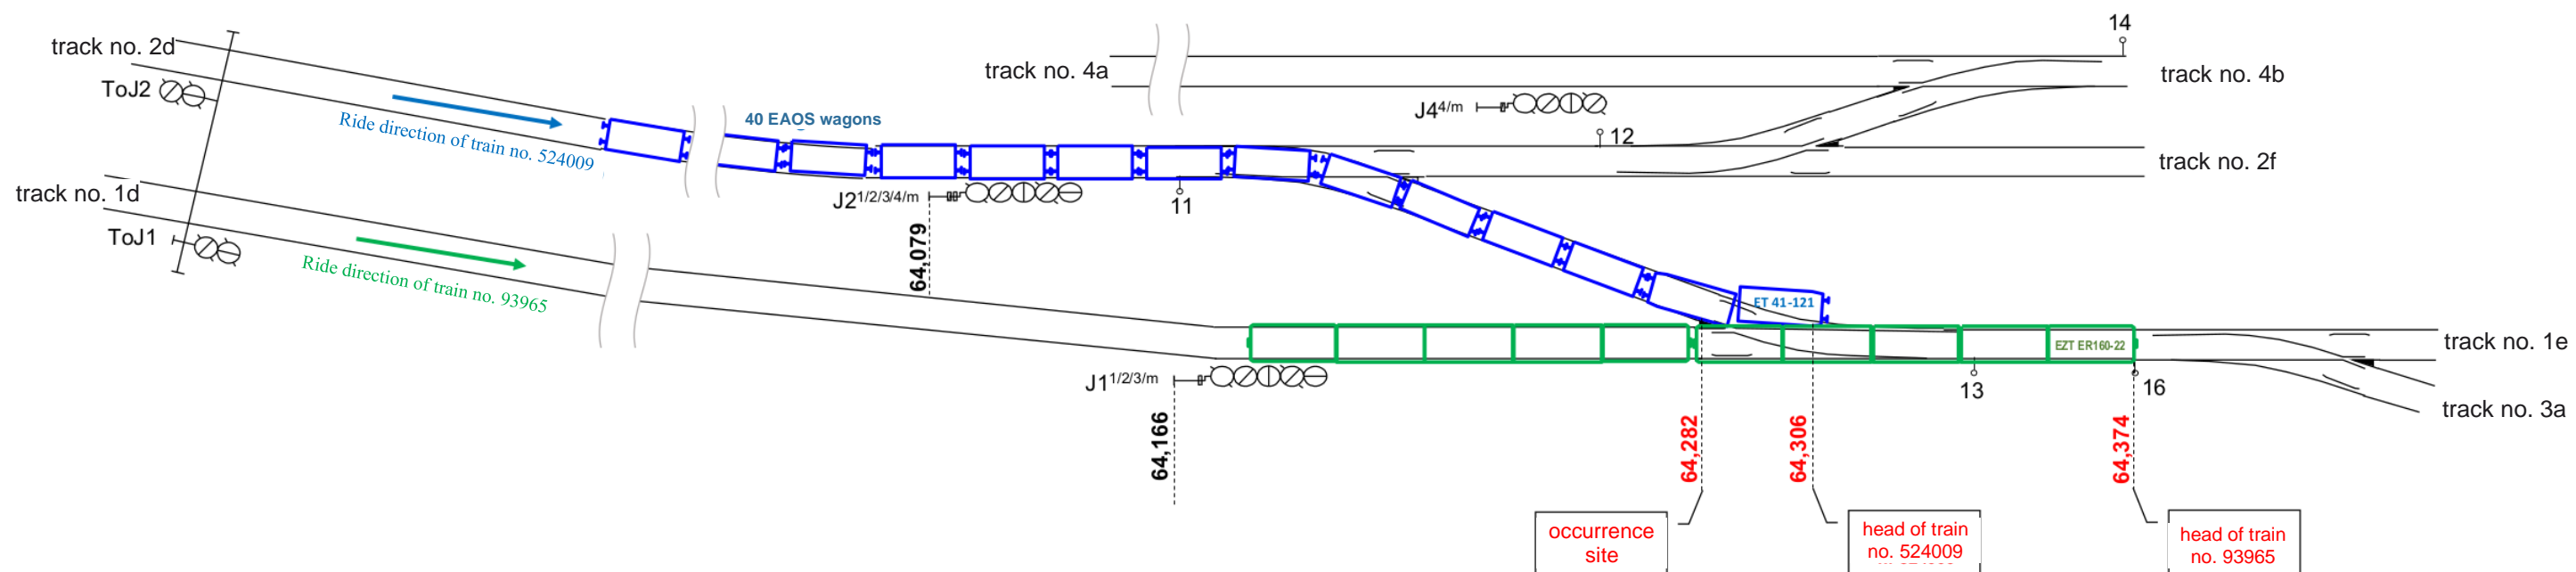
Figure 2 - Sketch of the accident (prepared by PKBWK)

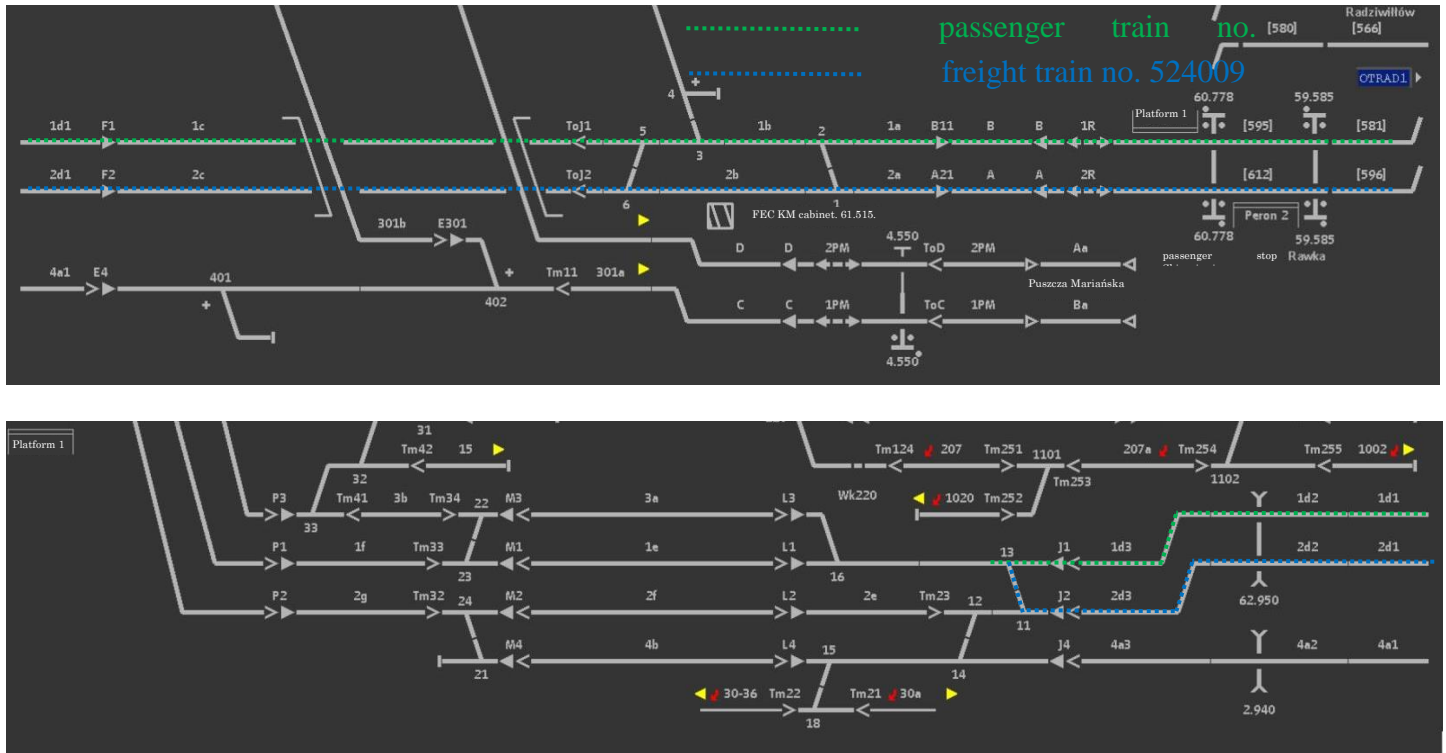
12:04:52.789312 hrs the ACE module sends information to the IM module that section Jz13 is occupied,
12:04:57.954876 hrs the EC module sends information to the IM module that switch no. 13 has been run through.

Figure 3 - A computer system screenshot with the train routes marked

Based on an analysis of the system records, it was established that the system operation was correct. At the time of the occurrence, switch no. 13 was locked in the right-hand position for the route set up for train no. 524009 from signal J2^{1/2/3/4/m} to track three.

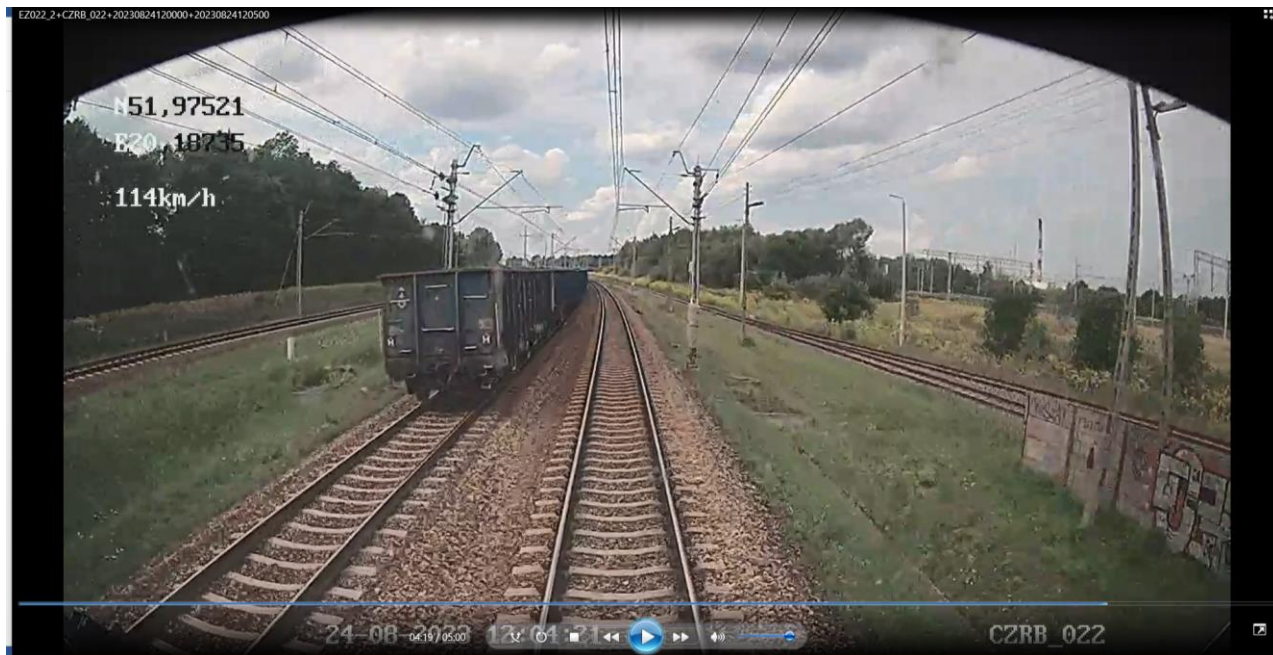
Photograph 7 - Driving foreground - the moment when the passenger train was approaching train no. 524009, a view from the camera of the EMU ER160-22

Driving at the speed of 111 km/h, the driver of the passenger train terminated the call at 12:04:39 hrs when the head of the train was 166 m ahead of the signal J1^{1/2/3/m} showing the aspect S1 "Stop", and implemented braking.

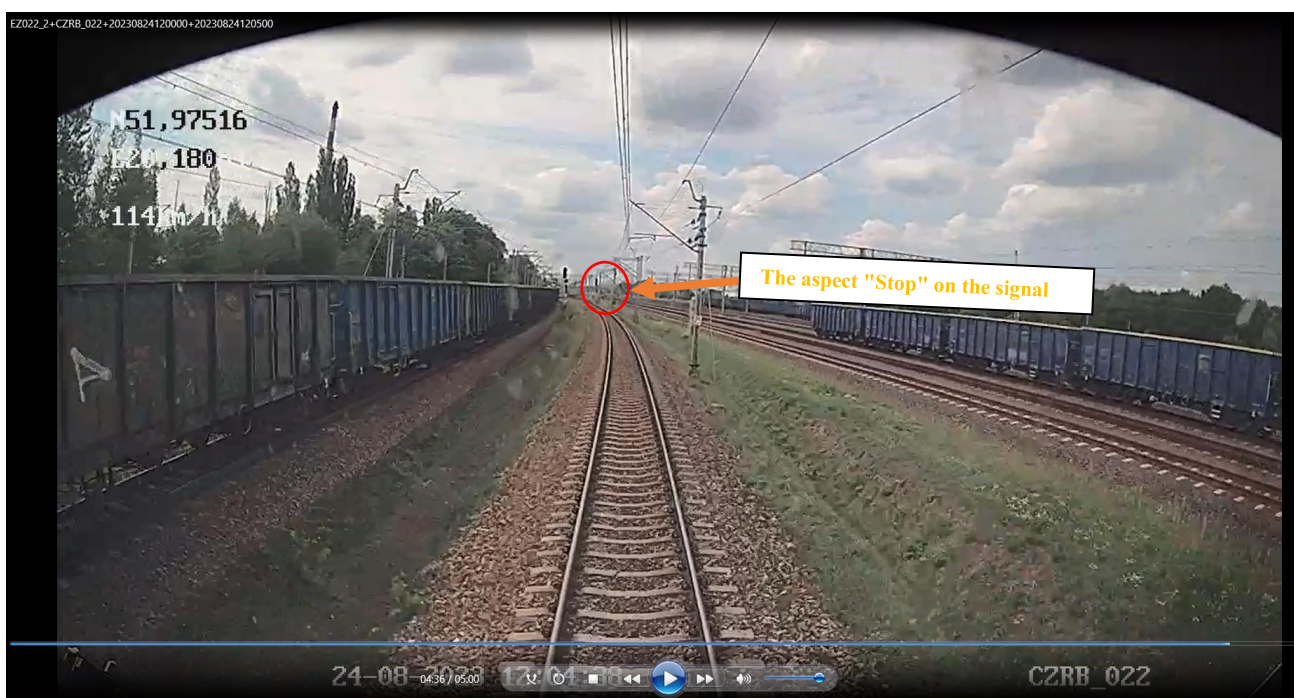
Photograph 8 - Driving foreground - a view of the intermediate signal J1^{1/2/3/m} from the camera of the EMU ER160-22

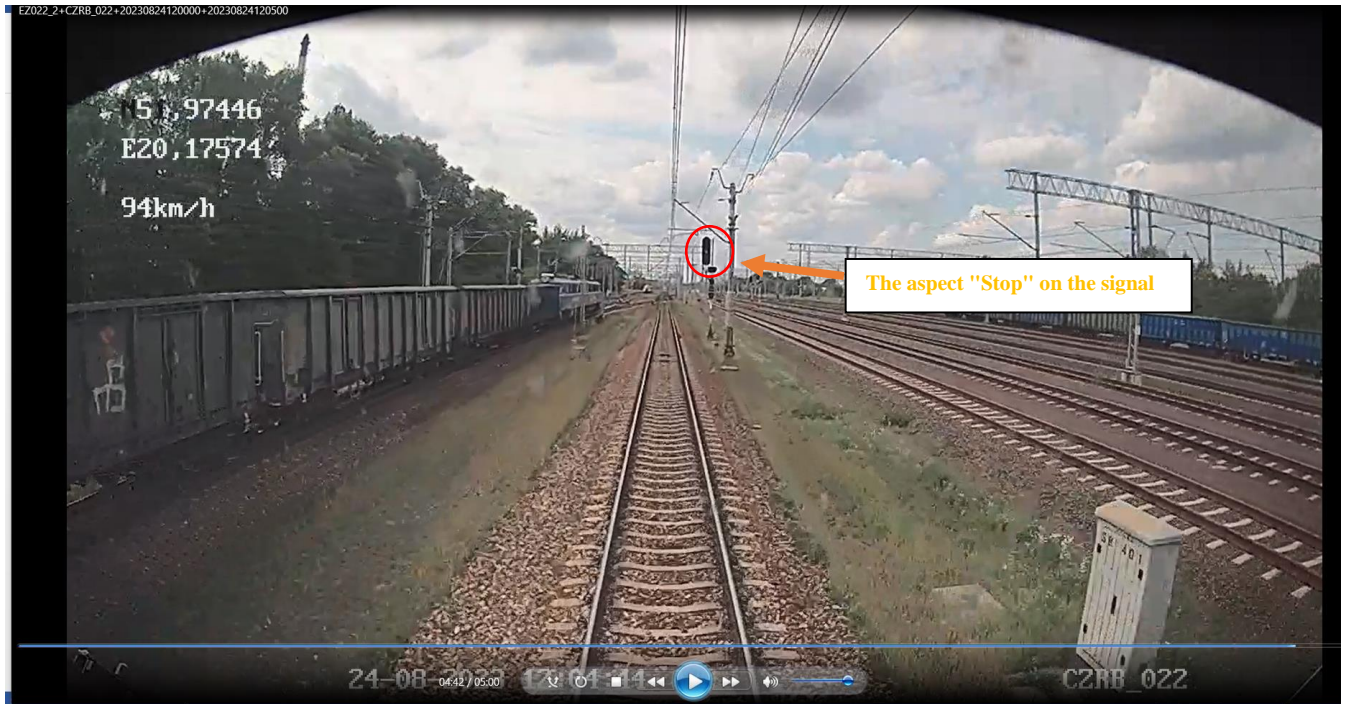
Photograph 9 - Driving foreground - a view of the signal J1^{1/2/3/m} from the camera of the EMU ER160-22

The driver of the passenger train applied the air brake reducing the speed to 78 km/h, and it was at that speed that he passed, at 12:04:46 hrs, the intermediate signal J1^{1/2/3/m} showing the aspect S1 "Stop" while at the same time pushing the Rp1 signal button "Attention". Despite applying the brake, the passenger train overtook the head of the freight train, entered turnout no. 13, "ran through" the switch, and found itself on route that had been correctly set up for the moving freight train. What happened at turnout no. 13 at km 64.282 as a result, was that the head of the ET41-121 locomotive drove into the left side of the first unit of the passing passenger train. The driver of the freight train transmitted the Rp1 signal "Attention" and after a while used the radio emergency signal "Radio-stop". The collision resulted in the derailment of the ET41-121 locomotive (the consequences of the occurrence are covered in Clause III.1.4 of the Report). The head of the freight train stopped at km 64.306, and the head of the passenger train at km 64.374.

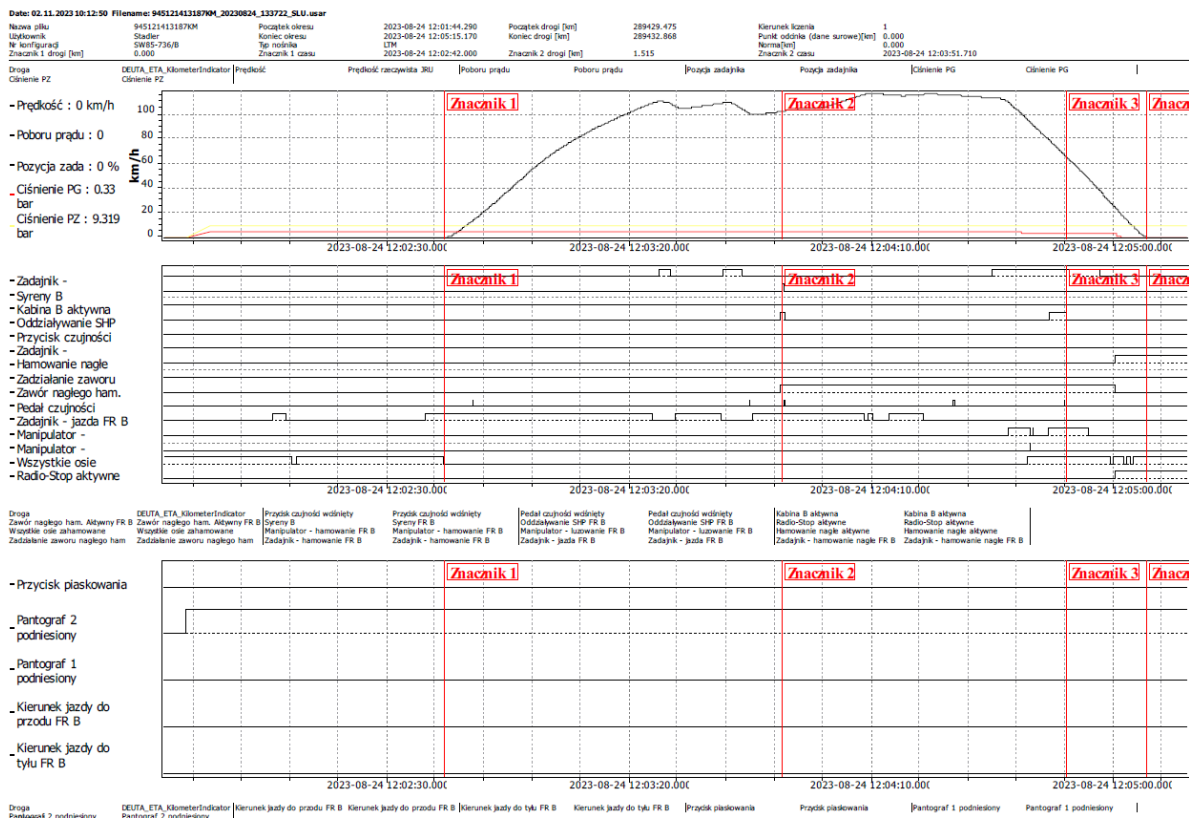
- 1) the time shown in the description is the recorded by the tachograph,
- 2) the train was driven from cab B,
- 3) the use of the vigilance button was recorded 7 times on the distance described.

Figure 4 - A graph of driving parameters of train no. 93965 "Koleje Mazowieckie - KM" Sp. z o. o. (prepared by PKBWK)

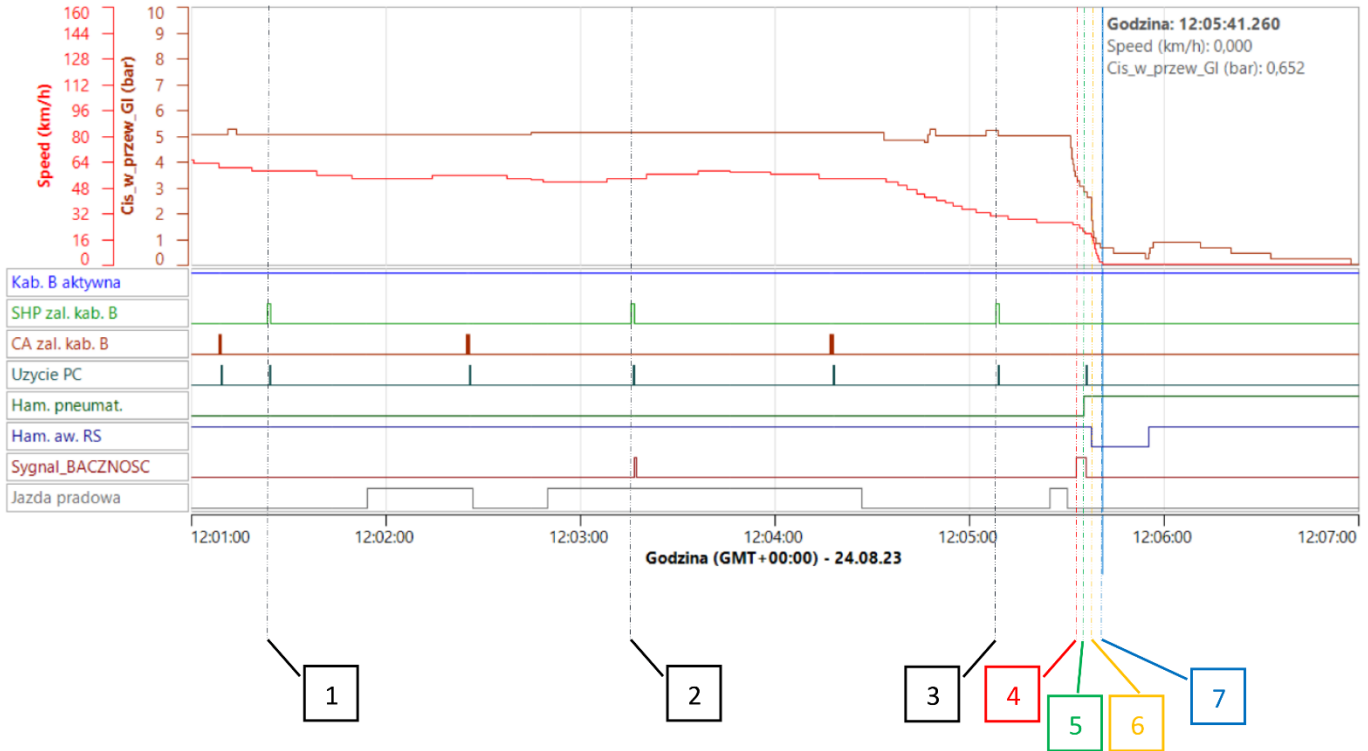
Figure 5 - A chart of driving of train PKP CARGO S.A. no. 524009 (prepared by PKBWK)

- 1- 12:01:23 hrs traversing over automatic train stop (SHP) of signal A, $V=58.4$ km/h
- 2- 12:03:15 hrs traversing over SHP of the warning disc ToJ2, $V=53.99$ km/h
- 3- 12:05:08 hrs traversing over SHP of the signal J2, $V=30.55$ km/h
- 4- 12:05:33 hrs the "Attention" signal is given, $V=24.83$ km/h
- 5- 12:05:35 hrs air braking is applied, $V=21.07$ km/h
- 6- 12:05:37 hrs Radiostop emergency braking starts, $V=17.38$ km/h
- 7- 12:05:41 hrs the train stops.
