REPUBLIC OF BULGARIA
NATIONAL AIR, MARITIME AND RAILWAY TRANSPORT, ACCIDENTS
INVESTIGATION BOARD (NAMRTAIB)

FINAL REPORT

**Investigation of railway accident – derailment of IDFT № 46660 between the stations Lyubenovo
transmission station – Radnevo on 03.02.2024**

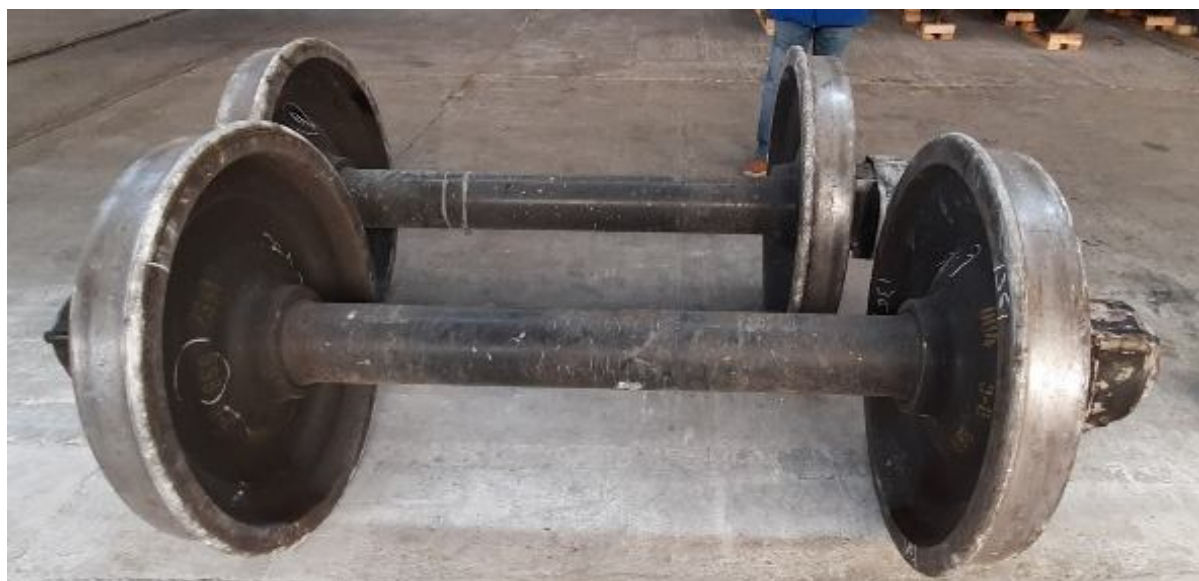
Fig. 2.3. The wheelsets of the derailed wagon № 21802475039-8

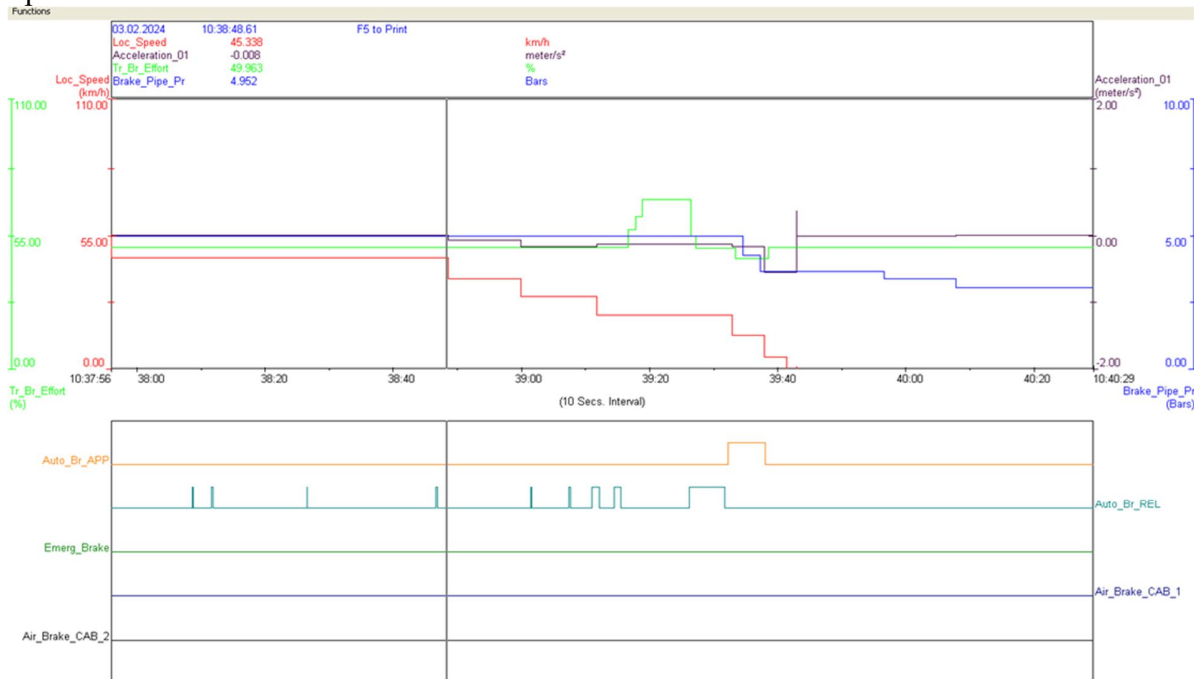
Fig. 4.5.

With a speed of 53.95 km/h, the train moved until 10:37:54 a.m., when it began to decelerate without activating the automatic train brake (Fig. 4.5). At 10:39:34 a.m. at a speed of 13.83 km/h, the pressure in the main air duct decreased due to the actuation of the automatic train brake by the locomotive driver (Fig. 4.6). IDFT No. 46660 settled in Radnevo station at 10:39:42 a.m. (fig. 4.7 and 4.8).

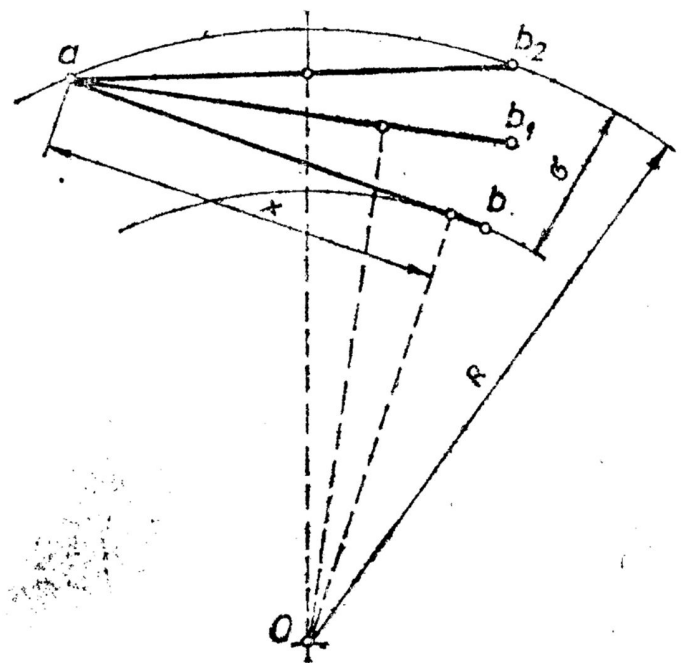
Fig. 4.15.

Simultaneously, the wagon moved in a curve. Calculations show that at a speed of 54 km/h and a base of the wagon $2l = 10$ m, the rear wheelset occupies a position of maximum crossing (Fig. 4.15).

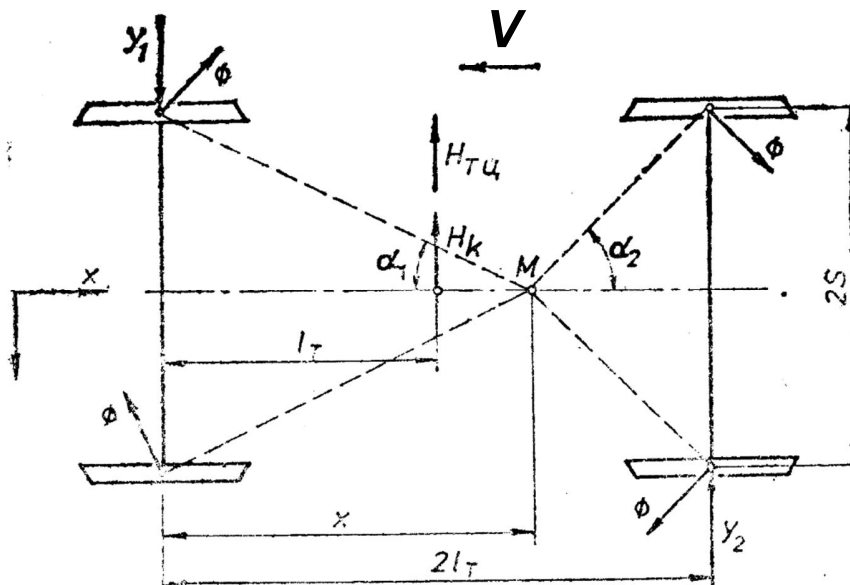
Y_1 and Y_2 are the guiding forces representing the reactions of the rails from the action of frictional forces, inertial forces and the action of the bodyshell (Fig. 4.16).

Fig. 4.16. Principal calculation scheme for defining the guided forces while moving the bogie in a curve.
