**Statens haverikommission**  
Swedish Accident Investigation Board

**NIB ANNUAL REPORT 2009**

**Swedish Accident Investigation Board**

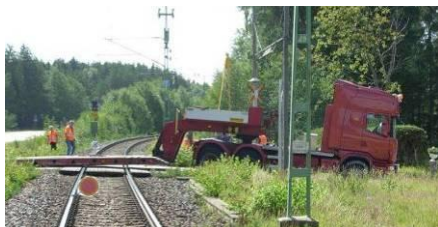
**RJ 2009:03**

Level-crossing accident between a lorry with a trailer and passenger train 3763 on the Stora Höga-Kode line, O county, on 11 April 2008.

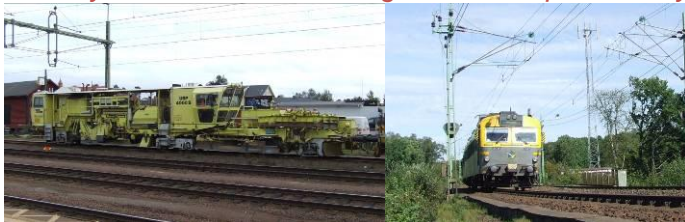
#### **Report RJ 2009:04**

Near collision incident between a carriage being shunted for transport and train 3539 at Bryngenäs station, Ö county, on 9 June 2008.
