Railway Accident Investigation Unit Ireland

Annual Report 2023

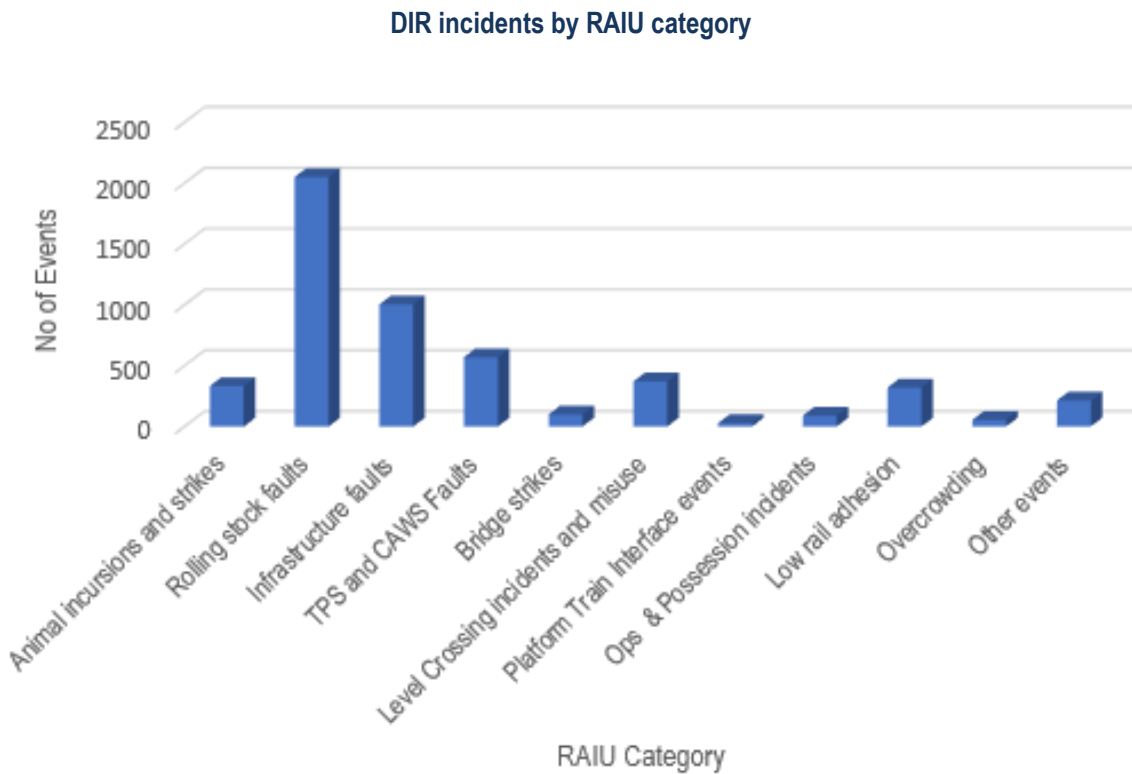
The above figures are presented in the bar chart below:

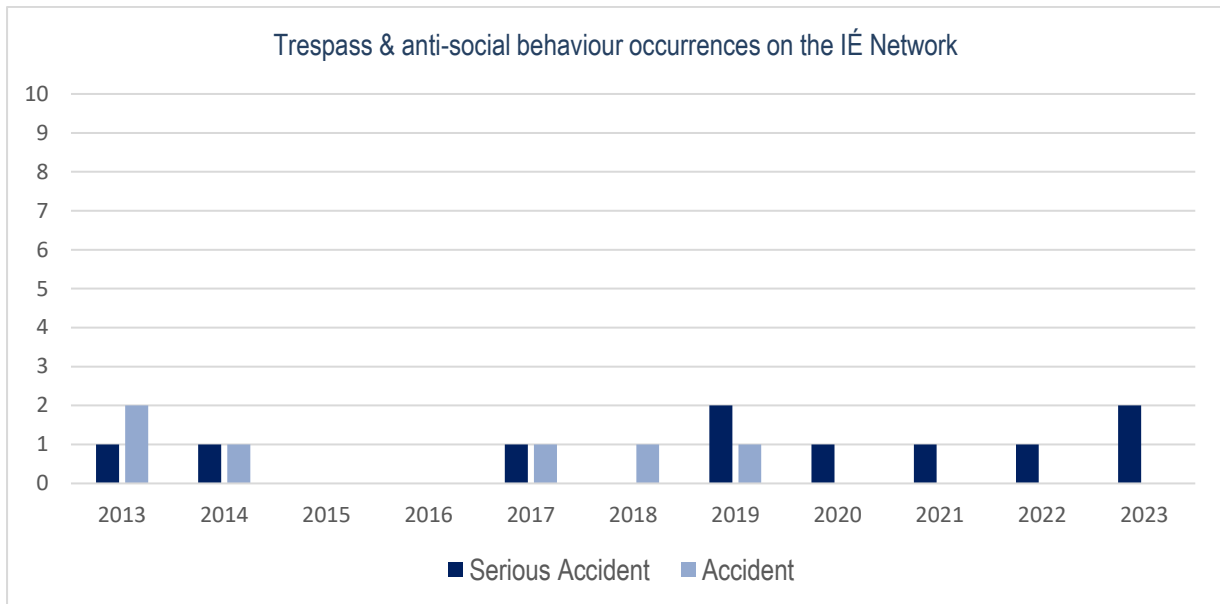
There were two reported fatalities as a result of trespass on the IÉ network in 2023, with the previous six years indicating low numbers.

Note, both 2023 serious accidents involved pairs of people trespassing, resulting in one further injury.

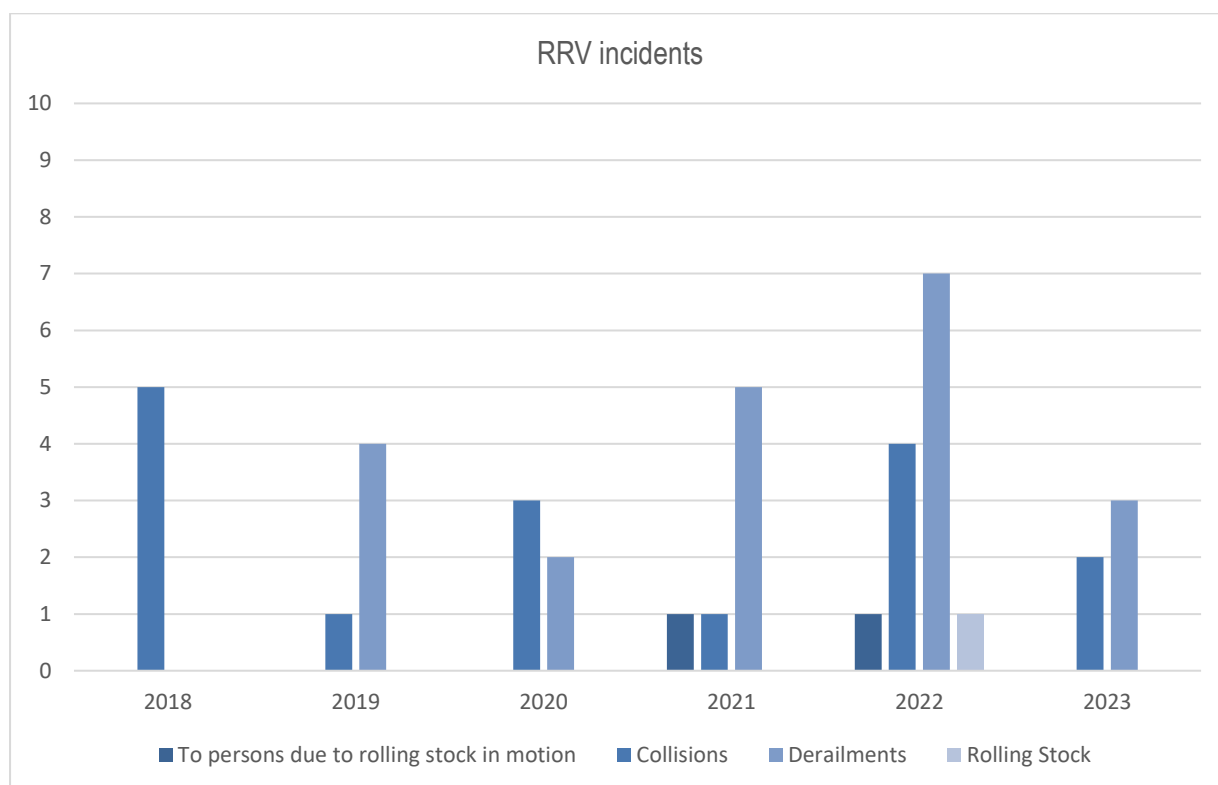
IÉ-IM have been notifying the RAIU of RRV occurrences since 2018, see figures below.

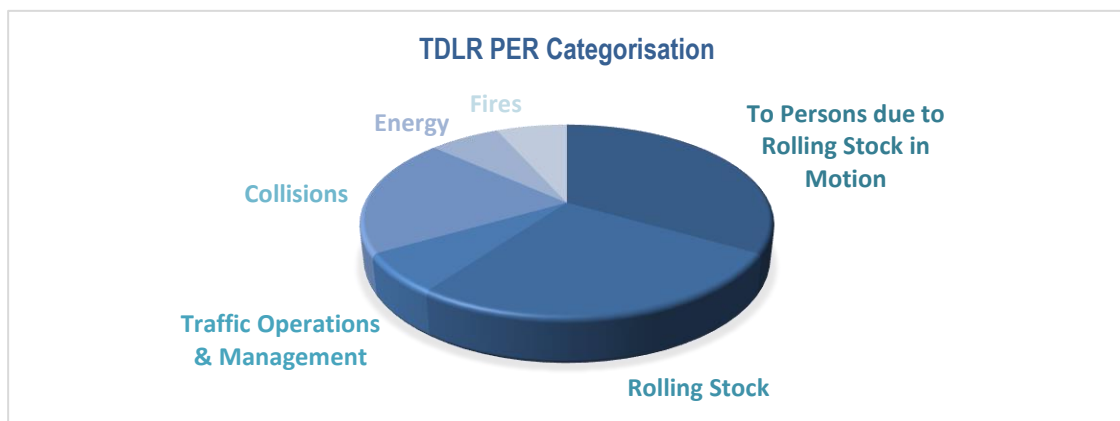
The pie chart below shows the percentages, in terms of categories, of the PERs for TDLR

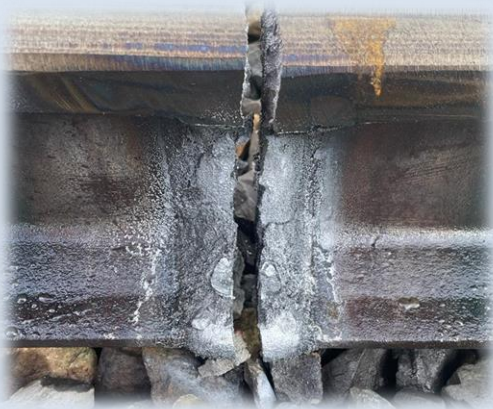
Broken rail near Emly Level Crossing, County Tipperary, 22nd February 2023

On the 22nd February 2023, at 07:56 hrs, the Signalman at Centralised Traffic Control (CTC) saw that a track circuit (near Emly LC) remained occupied after the passage of the 07:00 hrs passenger service from Cork to Heuston.

The Signalman contacted the Signal Electrical and Telecommunications (SET) Department to report the track circuit fault. SET staff members deployed to the location, and found a broken rail.

The location of the broken rail, had been subject to thermit welding the previous night, whereby the welders had some difficulties with the equipment associated with stressing the rails in preparation for welding. Just as the SET staff member had discovered the broken rail a train was approaching on the Up line. It was the 09:25 hrs passenger service from Cork to Heuston (Train A209). The SET staff member stepped out to a position of safety and signalled the train to stop. Train A209 travelled over the broken rail before coming to a stop.

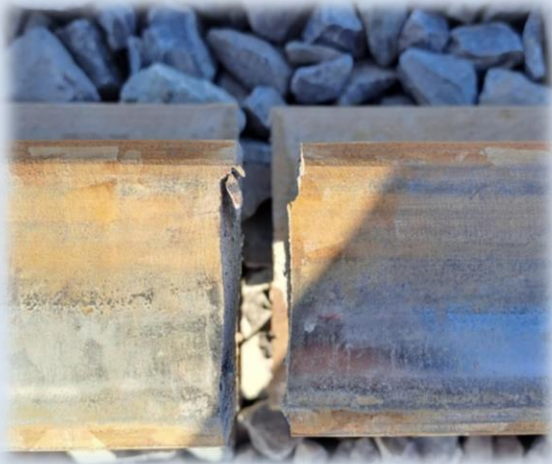
Broken rail, Newbridge, Kildare, 23rd February 2023

On the morning of the 23rd February 2023, as the 07:00 hrs Newbridge to Grand Canal Dock passenger service (Train P402) travelled on the Up line near Newbridge, Co Kildare; the driver saw an abnormal Continuous Automatic Warning System (CAWS) downgrade on the train's in-cab display and reported it to the Mainline Signalman. A number of other drivers reported the same abnormal downgrade at the same location.

The SET Department were advised, and an SET member of staff was dispatched to site to investigate and discovered a broken rail.

The broken rail was found to have fractured through a flash butt welded joint. The rail had been installed on the 28th January 2023 (five days earlier). The flash butt welding of the rail had been carried out off-site at IÉ-IM's Portlaoise Rail Welding Plant.

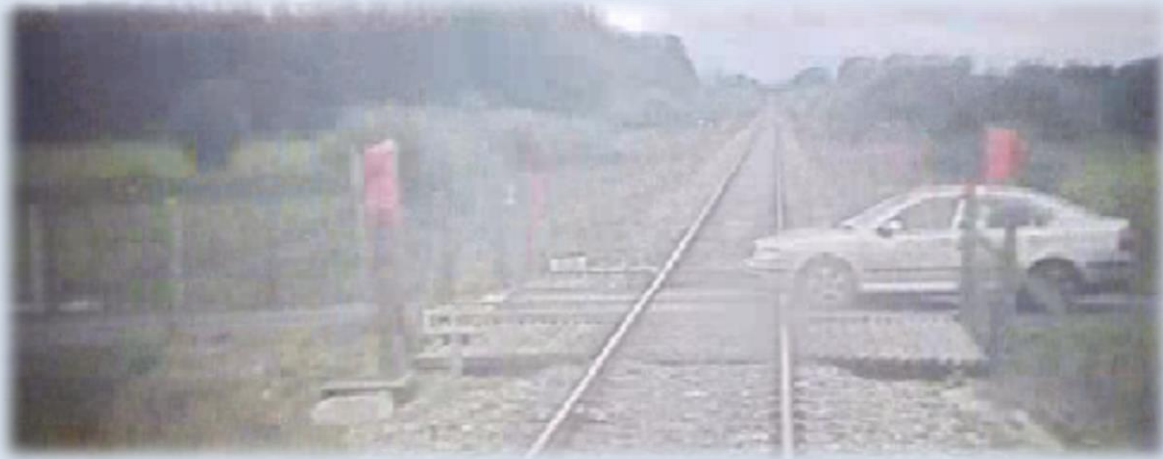
Collision between a car and a train at Prendergast's Level Crossing (XM190) Mayo, 9th September 2023

At approximately 15:15 hrs on the 9th September 2023 the 12:45 hrs Heuston to Westport passenger service was approaching Prendergast's Level Crossing, located between Ballyhaunis and Claremorris, when, at the same time a 2009 silver Skoda Octavia was approaching the level crossing, by road.

The gates at the level crossing had been left open to road traffic by a previous user, and the car did not stop on arriving at the level crossing.
